Constructing Longitudinal Joints In Hot-Mix Asphalt Pavements

C. R. FOSTER, S. B. HUDSON, and R. S. NELSON

This paper presents results of density and tensile strength test of samples cut from longitudinal joints in hot-mix asphaltic pavement. An unanticipated finding is that in semi-hot and cold joints there is a low-density zone at the joint in the lane paved first and a high-density zone at the joint in the lane paved subsequently. These zones are not present in hot joints made with pavers operating in echelon. These low- and high-density zones may well be the basic problem in constructing durable longitudinal joints in asphalt pavements.

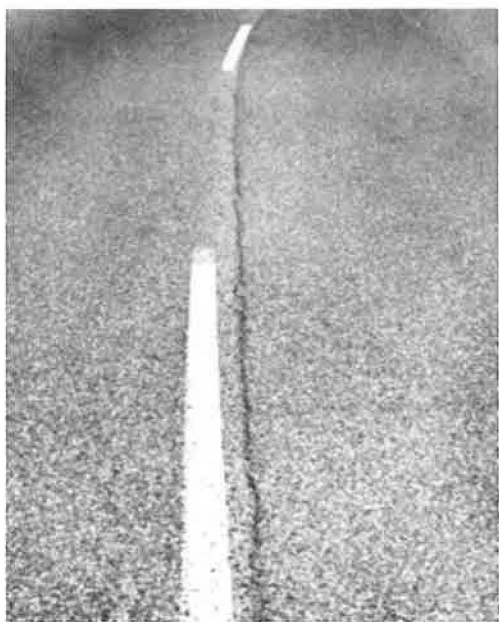
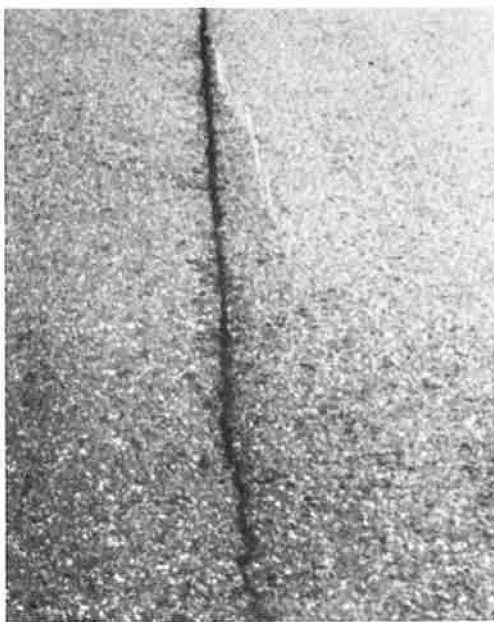
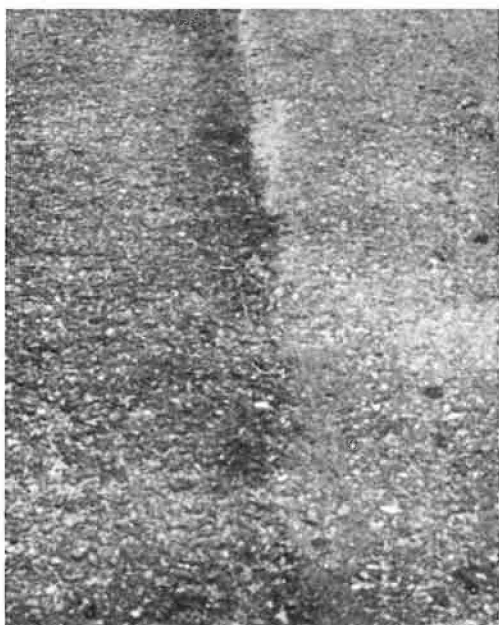
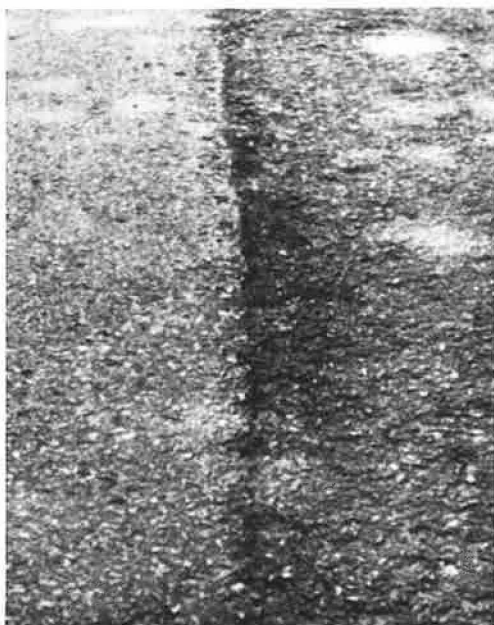
Figure 1. Visible defects at joints: (a) center line cracking, and (b) center joint raveling.

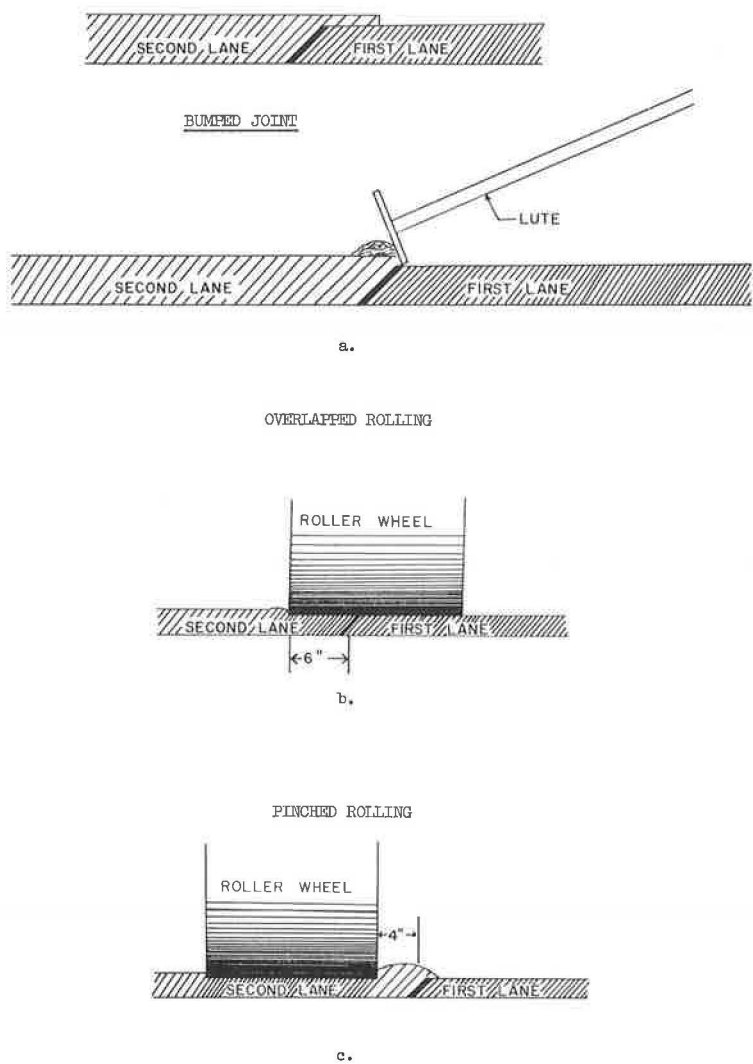
Figure 2.

back with a lute creating a bump (Fig. 2a). In the latter case, the overlap must be adjusted so that the roller can crowd the bump into the joint. Rolling may be started from the first lane overlapping the subsequent lane by about 4 in. (Fig. 2b) or on the subsequent lane pinching the material into the joint (Fig. 2c).

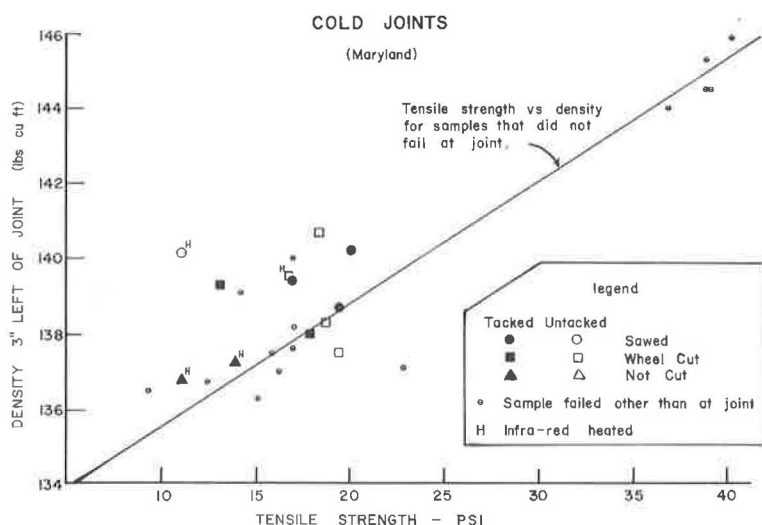
Figure 6.

Maryland Tension Tests.—Figure 6 is a plot of tensile strength vs density. Samples C-19 and C-22 failed at a crack present in the sample before the test was started and these values are not used. Also, three samples were not used because the density values seemed too low. Results of tests that failed at the joint are shown in large symbols. The points that plot well above the curve, indicating lower tensile strengths than nonjointed material of the same density, are all samples from joints cut back with either the wheel or the saw; however, some samples from joints that were cut back show strengths equal to nonjointed material. Cutting back the joint may, but not necessarily will, produce a low tensile strength. Figure 6 indicates that the tack coat (solid symbols) apparently increased the tensile strength for sawed joints but not for wheel-cut joints. Of samples that failed at the joint, nine were tacked and five were not; of those that failed away from the joint, four were tacked and seven were not. This indicates that the tack was not effective in increasing tensile strength.

The data plotted on Figure 6 do not indicate that infrared heating was effective in increasing the tensile strength of cut joints.

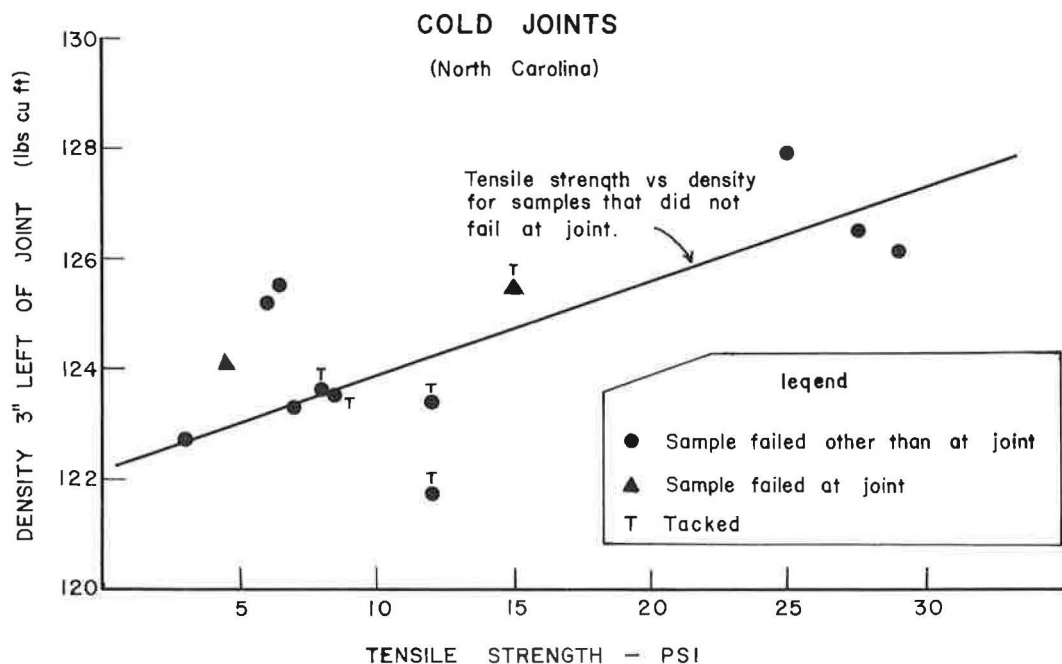
Figure 7.

North Carolina Tension Tests. — Figure 7 is a plot of tensile strength vs density.
