# HIGHWAY RESEARCH RECORD

Number 61

Maintenance Practices—1963  
Administration, Methods and  
Materials  
7 Reports

Presented at the  
43rd ANNUAL MEETING  
January 13-17, 1964

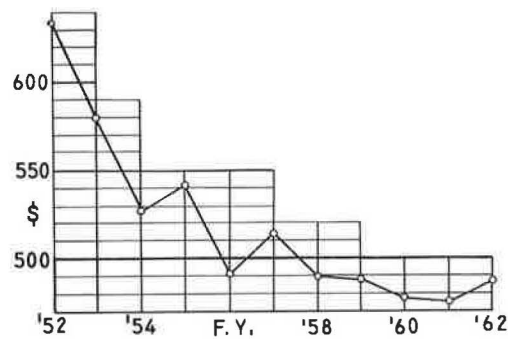
Figure 1. Average unit repair cost, all equipment except sedans.

Eleven months after the introduction of the in-service course on lubrication and preventive maintenance, the average annual unit repair cost decreased \$55 for FY 1953, with a further decrease of \$107 during the following year. With consideration for the units on inventory each year, this represents a saving of more than \$266,000 during the first year and an additional saving of over \$508,000 during the second year. The average annual repair cost per unit, starting with FY 1952 and including FY 1962, is shown in Figure 1.

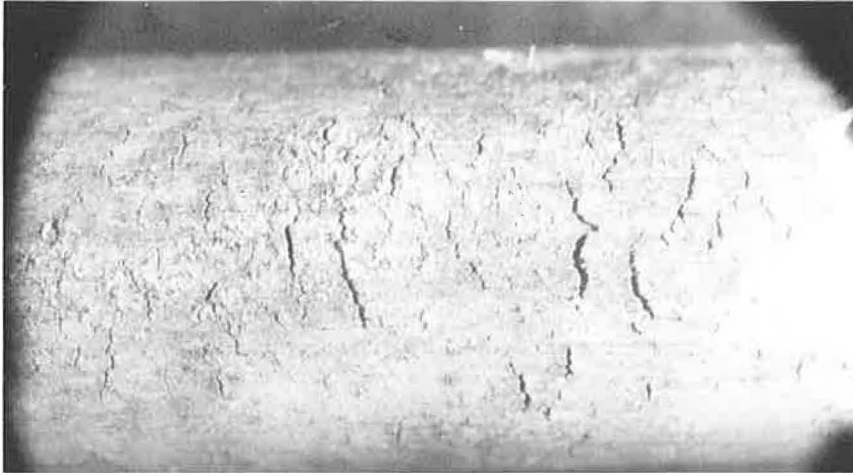
Figure 2. Specimen corroded by exposure to NaCl solution and pulled.

amount as indicated by the elongation data. A distinctive corrosion pattern was produced by each type of salt solution. A comparison of these surfaces shows that the specimen exposed to NaCl (Fig. 2) was appreciably more corroded than the specimens exposed to either CaCl<sub>2</sub> (Fig. 3) or urea (Fig. 4) solutions.

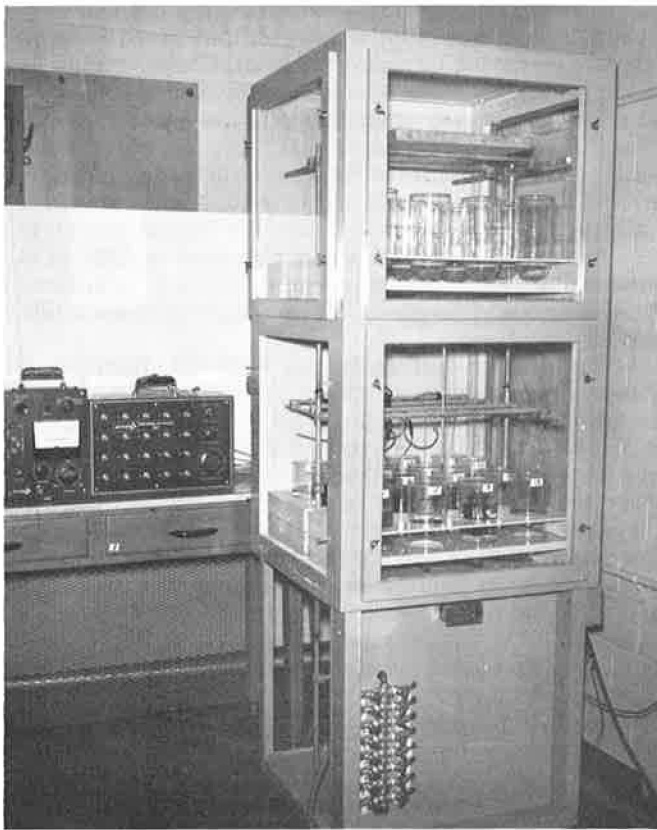
Figure 6. Apparatus for alternate immersion of specimen in ice melting solutions and suspending in air.

The machined specimens were then cleaned with acetone and two strain gages were cemented, using Armstrong Cement A-2,  $180^\circ$  apart on the gage lengths of each specimen. The specimens were then mounted in jigs and loaded to the proper stress level. Once the loaded specimens were stabilized, the strain gages were removed. The jig and everything except the test gage section of the specimens were coated with stop-off lacquer. Following this, the jigs were mounted in the apparatus (Fig. 6) which provided alternate immersion in the test solutions and air-drying of the specimens.

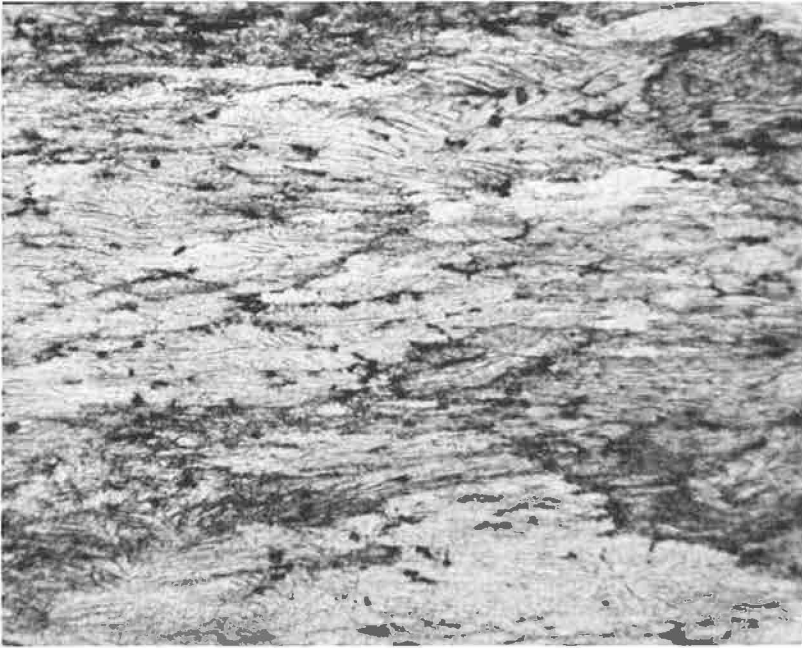
Figure 7. Photomicrograph of typical structure (parallel to long axis) of forged 7079-T6 billet (60X)—Keller's etch.

Figures 7 and 8 are photomicrographs (60X) representative of the 7079-T6 forging from which all specimens were cut. Figure 7 shows a view of the gross grain structure of the billet parallel to the long axis of forging. The grains, while not well defined, appear to be generally greater than 0.075 in. long. Even at this low magnification their length is greater than the field shown. Such grain size is considered typical for the alloy in a T-6 condition. Figure 8, taken perpendicular to the long axis of the 7079 forging, shows the distribution and size of the grains in Figure 7 from an end

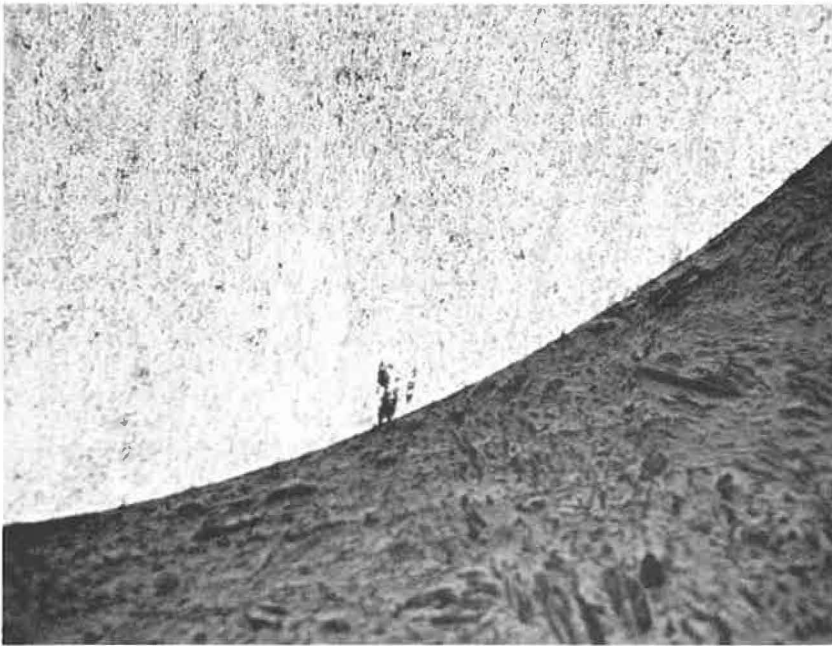
Figure 10. Photomicrograph of cross-section of specimen 13A after cyclic exposure under stress to NaCl solution for 238 hr (60X)—HF etch.

Figure 10 is a photomicrograph at 60X of specimen 13A, which failed after cyclic exposure of 238 hr in NaCl solution. This specimen appears different from that of Figure 9, as it was etched with Keller's solution. The pit shown is about 0.005 in. deep by 0.002 in. wide and was the only one found on the particular cross-section. In general, substantially fewer pits were found in the general area of the pit shown. In this series, surface pitting was less frequent and extensive on specimens exposed to NaCl solutions than ones exposed to CaCl<sub>2</sub> solutions.

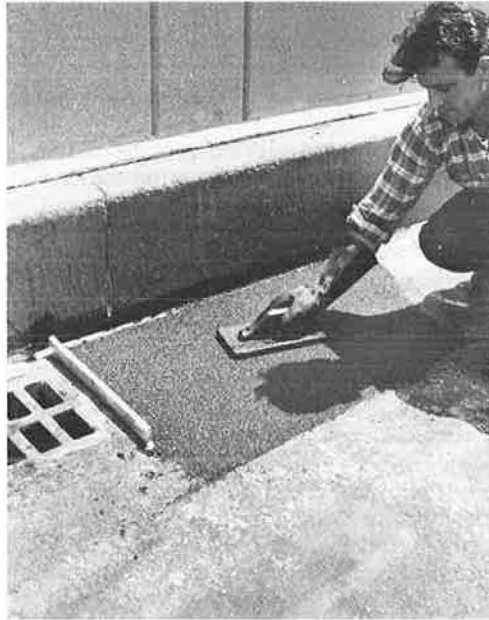
Figure 1. Goethals Bridge, epoxy-coal tar patching compound installed as deck repair.

The silica sand asphalt pavement was removed by heater planers and infrared heaters. Engineers sounded the concrete deck to locate areas of concrete deterioration and repairs were made using an epoxy coal tar patching compound for thin surface patches (Fig. 1) and portland cement concrete for deep patches.

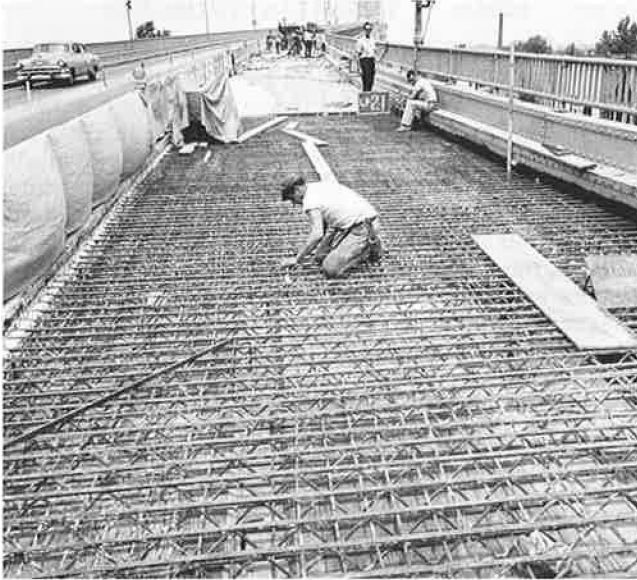
Figure 3. Bayonne Bridge, concrete rehabilitation of full slab depth.
