# **Effect of Bridge Deck Insulation on Icing Conditions**

MALCOLM D. GRAHAM, IGNATIUS F. RIZZUTO, and JOSEPH A. CORBISIERO Respectively, Director, Associate Civil Engineer, and Senior Civil Engineer, Bureau of Physical Research, New York State Department of Public Works

The effectiveness of urethane foam sprayed on the underside of bridge decks as insulation to reduce icing was evaluated. A tri-level interchange in Rochester, N. Y., was selected for the experimental installation. Surface temperatures of the upper and lower decks and the approach pavements were measured continuously before and after application of the urethane foam. Supplementary information included precipitation records, visual observations of icing, traffic studies, and an examination of a previously insulated bridge.

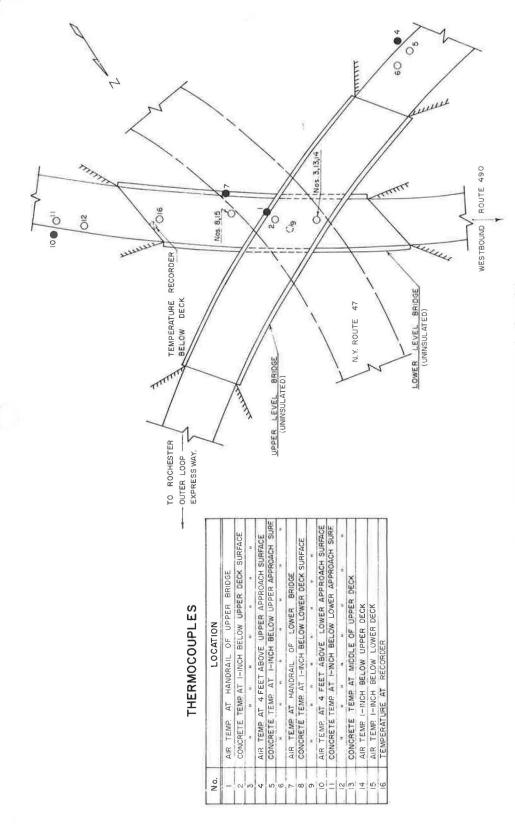
Figure 1. Location of thermocouples (1961-1962).

The experimental bridges are situated in the southeastern section of Rochester nea the city line. The two structures form part of a three-level interchange at the intersection of the Outer Loop Expressway, I-490, and N. Y. 47 (Figs. 1 and 3). An adjacent railroad overpass (Fig. 2) was used as a control structure after the test bridges were insulated.

Sixteen thermocouples were installed on the uninsulated test bridges and at other locations shown on Figure 1. Later, when the decks were insulated, three of the thermocouples were removed and placed in the adjacent uninsulated railroad overpass (Fig. 2). The thermocouples consisted of 24-gage nylon-coated copper-constantan wire installed in  $\frac{1}{2}$ -in. diameter holes in the decks and approach pavements. The holes were drilled completely through the decks, and the thermocouples were inserted from the underside (Fig. 4). This facilitated filling the annular space with an epoxy grout. (Laboratory tests of the epoxy grout and ordinary cement mortar showed no significant difference in heat transfer characteristics.) The leads were conducted along the underside of the decks and secured to the concrete with metal fasteners. The only exception to this procedure was the installation of the thermocouple for the uninsulated control deck. Because of the railroad's restrictions concerning the suspension of wire over the tracks, this thermocouple was installed through the top of the deck. Holes were drilled to a depth of 1 in. in the approach pavements and deck, and the thermocouples were installed from the top. The leads were conducted to the pavement's edge in saw

A 16-channel automatic recorder completed a full cycle of temperature measurements every 16 min (one channel a minute) and printed the results on a roll of calibrated graph paper. The recorder was protected by an insulated plywood housing mounted on the east abutment headwall of the lower bridge (Fig. 1). The housing was equipped with an electric baseboard heater, thermostat, and electric light.

differences and general temperature patterns. Unless otherwise noted, the information represents combined hourly averages of the thermocouples in each element, i.e., decks, approaches, and air. In this connection, all references to the lower deck are based on a single thermocouple, No. 8 in Figure 1. The results of thermocouple No. 9 were excluded since it was continually shaded by the upper deck and could not be compared with the exposed thermocouples.

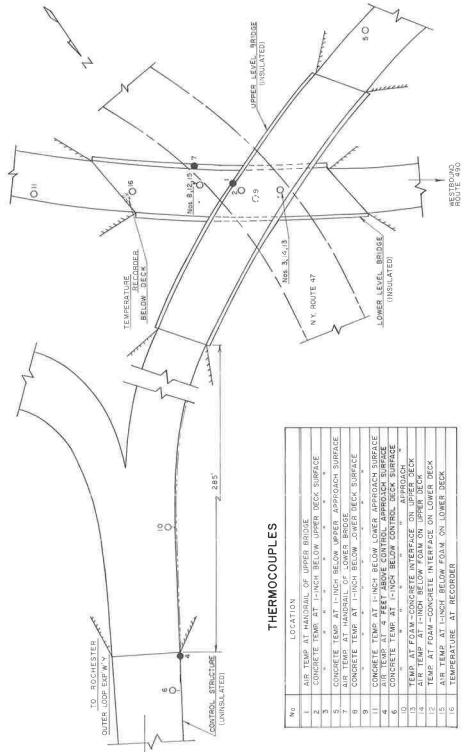
Figure 2. Location of thermocouples (1962-1963):

tions are shown in Figure 2. Consideration had been given to maintaining half of the upper and lower decks uninsulated to serve as the control. However, the possibility of creating a hazardous differential icing condition made this arrangement inadvisable. Instead, the nearby uninsulated railroad overpass was instrumented.

Electronic data processing was used to analyze the large volume of data. This made it feasible to use all the temperature readings to compute average parameters. However, the results are plotted in the accompanying illustrations only for the periods discussed. It is noted again that all references to the lower insulated deck are based on a single thermocouple, No. 8 in Figure 2, since thermocouple No. 9 was shaded all of the time.

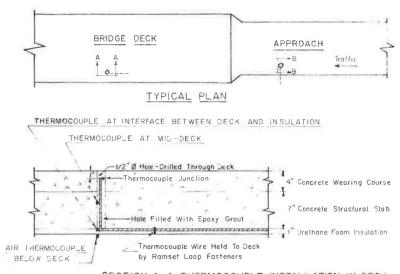
Figure 4. Typical thermocouple installations.

SECTION A-A THERMOCOUPLE INSTALLATION IN DECK

SECTION B-B THERMOCOUPLE INSTALLATION IN APPROACH

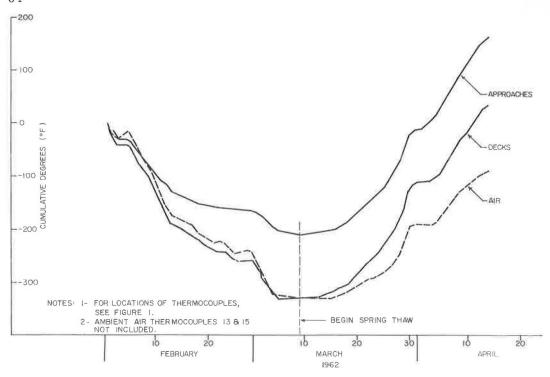
Figure 8. Cumulative degrees above and below 32 F, Feb. 2 through April 14, 1962, uninsulated condition.

A similar approach was used in the present study. Figure 8 shows the resulting graphs for the uninsulated decks, approach pavements, and ambient air. In this case, the recording period began when average temperatures were generally below 32 F (Feb. 2, 1962). Consequently, the curves exhibit an initial downward trend which continues until maximum negative values are reached corresponding to the beginning of the spring thaw on about March 9, 1962. Thereafter, they reverse their direction and climb steadily in response to above-freezing mean temperatures, completing the negative portion of the cycle. The fact that the positive half of the cycle is not included does not invalidate the results since any segment of the period can be studied in this manner.

Cumulative Temperature Changes. -Figure 11 depicts cumulative temperatures of the insulated decks, uninsulated control deck, approaches, and ambient air for the entire winter and subsequent thaw. The characteristic sine curves described in connection with the previous season (Fig. 8) are clearly evident in this case. The downward trend signifying the start of winter began about Dec. 9, 1962 and ended with the spring thaw on March 2, 1963. With few exceptions, all the curves descend progressively farther below the approach curve, again demonstrating the moderating effect of the embankments.

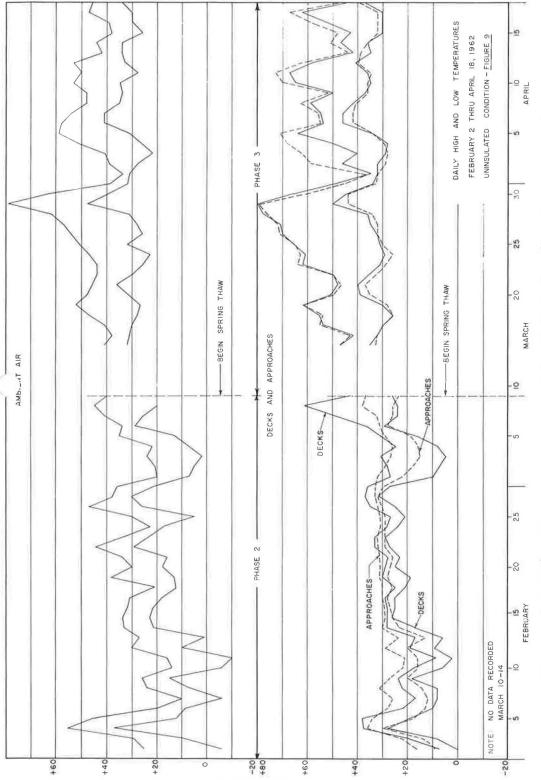
Figure 9. Daily high and low temperatures, Feb. 2 through April 18, 1962, uninsulated condition.

Phase 2 (Feb. 2 to March 9, 1962).—During this 36-day period, below-freezing temperatures prevailed. The structures were covered with several inches of snow most of the time, which moderated the effect of the sun on deck and approach temperatures. Consequently, a more stable temperature condition existed than would occur under traffic. This is illustrated in Figure 9 which depicts daily high and low temperatures for the entire recorded period.

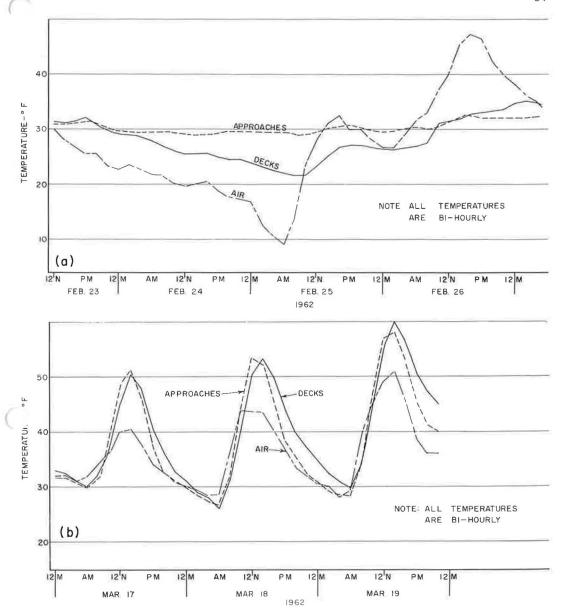
Figure 10. Typical temperature patterns (uninsulated condition): (a) Phase 2, and (b) Phase 3.

The characteristics of the temperature patterns in the approaches, uninsulated decks, and ambient air typical of this phase are shown in Figure 10a for a 4-day period in February 1962. The greater uniformity and generally higher temperatures of the approaches, compared with the decks and the air, are clearly evident. Throughout the recorded period, the variations in deck temperatures were often sufficient to produce a complete freeze-thaw cycle while the approaches remained essentially frozen. As a result, the decks completed 12 freeze-thaw cycles, compared with 6 and 18 for the approaches and air, respectively. Other corroborating comparisons, such as average temperatures and cumulative daily temperature changes (Fig. 7), can be made. However, because of the effects of the snow cover, the numerical values have limited significance.

Figure 10b illustrates several significant facts typical of this phase. In the absence of a snow cover, the approaches were as sensitive to ambient air temperature changes as the uninsulated decks. This is evidenced by almost identical temperature patterns. In fact, the approaches and decks developed the same average temperature for the period (44 F) and total number of freeze-thaw cycles (14). More important, however,

the approaches frequently attained below-freezing temperatures at the same time as the decks, or sooner. Therefore, when precipitation accompanied these freezing intervals, it is probable that ice frequently formed on the approaches before or at the same time as it formed on the decks. These findings are contrary to the premise that uninsulated decks always develop ice sooner and more frequently than their approach pavements.

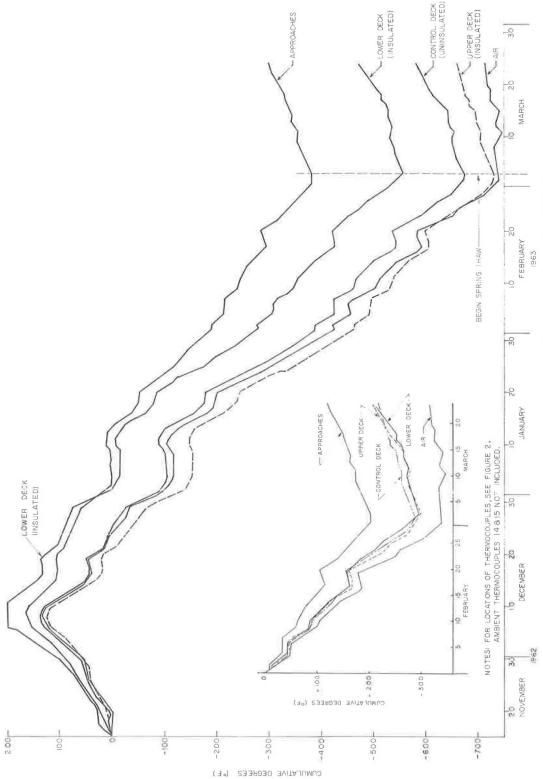
Cumulative degrees above and below 32 F, Nov. 15, 1962, through March 24, 1963 (insulated condition). Figure 11.

From the relative positions of the bridge deck graphs, it appears that the upper insulated deck was consistently colder than the lower deck and control structure. This would conflict with the results of the previous season, for which the temperatures of the two uninsulated decks were so similar that they were averaged for Figure 8. To permit a direct comparison with the first winter, the corresponding period on Figure 11 has been reproduced in the inset. This shows that from the beginning of February, the three decks maintained essentially the same temperatures. Moreover, the temperature patterns for the two seasons are nearly similar, except for a slight displacement of the spring thaw. It is apparent, therefore, that the urethane foam has been unsuccessful in maintaining the temperature levels of the approach pavements during much of the winter.

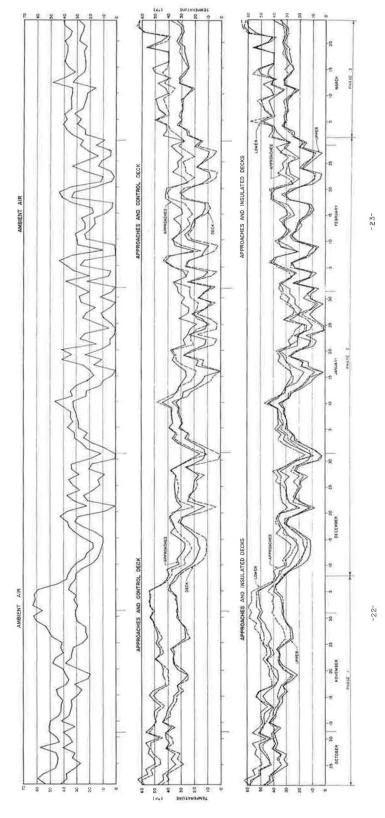
Daily high and low temperatures, Oct. 21, 1962, through March 24, 1963 (insulated condition).

Phase 1 (Oct. 21 to Dec. 8, 1962).—This 41-day period consisted mainly of mild days and cool nights. Every year, the latter part of this period is generally associated with early morning frost, as suggested by Figure 12 which shows that daily low temperatures frequently dipped below freezing after Nov. 15.

The insulated decks performed markedly differently from each other during most of this phase. In general, the lower insulated deck developed higher daily temperatures than the upper deck (Fig. 12). In fact, the daily low temperatures of the lower deck were very similar to those of the approaches, whereas the upper deck closely followed the control structure. This pattern was not as consistent with the corresponding high temperatures, although a parallel situation did occur occasionally. Significantly, the lower deck maintained virtually the same average temperature as the approaches for this phase, 41.7 F vs 41.6 F (Table 1); it was in a frozen state for less time (0.3 percent vs 2.8 percent); it underwent fewer freeze-thaw cycles (1 vs 4); and similar to the approaches, it froze after and thawed before the control deck (Fig. 13). On all counts, therefore, the lower insulated deck equaled or outperformed the approaches. This was not the case for the upper insulated deck, whose performance was almost identical to the control deck; i.e., average temperature, 39.1 F vs 40.1 F; portion of time below 31 F, 6.8 percent vs 6.0 percent; number of freeze-thaw cycles, 10 vs 10; and sometimes froze before the control deck (Fig. 13).

Corresponding counts for the evening rush hours between 4 and 6 PM, and for 24 hr were 1,150 vs 1,650 and 10,800 vs 5,200, respectively. These data suggested that the generally greater volume of traffic on the lower deck might have raised the deck temperature. However, no correlation could be established. In fact, it was found that the upper deck occasionally attained higher temperatures than the lower level (for example, Nov. 11 and 12 and Jan. 2-9, Fig. 12).

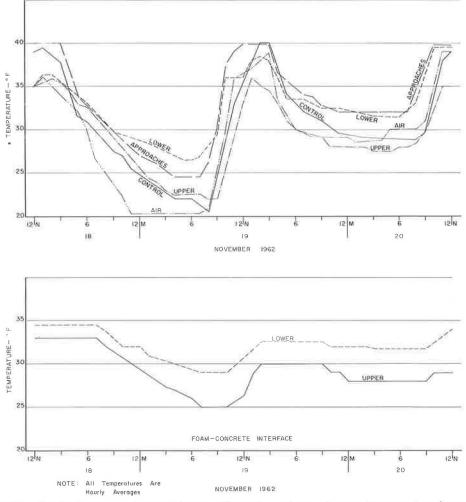
Figure 13. Typical temperature patterns, Phase 1, autumn freeze-thaw cycles (insulated condition).

Another important comparison can be made between the control deck and the approaches. Figure 13 represents hourly average temperatures for a typical 48-hr period in Phase 1. On Nov. 18, at approximately 1:30 PM, the control deck and approaches were at essentially the same above-freezing temperature. By 6:00 PM, the ambient air and control deck temperatures had fallen below the 31 F reference mperature. However, the approaches did not freeze until 2 hr later. The following norning, when the approaches attained a thawed condition (33 F) at about 9:30 AM, the deck temperature was 26 F. The next cycle showed an even greater difference in temperature variations. The control deck cooled to a low of 28.5 F on the morning of Nov. 20, 1962, and then thawed in the afternoon. In contrast, the approaches never cooled below 32 F. For the structures under discussion, therefore, the evidence demonstrates that the uninsulated control deck generally reached a frozen condition quicker and more often than the approach pavements, that it maintained below freezing temperatures for longer periods of time, and that it thawed after the approaches. The consequence, in terms of icing, would depend on conditions of humidity and precipitation.

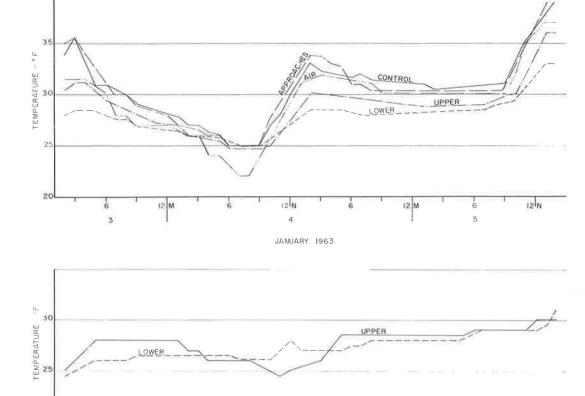
Figure 14. Typical temperature patterns, Phase 2, winter freeze-thaw cycles (insulated condition).

With regard to rates of freezing, Figure 14 shows that the control deck attained a freezing temperature (31 F) before the approaches on Jan. 3, 1963, but did not freeze until several hours after the approaches in the following cycle. Similar alternating conditions occurred throughout this phase, some of which were witnessed by field inspectors during periods of precipitation. This behavior is evidently the result of the equalizing effect of the approach embankments, which tend to absorb heat from the approaches after cold periods and to release heat stored during warmer periods. The sequence of thawing was also found to be equally divided.

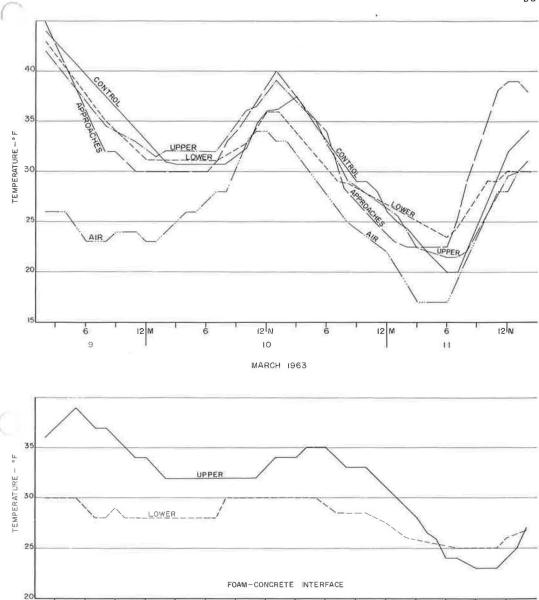
Figure 15. Typical temperature patterns, Phase 3, spring freeze-thaw cycles (insulated condition).

cyclical patterns (Figure 15), maintained almost the same average temperature, and underwent an identical number of freeze-thaw cycles (Table 1). As in the previous year, the approaches frequently attained a frozen condition before the control deck. Significantly, the approaches also maintained below-freezing temperatures a greater percent of the time (18.3 percent vs 15.6 percent for the control deck). These data further disprove the belief that uninsulated decks always develop ice quicker and more often than approach pavements. However, except for a few instances, the approaches attained above-freezing temperatures long before the control deck.
