Break-Away Components Produce Safer Roadside Signs

ROBERT M. OLSON, NEILON J. ROWAN, and THOMAS C. EDWARDS,
Assistant Research Engineers, Texas Transportation Institute, College Station, Texas

Studies of the behavior of certain types of roadside sign supports subjected to collisions are described in this paper. The selection of the types of supports considered was predicated on Texas Highway Department design procedures and the development of interim concepts which would minimize hazards. Certain devices were introduced into the sign supports, and full-scale crash tests were conducted to observe the impact behavior of supports containing these devices. These studies have resulted in revised design details which have been included in current construction operations in Texas.

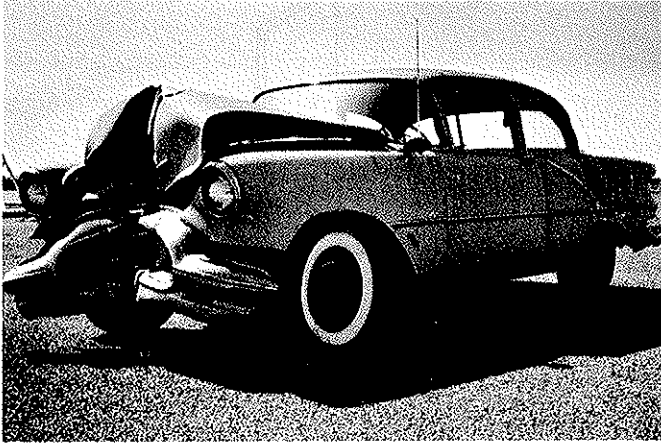
Figure 3. Vehicle damage, slow-speed fixed post test.

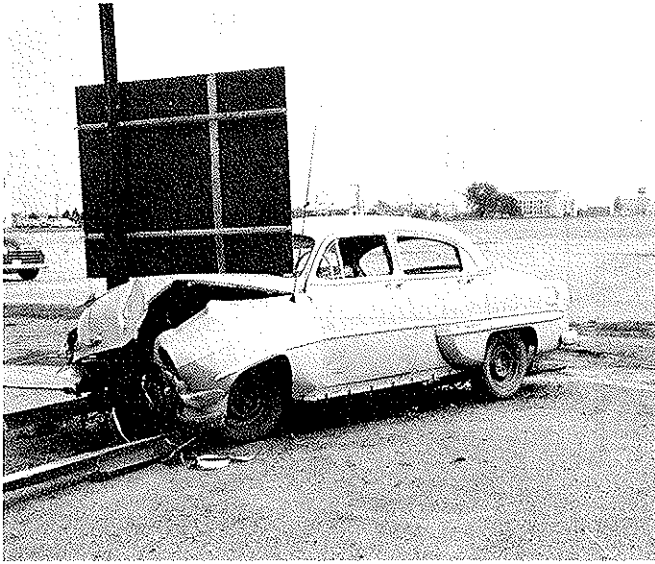
Figure 5. Crash Test No. 32.

failure occurred after much of the impact energy had been dissipated (Fig. 4). A final test on a fixed-base interstate-type sign support was conducted primarily to obtain accelerometer data for comparison with film records. Figure 5 shows the vehicle and sign following the crash.

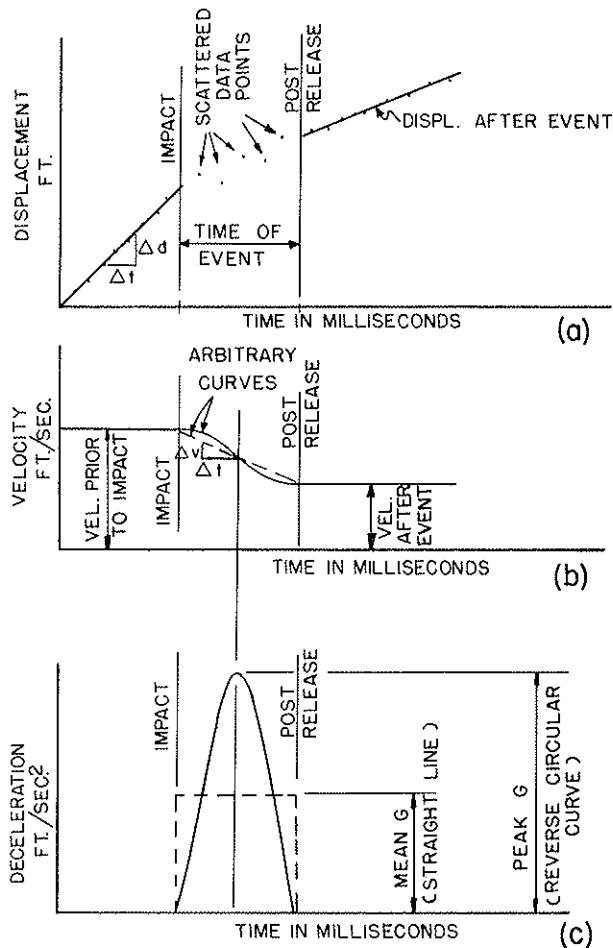
Figure 14. Film analysis by graphical differentiation.

The slope of the displacement-time curve is plotted and yields the velocity-time curve (Fig. 14b). Similarly, the slope of this curve is the deceleration-time curve shown in Figure 14c.

The film speed used and the 3-in. stadia increment on the vehicle permit a reliable plot of distance-time curves before impact and following the collision. However, the scatter of points during the event permits a variety of curves to be fitted to the data. In Figure 14b two arbitrary curves have been fitted to the data, and as a result the slopes of these curves give a striking difference in the value of decelerations (Fig. 14c). Thus the process of differentiating distance-time curves and velocity-time curves

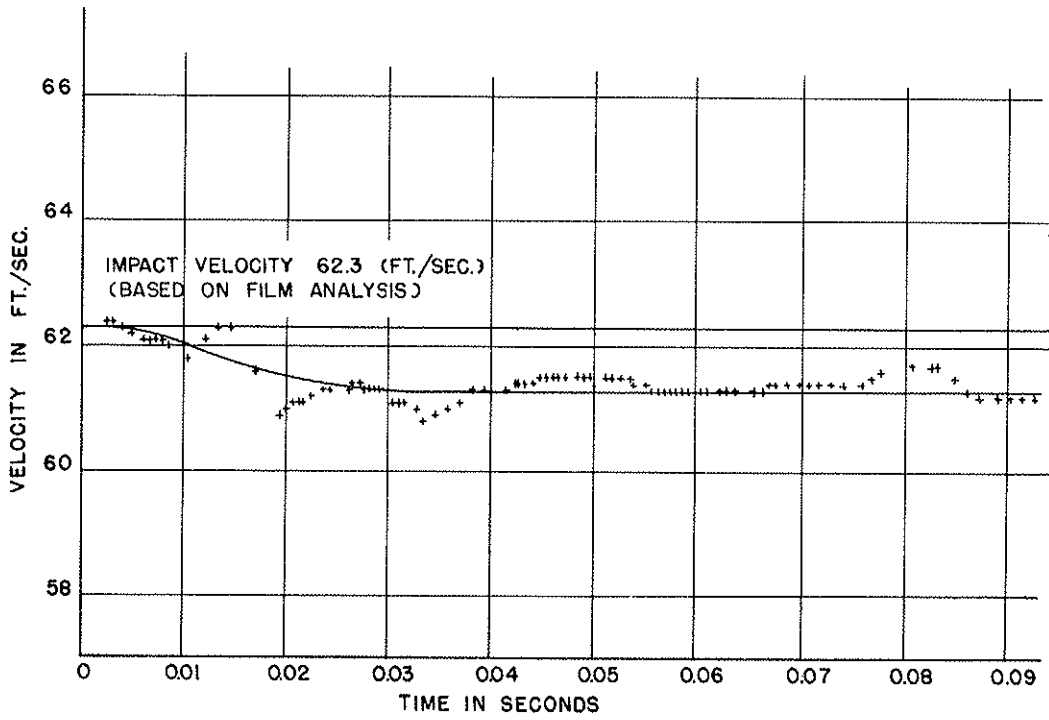
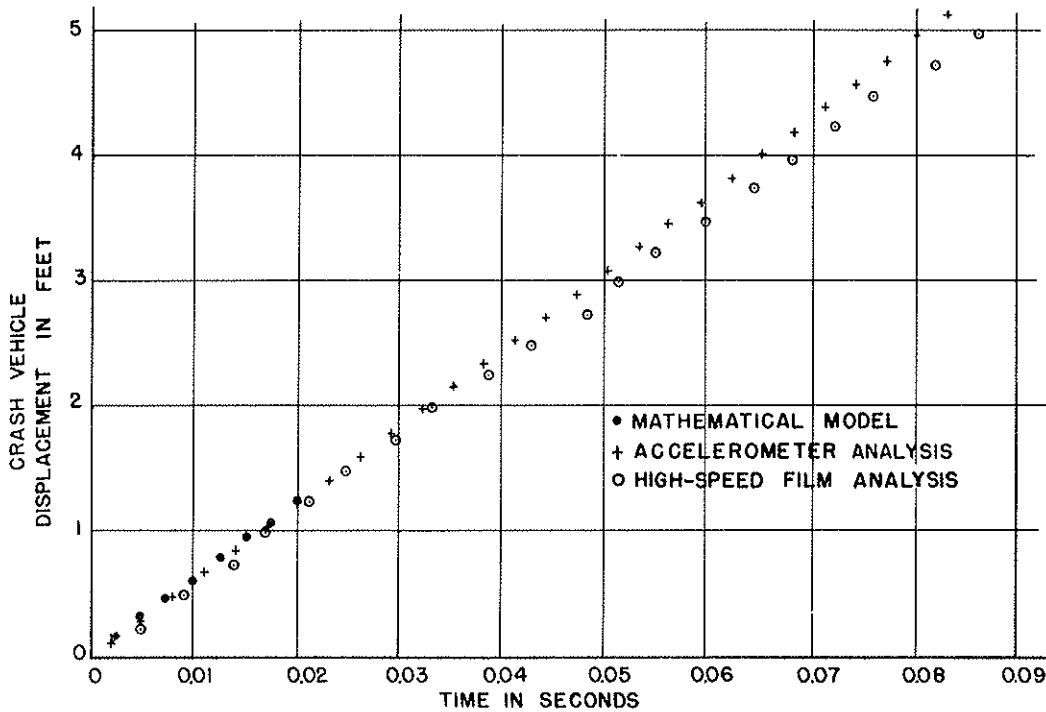
Figure 16. Test No. 41.

Figure 17. Test No. 41.

Figure 18. Test No. 41.

A typical set of curves for Test No. 41 is shown in Figures 16, 17, and 18. The displacement-time plot in Figure 18 shows crash vehicle displacement with time as predicted by mathematical simulation, and the actual determinations by accelerometer and high-speed film analysis.
