MICROSTRUCTURE AND STRENGTH OF THE BOND BETWEEN CONCRETE AND STYRENE-BUTADIENE LATEX-MODIFIED MORTAR

J. E. Isenburg and D. E. Rapp,

Various surface preparations were used in resurfacing concrete with a latex-modified mortar. A 1-in. mortar cap was applied to the circular surface of 14-day old, high early strength concrete cylinders treated in various ways. After aging 14 days, several cylinders of each group were fractured in a shear bond test, and an unfractured cylinder was sawed to provide a $\frac{1}{2}$ -in. cube that included the interface between concrete and mortar. These cubes were fractured normal to the interface, producing a surface free of sawing artifacts. After they were examined in the scanning electron microscope, these sections were fractured again to simulate the shear bond test and then reexamined. Several performance variations are explained by the scanning electron photographs.

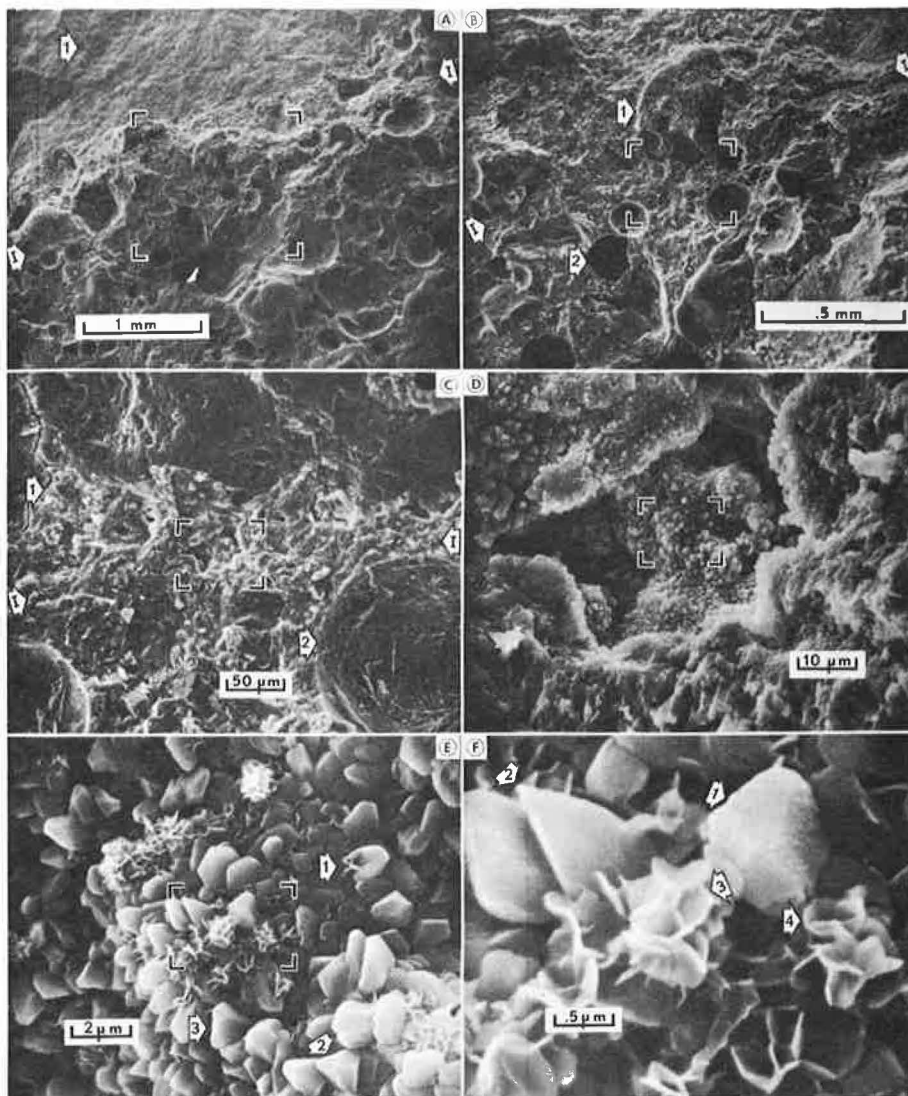
It was shown previously that the shear bond strength of the latex-containing overlay was lower when the concrete substrate was not sandblasted. Figures 5, 6, and 7 show an explanation for this result. Figure 5 shows the overlay-substrate interface for the standard latex-containing mortar and the unsandblasted concrete substrate. In Figure 5a, the interface marked with the arrows I runs from the lower left to the upper

Figure 5. Standard unsandblasted sample: overlay-substrate interface.

right, with the substrate to the left and the overlay to the right. Note the limestone grain (arrow 1) in the substrate less than 1 mm from the interface. Figure 5b shows a sand grain (arrow 1) in the substrate near the interface and several bubble holes in the overlay (arrow 2). These holes are attributed to entrained air bubbles; evidently the fracture plane intersected the bubble hole, revealing it to be a hollow sphere. This interpretation is supported by the presence inside the hole of crystal growths, which are apparently hydration products. Figure 5c shows a string of tiny open pockets along the interface. Inside these is a 10- μm to 100- μm thick layer of material, extending from the interface to arrow 1. Figure 5c also shows the crystals that have grown in the bubble holes (arrow 2). Figure 5d shows that the crystals lining one of the larger pockets are of 2 types; leaf-shaped and granular. Details of the crystal habit of these 2 forms are pointed out in Figures 5e and 5f. These open pockets lined with crystals follow the interface just below the surface of the concrete substrate.

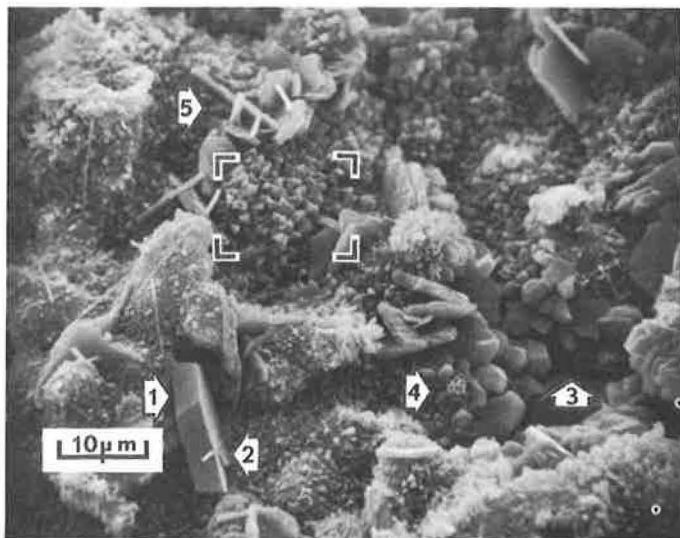
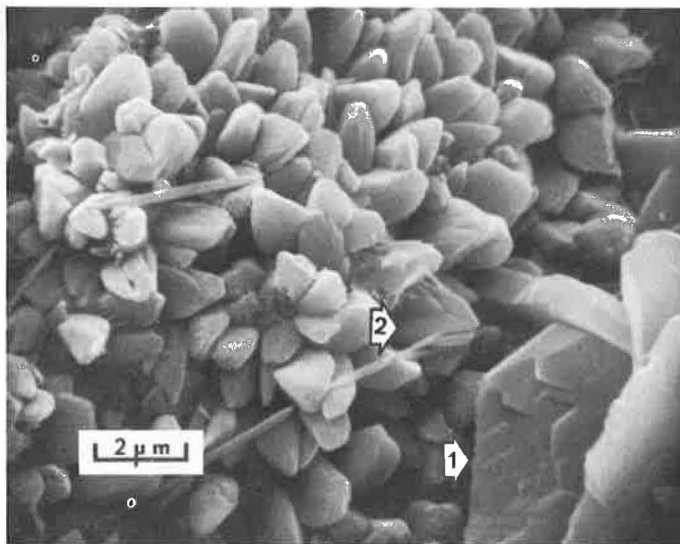
Figure 7. Standard unsandblasted sample: overlay side of shear bond fracture.

which show the mortar side of the fracture surface corresponding to the substrate shown in Figure 6 (i.e., the roof of the cavern that was split apart by the shear bond fracture). Figure 7a is remarkable in that it shows 5 different crystal shapes, all growing together and lining the roof of the cavern. One large plate (arrow 1) in the form of a rhombohedral pinacoid has a needle (arrow 2) growing out of it. Also seen are the granular ground mass (arrow 3) with its pyramidal shape and the accompanying tiny, twinned, leaf-shaped crystals (arrow 4). Finally, there is a new type of plate crystal (arrow 5), as shown in Figure 7b that is terminated by a series of hexagonal steps (arrow 1). Figure 7b also shows the succession of mineral growth, e.g., the granular crystal (arrow 2) in which a needle has been included, with a subsequent disruption of the growth habit of the grain.

Thus, it appears that the pockets lined with crystals are actually "caverns" that extend parallel to the interface for relatively great distances and that constitute a significant proportion of the interfacial area. This is verified by Figures 7a and 7b,

Figure 7a

Figure 7b

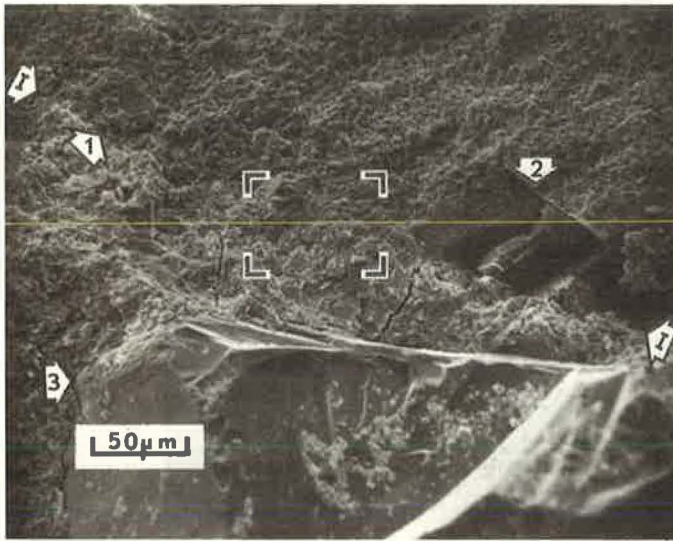
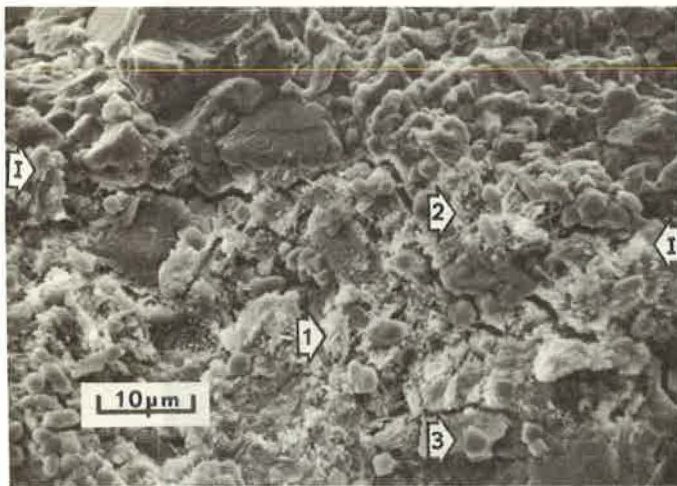
Figure 8. Standard 3-day composite sample: overlay-substrate interface.

The next series shows the differences in morphology observed with the standard samples were aged 3, 7, and 14 days. The morphology correlates with an increasing degree of fracture through the concrete substrate, rather than through the mortar overlay or interface. Figures 8 and 9 show the fracture surfaces perpendicular to the overlay-substrate interface, analogous to those shown in Figures 1, 2, and 5. Figure 8 shows the standard sample aged 3 days. Again the interface is marked by arrows, with the substrate above and the overlay below. Figure 8a shows the perimeters of a

limestone grain (arrow 1) that is flush with the interface. The fractured mass in the limestone grain (arrow 2) is probably calcite because of its rhombohedral form. The large mass (arrow 3) is a sand grain in the overlay mortar. Microcracks can be seen around the peripheries of the sand and limestone grains. Figure 8b clearly shows the microcrack along the mortar side of the limestone-mortar interface. The needle-like crystals lining the channels and fissures (arrow 1) are characteristic of early aging times. The interface can be located only approximately on this scale. A pocket of needles seems to have penetrated the limestone grain (arrow 2), whereas the particle characteristics of the limestone are present in the mortar (arrow 2). Thus, the latex-containing overlay dry-cured for 3 days resembles the control overlay wet-cured for 28 days in that it exhibits needle-filled channels and microcracks on the mortar side of the interface.

Figure 8a

Figure 8b

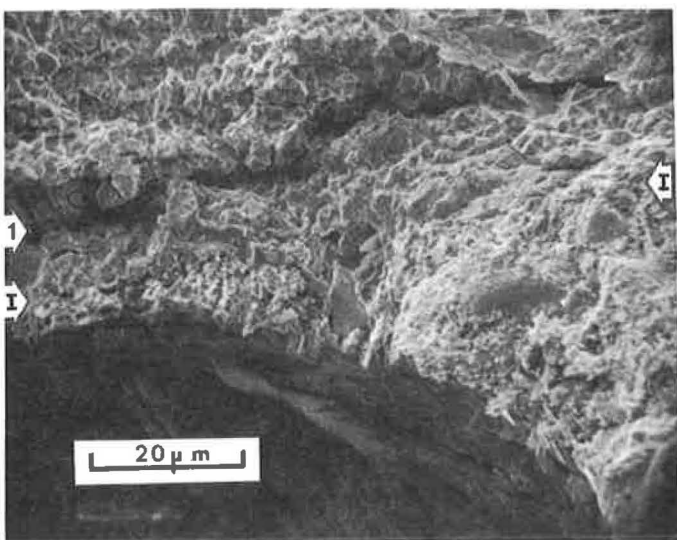
Figure 9. Standard 7-day composite sample: overlay-substrate interface.

Figure 9 shows the standard sample aged 7 days. Again, the interface is marked with arrows and the latex-containing mortar is shown in contact with a limestone grain. These figures show that there are 2 significant differences between 3-day and 7-day aging:

Figure 9a

Figure 9b
