EVALUATION OF BREAKAWAY LIGHT POLES FOR USE IN HIGHWAY MEDIANS

N. E. Walton, T. J. Hirsch, and N. J. Rowan, Texas Transportation Institute, Texas A&M University

Crash tests were conducted to determine the impact behavior of median-mounted light poles and secondary collisions of vehicles striking downed poles on a traffic lane. A relative hazard index was developed to describe the relative hazard created by the proximity and frequency of light poles. It was concluded that a 20-deg impact by a 2,900-lb vehicle at 45 mph would not cause a pole to encroach on the opposing traffic lane if the median is 40 ft wide. A 4,000-lb vehicle impacting at 25 deg and 60 mph would cause a pole to encroach approximately 11 ft into the opposing lane. Under both conditions, the impacting vehicle would cross into the opposing lanes and might be more of a hazard than the poles themselves. A medium-sized vehicle impacting a downed pole within the traffic lane presents no more hazard than the original impact. From a relative hazard standpoint, median-mounted luminaire systems produce less hazard than house-side systems for median widths of 30 ft or greater.

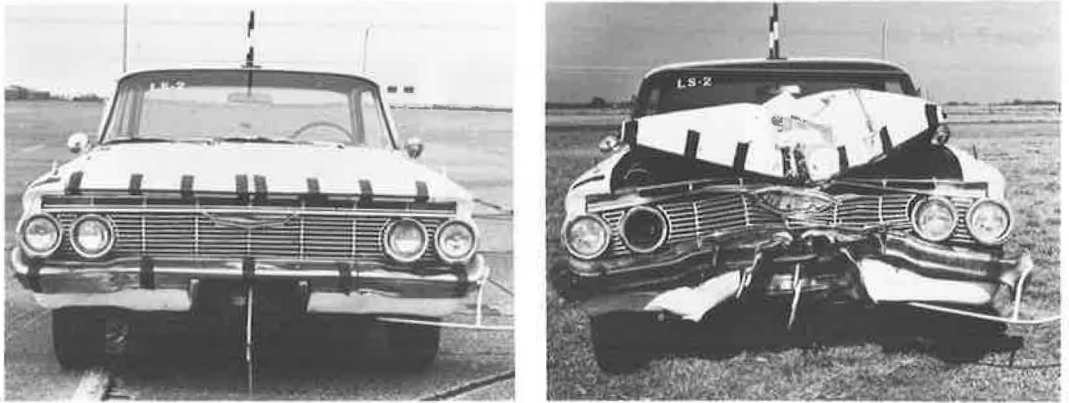
Figure 9. Front of vehicle before and after test LS-2.

The front end of the vehicle had a residual deformation of 1.5 ft (Fig. 9). The increased damage is primarily due to the higher impact speed.

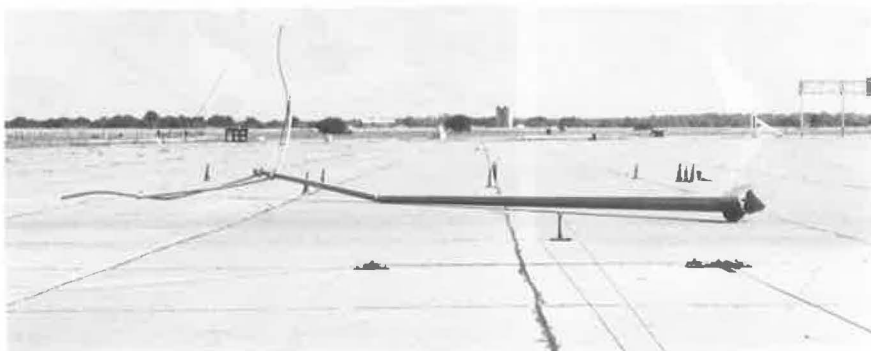
Figure 11. Light pole before test LS-3.

Test LS-3 was designed to determine the behavior of an automobile striking a "downed" light pole under conditions that would have resulted from a crash such as that of test LS-2. The support from test LS-2 was placed in such a way that the 12.5-ft wide concrete slabs that make up the test apron would simulate the oncoming inside traffic lane. That is, the base extended 11 ft into the simulated lane at an angle of 33 deg and pointed toward the approaching test vehicle as shown in Figures 11 and 12. The test vehicle, which was traveling in the center of the simulated traffic lane, struck the support at 61 mph, passed over it, and continued virtually straight ahead as shown in Figure 13. Figures 14 and 15 show the support after the test; Figure 16 shows the path of the vehicle.

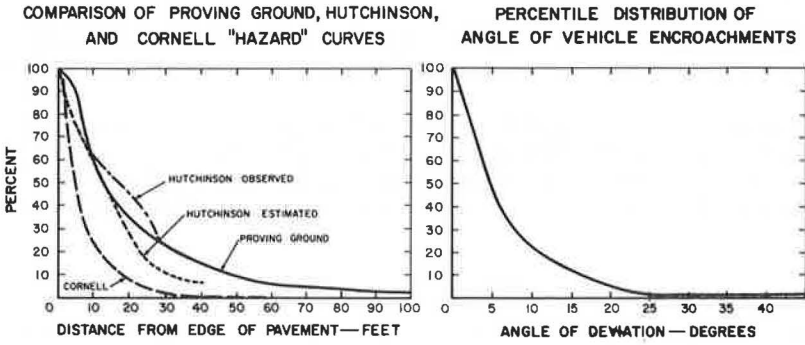
Figure 18. Relation of cross section design and highway safety.

Table 3 summarizes the data for each of the alternative lighting systems and presents the relative hazard index for a 44-ft median, a design of special current interest. A similar comparison can be made for any median width. This relative hazard index is computed as the product of the relative index of a vehicle impacting a light pole based on lateral distance from the traveled way, the relative number of hazards per unit length of roadway, and the relative number of traffic streams (directions) to which the light poles are exposed. To explain the source of each of these factors, reference is made again to Table 3. Column 5 gives the lateral distance of the support from the edge of the traveled way for each of the alternative designs. The two distances given for alternative designs 5 and 6 represent two supports in alternative design 5 and an offset situation in alternative design 6. Column 6 of Table 3 gives the percentage of probability that an errant vehicle will travel a sufficient lateral distance from the traveled way to become involved in a collision with a support. These values are based on frequently referenced data reproduced in Figure 18a from Hutchinson reported by Stonex (5).

Column 7 of Table 3 gives the estimated percentage of probability of secondary collisions caused by the light pole falling in an opposing traffic lane and being struck by an oncoming vehicle. The percentage of probability is determined on the basis that only supports struck at angles greater than 20 deg will fall in the opposing traffic lanes. Further, this effect is considered only for 45- and 50-ft supports. Shorter support lengths are assumed to always fall within the median. The percentage of probabilities was obtained from Figure 18b.

was 31 ft. Given that an encroachment of more than 4 ft into a traffic lane may result in a collision, the estimated percentage of impacts greater than 20 deg was determined from Figure 18b.
