NATIONAL COOPERATIVE HIGHWAY RESEARCH PROGRAM
SYNTHESIS OF HIGHWAY PRACTICE

112

**COST-EFFECTIVENESS OF
HOT-DIP GALVANIZING
FOR EXPOSED STEEL**

TRANSPORTATION RESEARCH BOARD
National Research Council

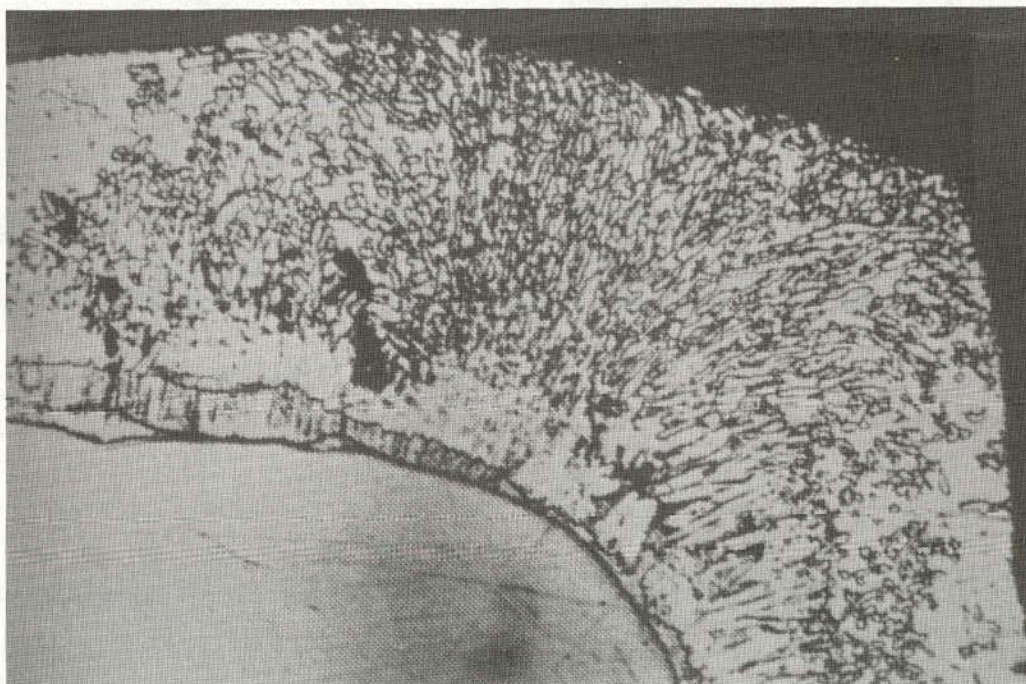
FIGURE 1 Galvanized edge with built-up thickness.

The FHWA report (2) also addresses the service life of coatings on different types of bridges. As many paint systems have a propensity to fail at the sharp edges of a beam or angle, paint failures appear most frequently on truss-type bridges, which have many more edges than girder bridges. In Massachusetts, paint systems on girder bridges outlast the same systems on truss bridges by three years. In sharp contrast to this failure of paint coatings, galvanized edges tend to build up in thickness, as shown in Figure 1 and, thus, create a complete protective envelope around the steel object.

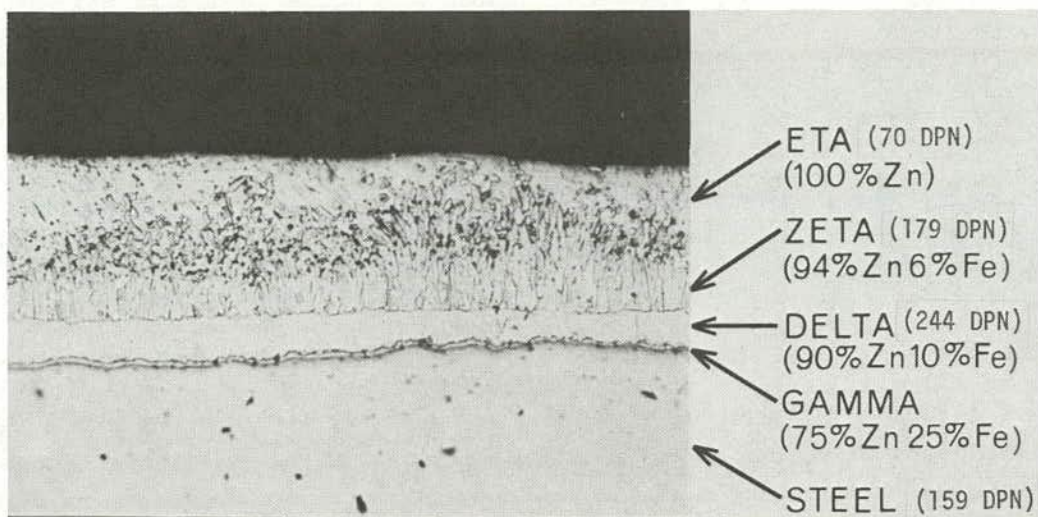
FIGURE 2 Photomicrograph of a section of a typical hot-dip galvanized coating showing serious alloy layers metallurgically bonded to the base steel.

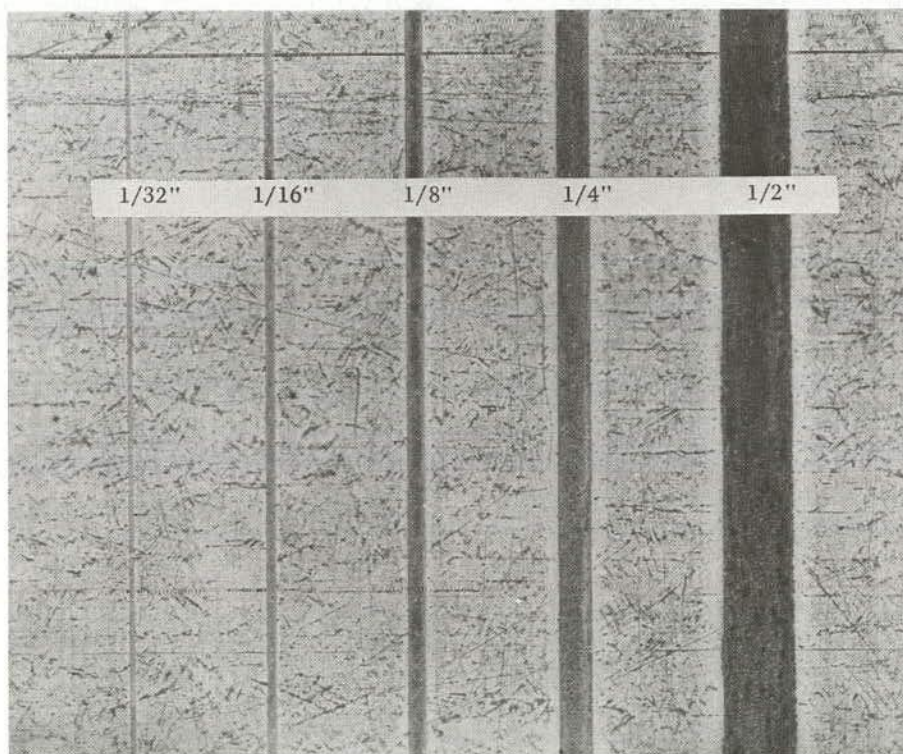
FIGURE 3 Example of cathodic protection exerted by a film of zinc across gaps of exposed steel.

atmosphere. An experiment that demonstrates this was reported by Frazier (27). A steel plate was given a one mil-thick coating of zinc. The coating then was scored to the base steel with a series of lines $\frac{1}{32}$, $\frac{1}{16}$, $\frac{1}{8}$, $\frac{1}{4}$, and $\frac{1}{2}$ in. wide and exposed to an industrial environment for 56 months. Visual inspection revealed no red rust in the $\frac{1}{32}$ and $\frac{1}{16}$ in. scored areas, a few red pinpoints in the $\frac{1}{8}$ in. area, a reddish surface smut in the center of the $\frac{1}{4}$ in. area, and some surface rusting in the $\frac{1}{2}$ in. gap. The surface of the panel was darkened by oxidation and soiling; however, along the edges of the scored gaps the coating remained light and clear from the dissolution of the zinc as it sacrificially protected the scored area. The combined width of the clean edges equalled the width of the scored area except at the $\frac{1}{2}$ in. gap. Figure 3 shows the extent of sacrificial protection of steel by a thin coating of zinc, the effect of which increases with increasing thickness of the galvanized coating.

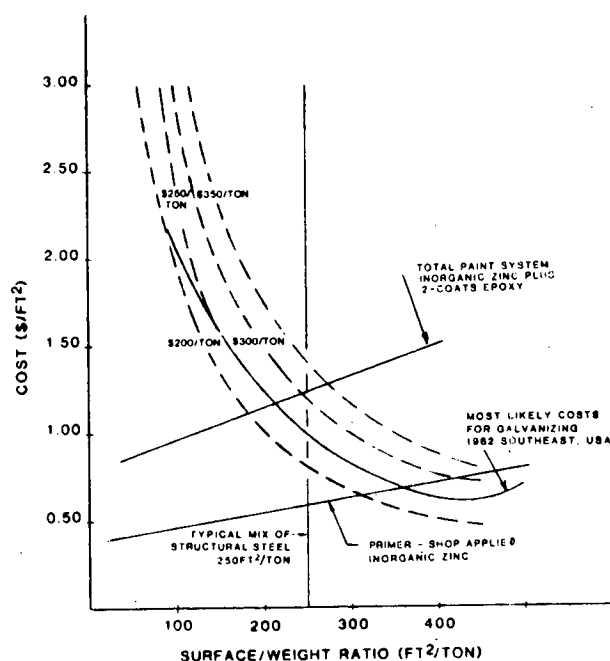
FIGURE 4 Initial costs of painting compared to galvanizing.

When costs are to be equated it is necessary to know how many square feet of steel are present in a ton of steel. Small angles and hand rails have a high ratio of surface area per ton of steel. In contrast, a girder may average 125 sq ft per ton of steel. Based on the costs found in his survey, Seelinger prepared a graphical representation that relates the cost of painting per square foot to the cost of galvanizing per square foot (Figure 4).

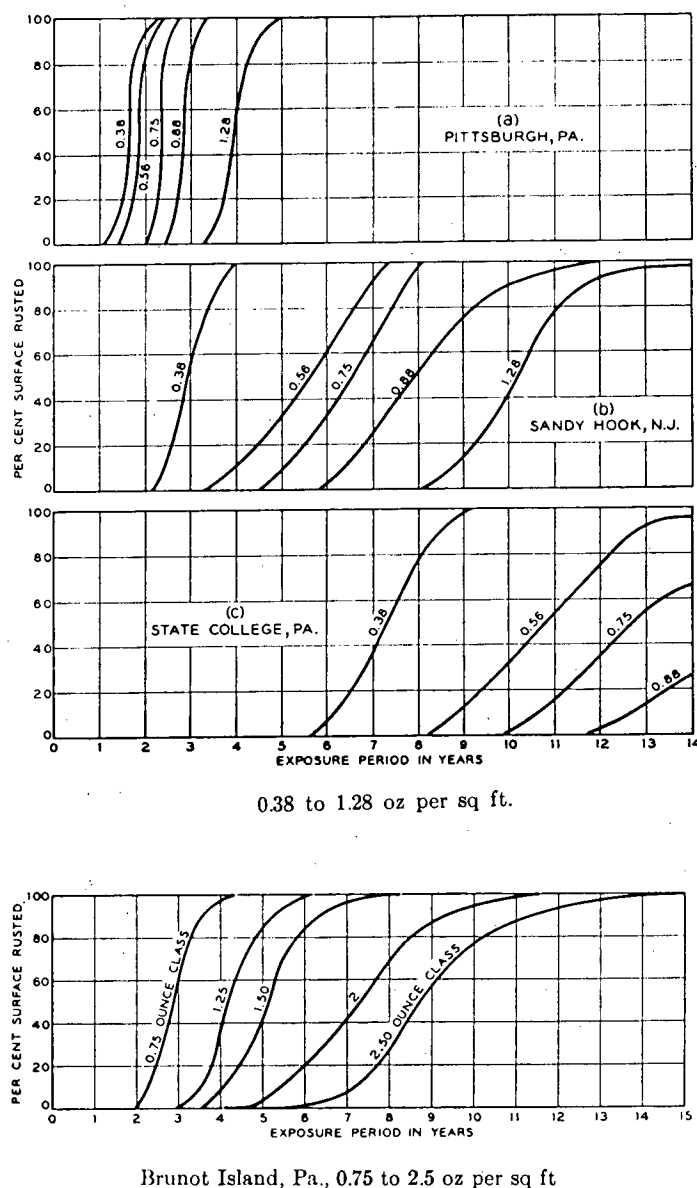
FIGURE B-1 Progressive development of rust on galvanized steel specimens exposed in various environments.

Figure B-1 shows that the slope of the time:corrosion curves represents the relative corrosivity of the respective locations.

The two industrial sites differ only slightly. The industrial-foggy marine area of Sandy Hook is not very corrosive toward zinc and, of course, the rural location of State College is the least aggressive. To illustrate the results after 28 years of exposure at Key West, 34 years at Altoona, and 50 years at State College, a brief summary of the major factors describing the performance

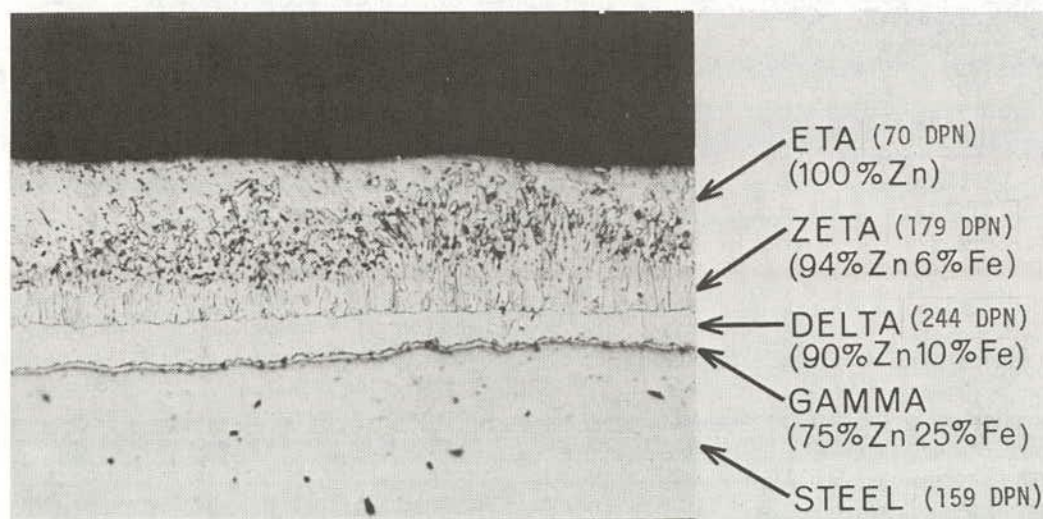
FIGURE C-1 Photomicrograph of a typical hot-dip galvanizing coating showing various alloy layers.

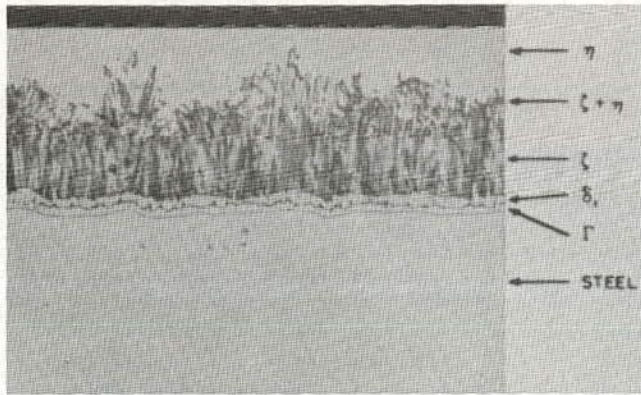
FIGURE C-2 Growth of alloy layers after one minute immersion.

The total thickness of a coating, and the amount of alloy layer that forms can be varied by adjusting the galvanizing conditions such as the temperature of the molten zinc, the time of immersion of the steel item, and the speed with which the item is withdrawn from the zinc bath. The relationship existing between these factors was investigated for three temperatures: 815, 851, and 887° F. The immersion times ranged from 30

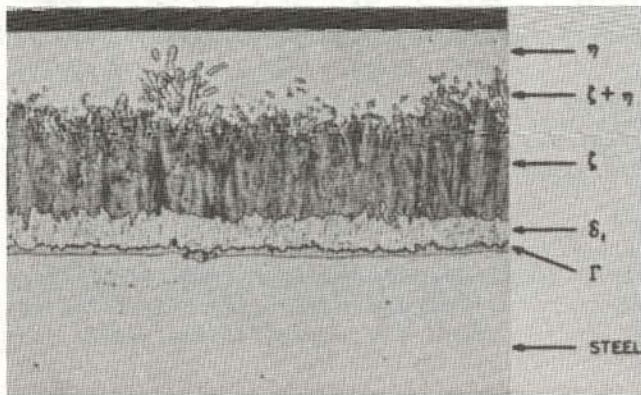
FIGURE C-3 Growth of alloy layers after five minutes immersion.

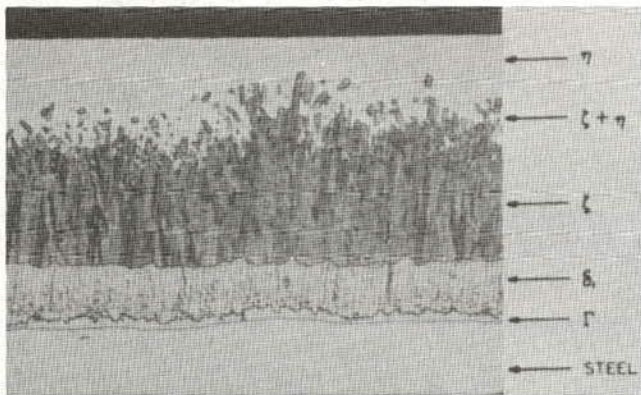
FIGURE C-4 Growth of alloy layers after 10 minutes immersion.

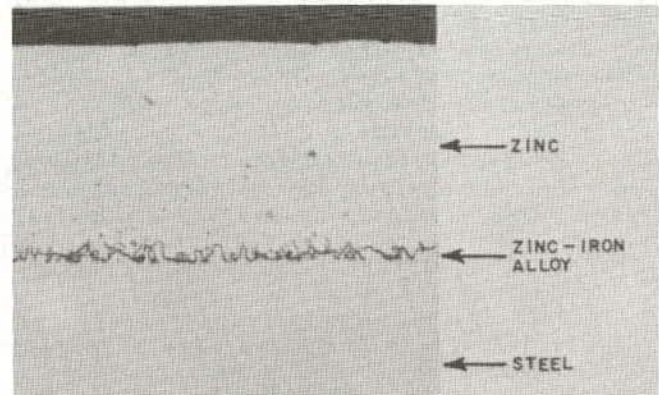
FIGURE C-6 Alloy layer from galvanizing bath with 0.15 percent aluminum.

In hot-dip galvanizing aluminum is added to the bath in much smaller quantity not to interfere with alloy formation but to increase the brightness of the galvanized item as it is being withdrawn from the molten bath. Sometimes when a dull product is encountered it may be caused by a lack of aluminum in the bath. (Some additional information is contained in Appendix C.)

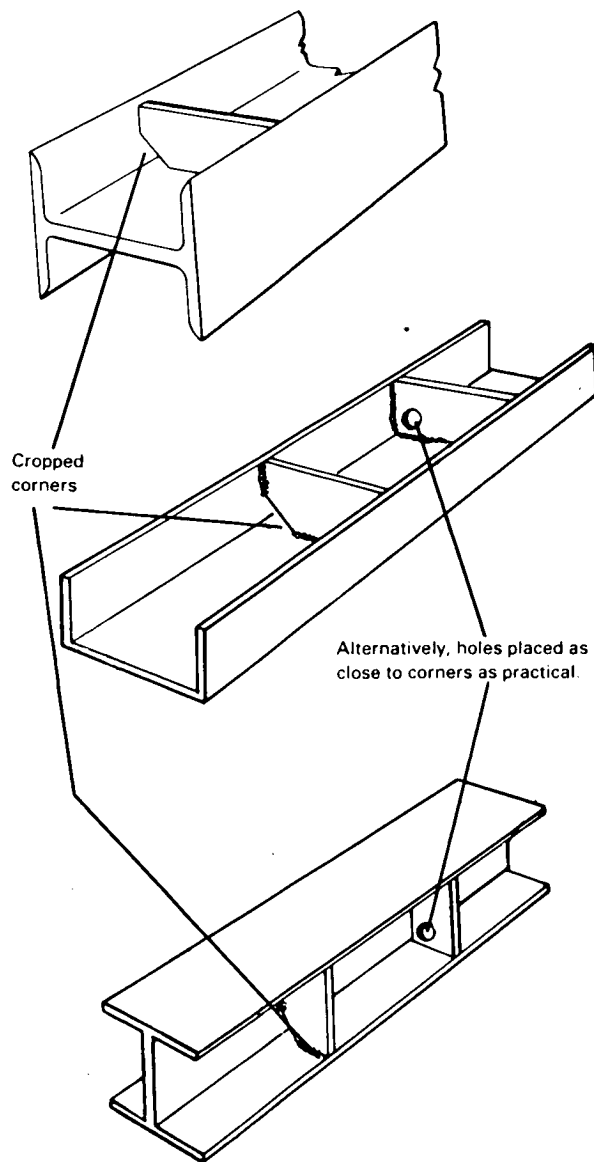
FIGURE D-1 Generously cropped corners provide for free drainage. Where cropping is not possible, holes no less than $\frac{1}{2}$ in. in diameter close to the corners are required.

Hollow structures with enclosed sections must have provisions for adequate venting during galvanizing. Any moisture present at the galvanizing temperature is converted to superheated steam that expands at explosive velocities and can spatter large quantities of molten zinc outside of the tank. Correct venting also ensures that all interior surfaces are reached by the molten zinc. Internal baffles should be cropped on the bottom to permit free flow of molten zinc. Likewise, strengthening gussets in channels and fabricated columns should be cropped to facilitate drainage (Figures D-1 and D-2).

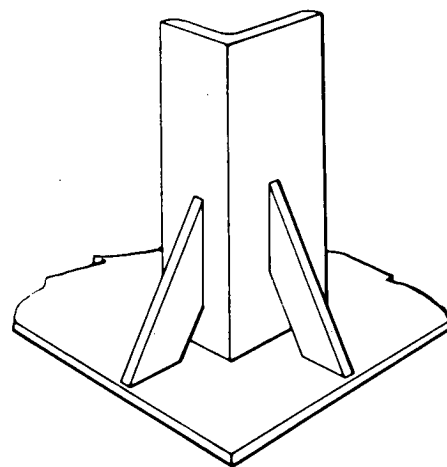
FIGURE D-2 Stiffener plates should be cropped or bar stiffeners should be used.

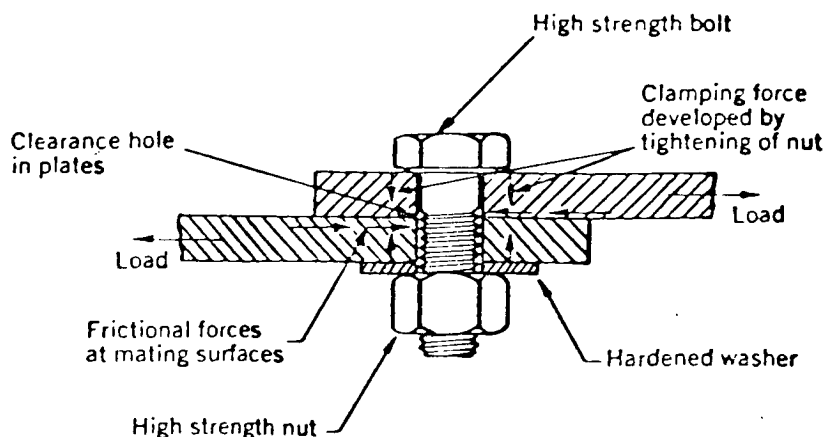
FIGURE D-3 Friction joint with a hexagon-head high-strength bolt in a clearance hole.

There are two main design methods used in high-strength bolting: 1) friction-type joints and 2) bearing-type joints. The principle of the friction-type joint, shown in Figure D-3, is that in clamping members tightly together shear load is transmitted from one member to another by means of friction between the contacting surfaces. Development and availability of high-strength bolts has permitted the design of bolted joints in which very high bolt tension produces high friction forces across mating surfaces. The friction force is controlled by the tension of pre-load developed in the bolt in tightening and the coefficient of friction on the mating surfaces.

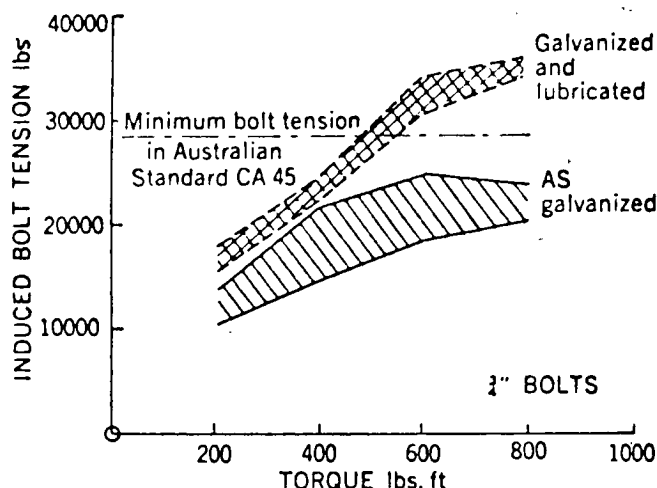
FIGURE D-4 Relation between torque and induced tension for galvanized high-strength bolts and for galvanized and lubricated high-strength steel.

With "as galvanized" assemblies there is a wide scatter in induced tension at any torque level. Hence, torque cannot be used as a reliable method for gauging the required bolt tension.
