MECHANICAL ALTERATION OF THE TEXTURE OF OLD CONCRETE PAVEMENT WITH THE KLARCRETE MACHINE

Marion F. Creech, Virginia Highway Research Council, Charlottesville

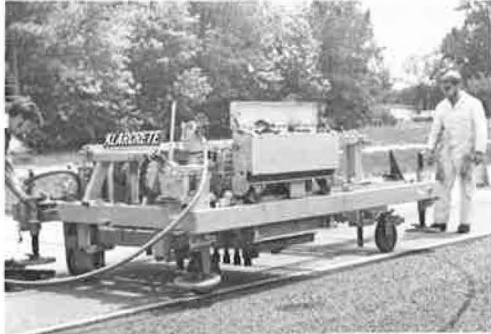
Figure 2. Klarcrete machine being positioned for operation.

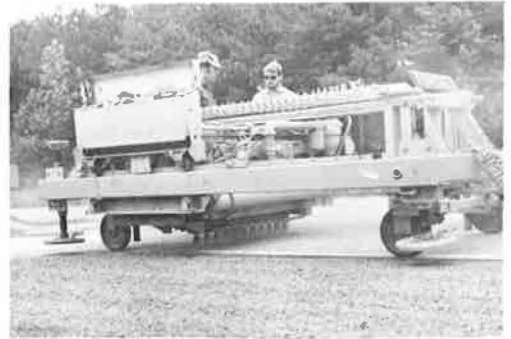
Figure 3. Klarcrete machine in operation.

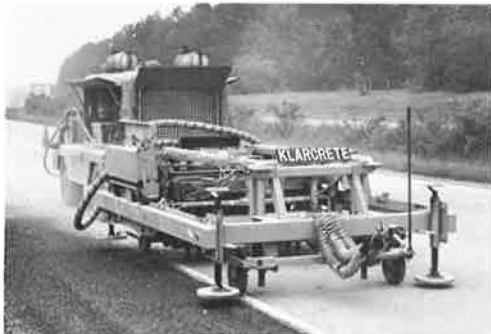
Figure 4. Full view of Klarcrete machine and compressor.

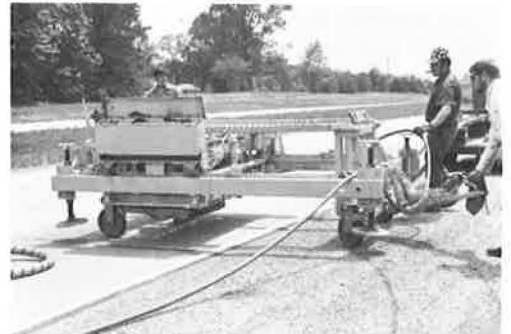
Figure 5. Klarcrete machine being turned and positioned.

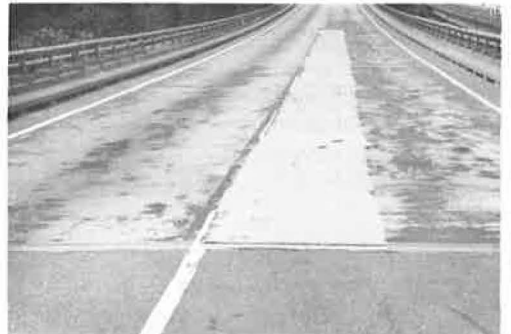
Figure 6. Coal-tar epoxy on deck of northbound Meherrin River bridge.

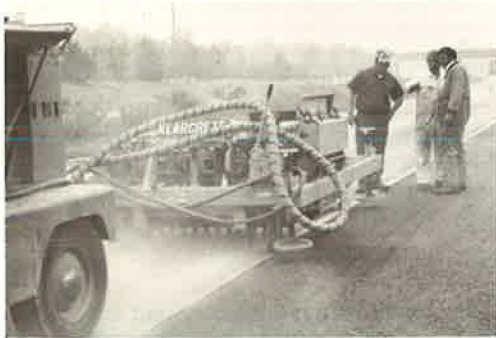
Figure 7. Dust produced by Klarcrete machine operating on dry pavement.

When the machine is operating on dry pavement, air pollution by dust can be great (Fig. 7). However, on wet pavement, no air pollution occurs. Figure 8 shows the machine operating after a downpour, but a water truck with a spray bar was employed at other times. In very hot weather, water evaporation is fast and the pavement has to be wetted often. The machine operates as well on wet pavement as on dry. A companion problem was that particles left by the machine had to be swept from the road with a mechanical sweeper that produced a dust cloud. The particles, nearly 1/4 in. (6.35 mm) in depth, turned into a paste-like substance when sprinkled with water and could not be swept from the road. This problem was not solved at the test site and the particles were swept from the road while dry. A solution for this could be a vacuum type of street sweeper such as those used by some cities.

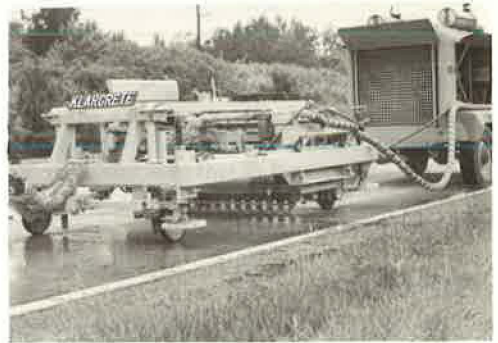
Figure 8. Klarcrete machine operating on wet pavement.

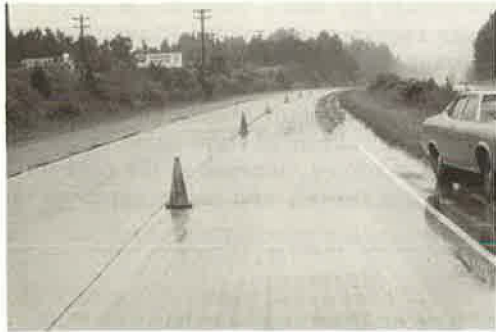
Figure 9. Wet pavement after treatment with Klarcrete machine. Note the ponding of water on the untreated portion.

The sharp surface of the granite aggregate protruded above the surrounding cement mortar to produce a texture that was coarse. The coarse texture allows considerable space for water to escape and also exposes a polish-resistant aggregate for contact with the tires of vehicles. Figure 9 shows the pavement after a heavy rain, when all of the pavement had been treated except the extreme right portion with the edge line marking.

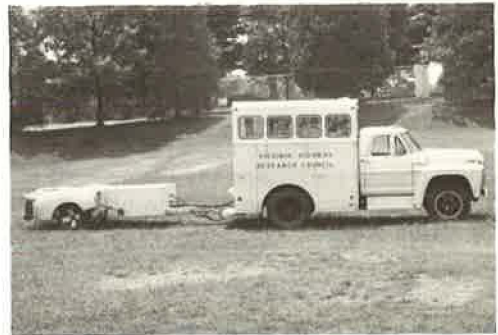
Figure 10. The Virginia Highway Research Council's skid-resistance measurement vehicle.

To determine if the expected improvements were realized, skid tests were performed with the Virginia Highway Research Council's skid trailer (Fig. 10) on the treated section and on a control section adjacent to it. The following tests were performed in both the traffic and passing lanes:

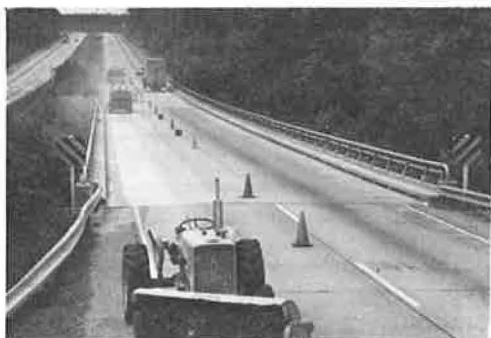
Figure 21. Long-range view of Klarcrete machine in operation on bridge deck.

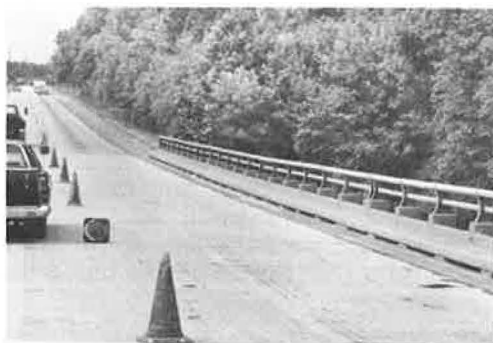
Figure 22. The southbound bridge after cleaning.
