A BREAKAWAY CONCEPT FOR TIMBER UTILITY POLES

G. K. Wolfe, M. E. Bronstad, and J. D. Michie, Southwest Research Institute; and J. Wong, Insurance Institute for Highway Safety

The feasibility of modifying existing timber utility poles so that they will readily break away upon impact was investigated. Various drilled holes and groove patterns were experimentally examined during 13 pendulum tests of full-size class 4-40 poles by using a 4,000-lbm (1814-kg) mass striking the specimens at 20 mph (32 km/h). Two weakened zones, located 6 in. (152 mm) above grade and 6 ft (1.8 m) from the pole top, facilitated the detachment of the 27-ft (8.2-m) center section. Based on Federal Highway Administration criteria [400 16·s (1780 N·s) for pendulum tests], linear impulse test results of weakened and unweakened poles indicate that poles with a large probability of being struck by an errant vehicle may be easily modified to a breakaway structure. Vehicle crash tests are recommended as the next step in breakaway concept development.

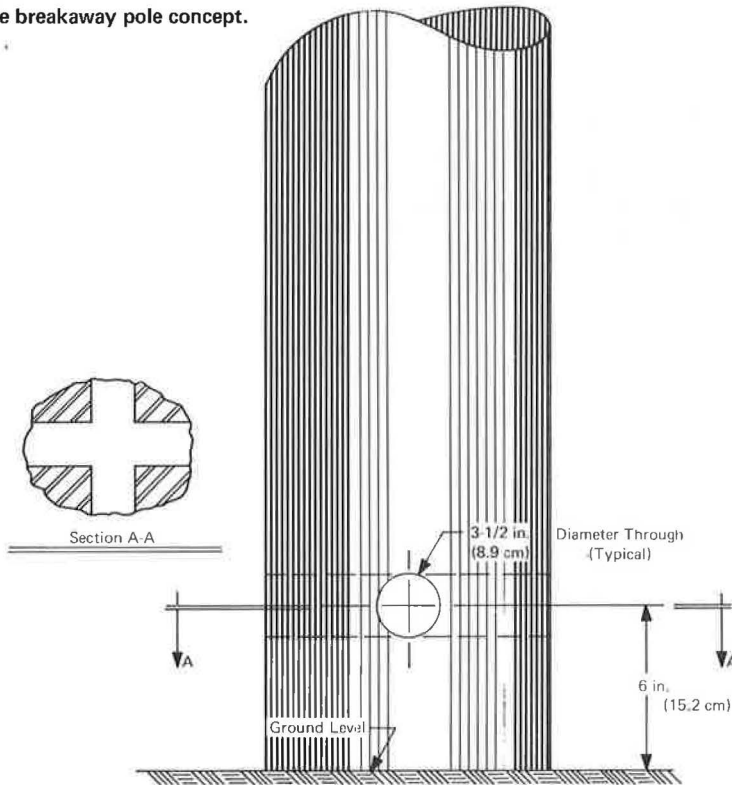
Figure 1. Two-hole breakaway pole concept.

The method used in this program to effect a weakened zone in the timber specimens is to drill and cut a pattern of holes and grooves at two selected elevations (3). This approach can be accomplished in actual service by maintenance personnel using standard equipment. A possible drawback of this method is that the integrity of the preservative treatment may be violated in most modifications, leaving the pole vulnerable to rot. However, field application of preservatives offers protection.

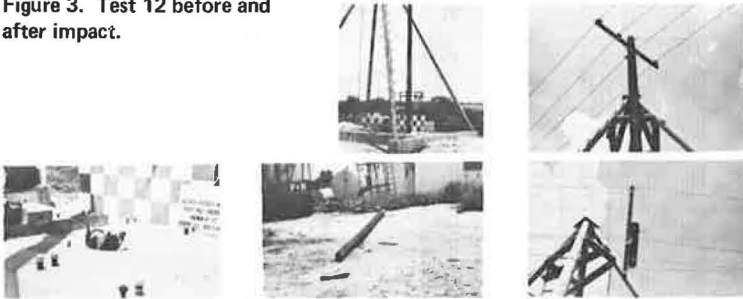
Figure 3. Test 12 before and after impact.

Tests 11 and 12 were repeats of tests 9 and 10 with the exception that tension of each of the four utility lines was adjusted to 190 lbf (845 N) prior to each test, and slightly more area was removed from the lower section to lessen the linear impulse. Figure 3 shows photographs of test 12 before and after impact; Figure 4 shows sequential photographs of test 12.

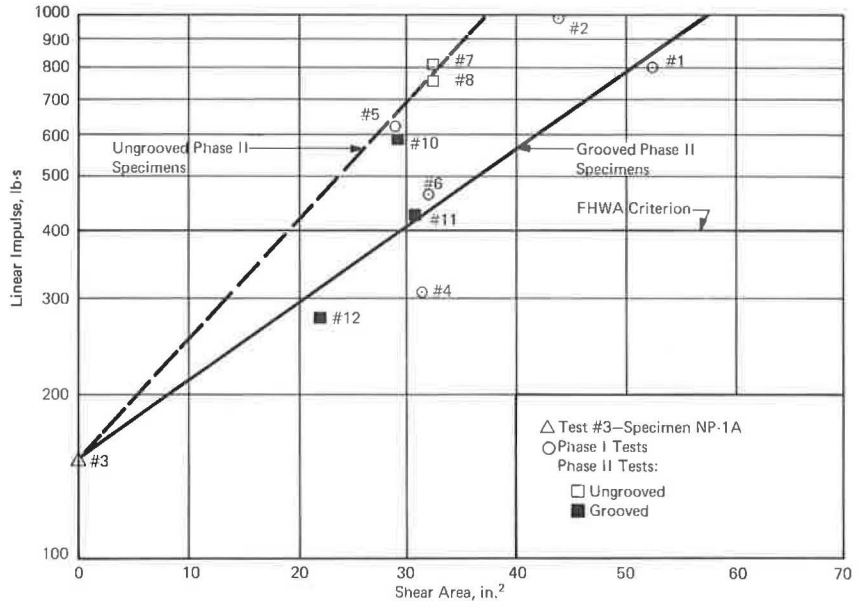
Figure 5. Linear impulse versus shear area.

Results of pendulum tests are shown in Figure 5 in the form of linear impulse versus shear area of the lower test section. Phase I tests 1, 2, 4, 5, and 6 were performed on pole specimens that were unrestrained or not loaded by service lines; results are indicated by open circles. The origin point (i.e., zero shear area) was determined in test 3 by impacting a detached but suspended pole segment; the linear impulse measured in this case is that required to accelerate the pole segment to pendulum mass speed.

In phase II tests, the pole specimens were under typical service line restraints and loads; results are shown in Figure 5 by squares. The importance of the groove cut around the test pole is illustrated by comparing tests 7 and 8 (ungrooved specimens) with tests 10, 11, 12, and 14 (grooved specimens). Although insufficient testing was performed to quantify the curves, two definite trends are shown in Figure 5. From this evidence, it seems apparent that shear area alone is an insufficient parameter to control the fracture mechanism; the geometry of the weakened section including stress risers such as grooves is also a prime factor.

As indicated in Figure 5, a net shear area of approximately 30 in.² (190 cm²), with proper consideration of geometry, appears to constitute an adequate design of a lower weakened section for the breakaway timber utility pole concept; however, this finding should be investigated with vehicle crash tests before a finalized value is established.

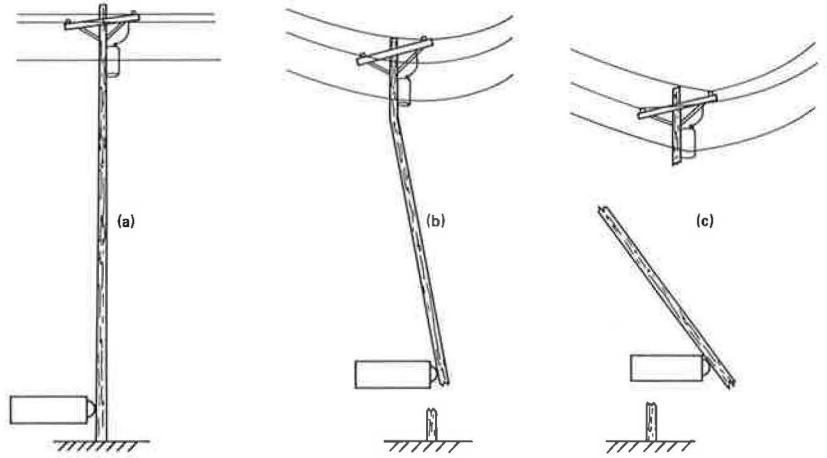
Figure 6. Utility pole fracture sequence: (a) before impact, (b) lower section fracture, and (c) complete fracture.

As might be expected, there was a marked change in fracture mechanism between the single-pole tests (phase I) and the system tests (phase II). Principally the simulated lines in phase II tests introduced a vertical load in the test specimen. More importantly, these lines provided considerable constraint at the pole top. From analysis of high-speed movies, this constraint approximated a rigid fixity, at least instantaneously, from the cross-arm connection down to the single-wire connection. Flexural loads due to this constraint were introduced in the upper weakened section after the lower section had sheared. This sequence is shown in Figure 6. In one test (test 10), the utility lines were atypically slack and did not provide the necessary fixity; hence, the upper section failed to break.

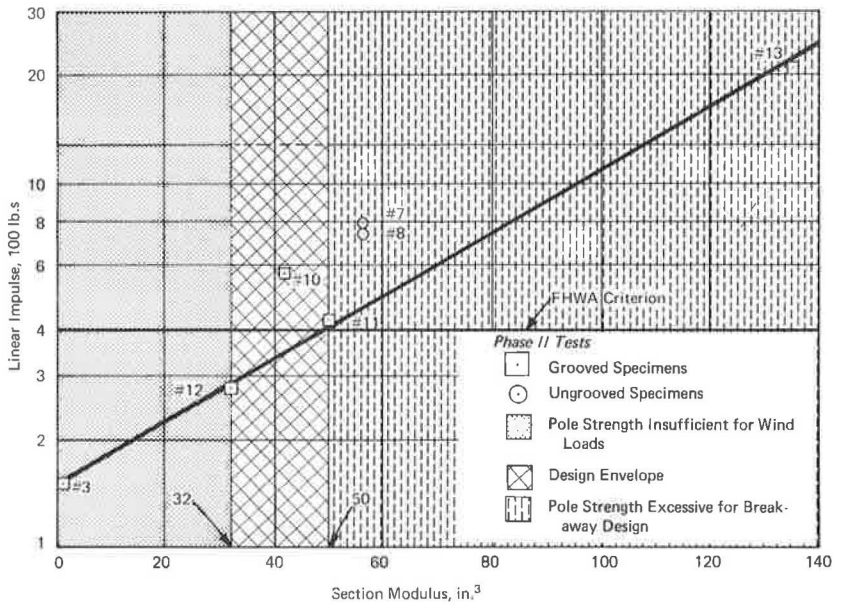
Figure 7. Linear impulse versus section modulus.

the pendulum tests are shown in Figure 7 as a function of section modulus of the modified poles. Also shown are the FHWA linear impulse recommendation and the minimum section modulus requirement for normal loads. It can be seen that a section modulus "window" exists from 32 to 50 in.³ (524 to 819 cm³) where the functions of both break-away and normal load-supporting capabilities are met.

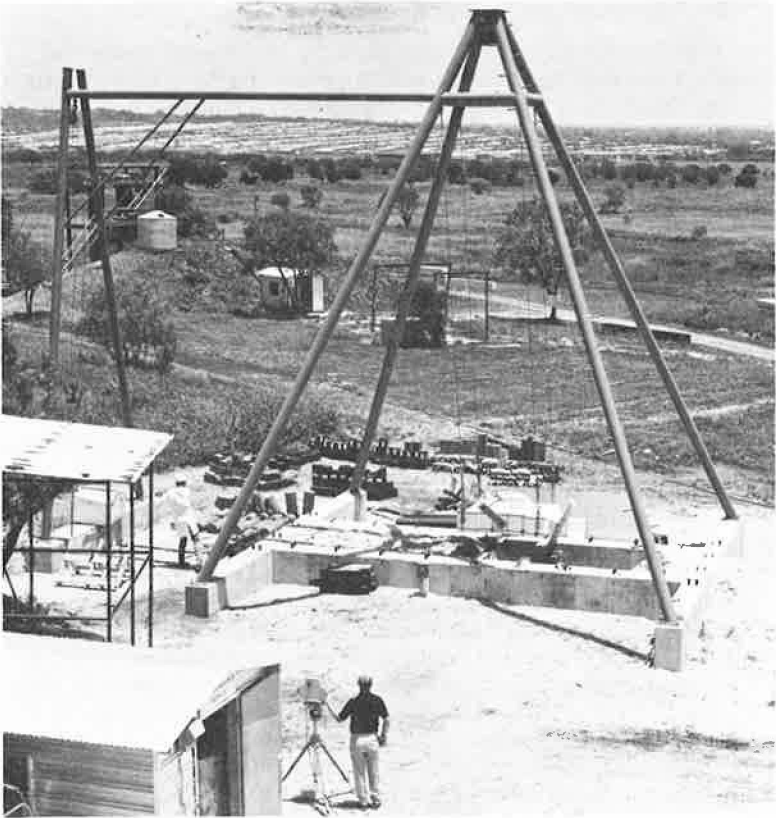
Figure 8. Southwest Research Institute pendulum impact tester.

The facility consists of a pendulum, operating equipment, and test control and data acquisition instrumentation. An overall view of the facility is shown in Figure 8. A 4,000-lbm (1800-kg) mass is suspended in such a manner that it remains horizontal throughout the normal swing arc of 26-ft (7.92-m) radius and strikes the specimen 20 in. (0.5 m) above grade. The 3- × 6- × 1.5-ft (0.9- × 1.8- × 0.4-m) mass is faced with a steel bumper fabricated from 8-in. (203-mm) diameter extra heavy pipe and filled with concrete. A 1-in. (25-mm) thick, 70 durometer neoprene pad attached to the steel bumper provides the impact surface of the mass.

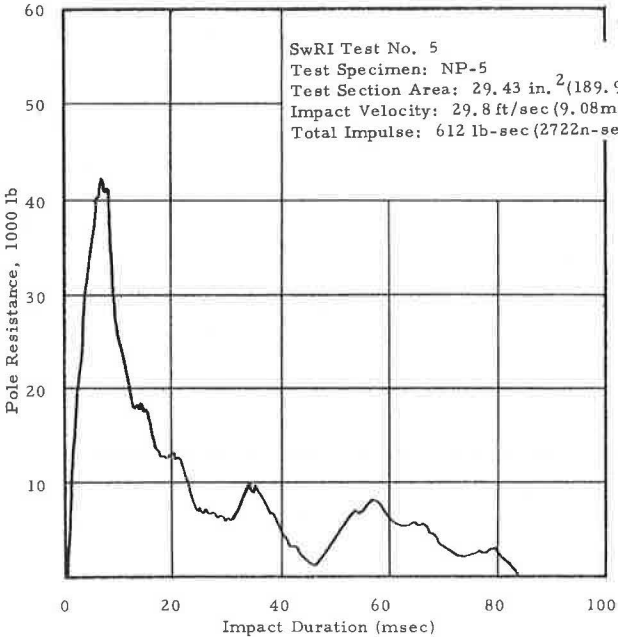
Figure 9. Typical force-time data for pole test.

Signals from an accelerometer, mounted at the rear of the mass, were continuously recorded throughout impact by a high-speed magnetic tape recorder operating at 60 in./s (1.5 m/s). The recorded data were later replayed through an oscillograph without electronic filters at various tape deck and oscillograph speeds. Frequency response of the system, as determined by the M-400 oscillograph galvanometer, was 0 to 240 Hz. A typical data trace is shown in Figure 9. The accelerometers were subjected to a calibrated 2.8-g, 100-Hz acceleration before and after each test; the recorded signal served as a calibration standard for data processing. Signals from a break-wire speed trap provided impact velocity data.
