Eliminating Vehicle Rollovers on Turned-Down Guardrail Terminals

T. J. Hirsch and C. E. Buth, Texas Transportation Institute
John F. Nixon, David Hustace, and Harold Cooner, Texas State Department of
Highways and Public Transportation

A relatively simple method has been found to modify the turned-down ends of highway guardrails to eliminate or minimize the probability that a vehicle impacting them will ramp and roll over. To modify the standard guardrail, the $\frac{1}{2}$ -in diameter bolts are removed from the first five posts. With these bolts removed, the rail will drop to the ground if the turned-down terminal section is struck by a vehicle, which eliminates ramping of the vehicle. To hold the rail at its proper height [69 cm (27 in) in Texas] before and during a vehicle impact along the length of need, backup plates are bolted to the first five posts. The action of this modified guardrail terminal is simple. When a vehicle tire or bumper pushes down on the turned-down terminal, the rail drops from the first

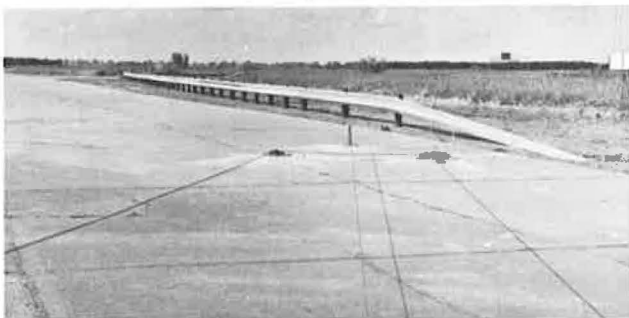
Figure 12. Terminal before test 1.

The guardrail installation evaluated in this test was a variation of the final design described above. In this installation, posts 2 and 4 (Figure 2) were omitted, and 15-cm (6-in) long backup plates were used on posts 1, 3, 5, 6, and 7. The remainder of the rail was installed as shown in Figure 1. This installation is shown in Figure 12.

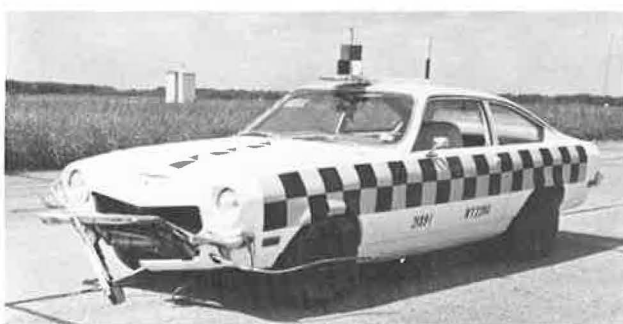
Figure 13. Vehicle after test 1.

section and the vehicle were considered good. The critical roll angle of such an automobile is about 53.4° . The damage to the vehicle and the guardrail is shown in Figures 13 and 14 respectively. One post and two 7.6-m (25-ft) pieces of W-section of the guardrail had to be replaced.

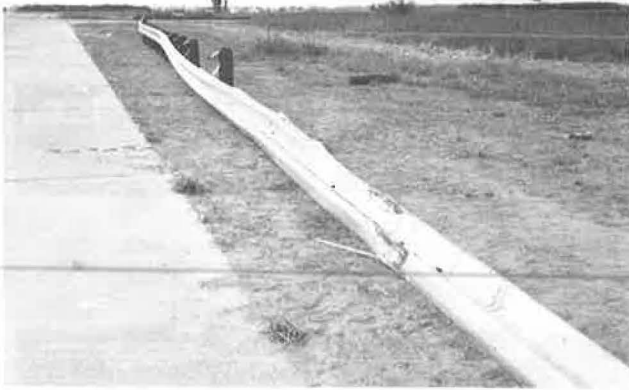
Figure 14. Guardrail and terminal after test 1.

The original objective of this test had been to impact the guardrail along the length of need and obtain a redirection of the vehicle. The vehicle, however, pushed down the rail and rode over it without rolling over. There are two apparent reasons for this: (a) The right front bumper of the vehicle actually impacted the rail 30 cm (1 ft) upstream of post 1 on the terminal section and not on the length of need and (b) the rail was only 61 cm (24 in) high at post 1 because of the repairs after test 1 (Figure 14) and, consequently, the bumper of the

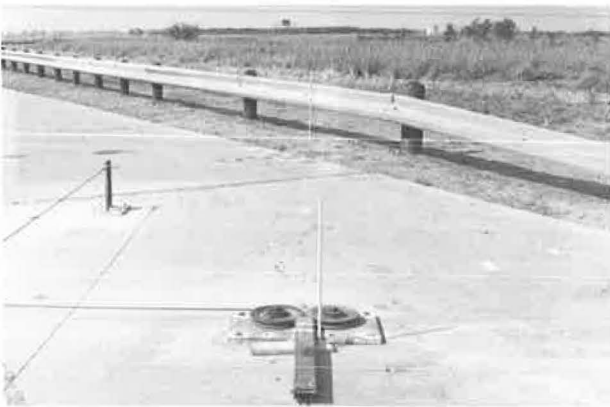
Figure 15. Guardrail and terminal before test 2.

The guardrail installation evaluated in this test was identical to that used in test 1, except that 0.32 by 1.9-cm ($\frac{1}{8}$ by $\frac{3}{4}$ -in), mild-steel straps 20 cm (8 in) long were added at the guardrail-to-post connections having backup plates. This installation is shown in Figure 15.

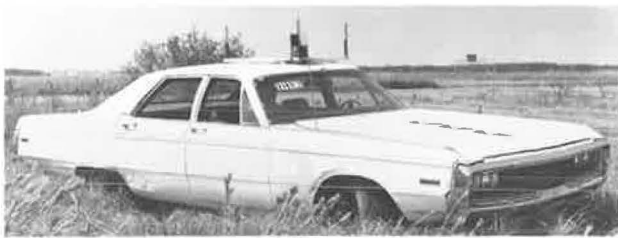
Figure 16. Vehicle after test 2.

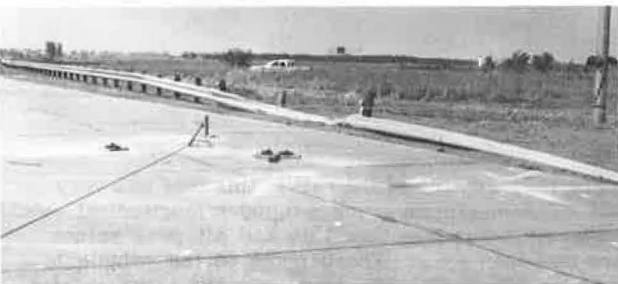
Figure 17. Guardrail and terminal after test 2.

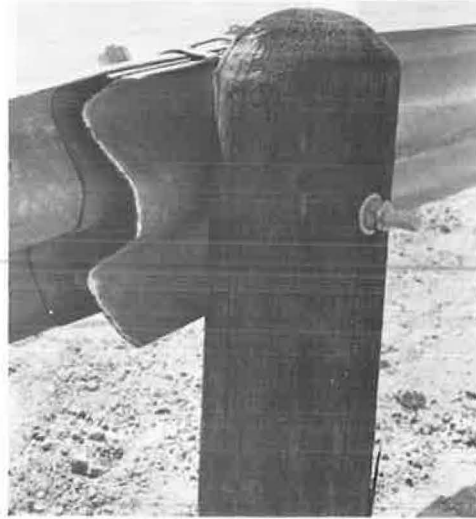
Figure 18. Post 1 with backup plate and metal clips before test 3.

1. The point of impact of the vehicle was moved 30 cm (1 ft) downstream from post 1 into the length of need.
2. In the repair of the guardrail and terminal section, care was taken to ensure that the rail was 69 cm (27 in) high at post 1. During installation, the end piece of rail was bolted to post 1 and pretwisted through an angle of slightly more than 180° to put a permanent 90° twist in it. This gave a neater fit and closer dimensional tolerance after the bolt was removed from post 1 and the backup plates were installed. The installation at post 1 is shown in Figure 18.
3. The length of the backup plates was increased

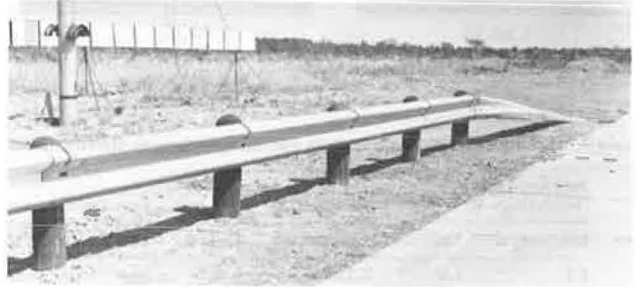
Figure 19. Guardrail and terminal before test 3.

The installation shown in Figure 19 was impacted by a 2037-kg (4490-lb) automobile at an angle of 25° and a speed of 94.4 km/h (58.7 mph). The point of impact was 30 cm (1 ft) downstream of the beginning of the length of need. The guardrail contained and redirected the vehicle without adverse pocketing and snagging, and therefore its performance was good. The vehicle left the rail at an angle of 17.5° and a speed of 58.1 km/h (36 mph). Damage to the front wheel caused the vehicle to follow a curved path and return to the guardrail with another impact at a point approximately 61 m (200 ft) downstream. During the redirection, there was some interaction between the front wheel of the vehicle and the guardrail posts, but there was no snagging effect. The

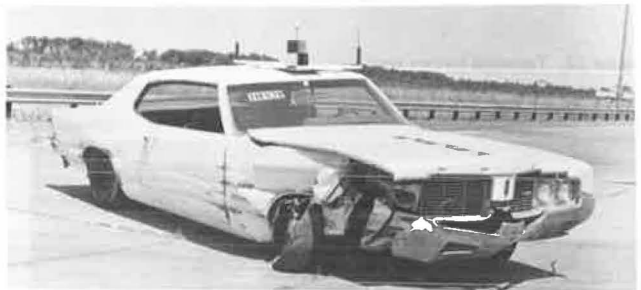
Figure 20. Vehicle after test 3.

damage to the vehicle and guardrail is shown in Figures 20 and 21 respectively. The rail remained nested in the backup plates and at the intended height. Post 3 was broken off at ground level and post 2 and 4 were bent back. The repairs to the guardrail consisted of replacing one post and one 7.6-m (25-ft) section of flex beam. This test was considered very successful.

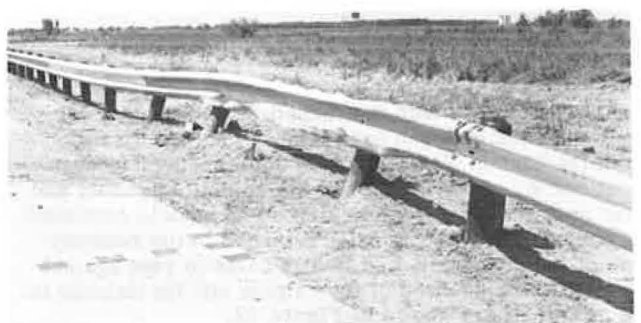
Figure 21. Guardrail after test 3.

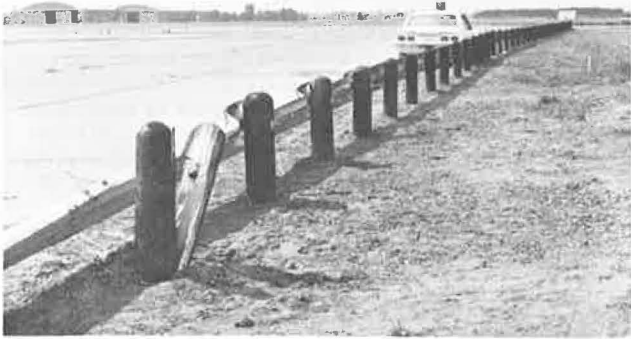
Figure 22. Position of vehicle and damage to guardrail after test 4.

mph). On contact with the turned-down terminal section, the vehicle began to ride up. The rail disengaged from the backup plates and was depressed. The right front corner of the bumper of the vehicle impacted the first post and split it vertically. The vehicle continued forward, rode over the rail, returned to the roadway side of the guardrail, and finally came to rest against the rail. The position of the vehicle and the damage to the guardrail are shown in Figure 22.

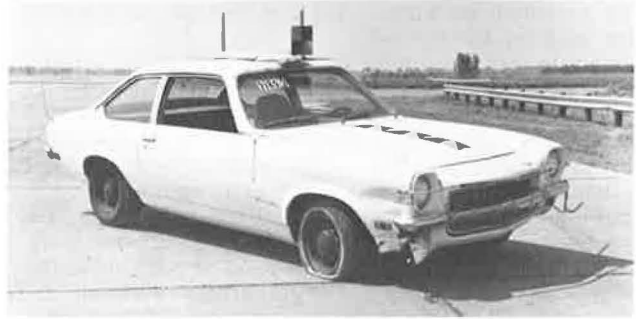
Figure 23. Vehicle after test 4.

The performance of the rail in this test was very good. The maximum average 0.050-s longitudinal deceleration was less than 1.8 *g* and all peak values were less than 4.5 *g*. The damage to the vehicle is shown by Figure 23. The repairs to the rail consisted of replacing one post and one backup plate. (Before this test, it had been anticipated that the vehicle would remain astraddle of the rail and knock down several posts, but this did not happen.)

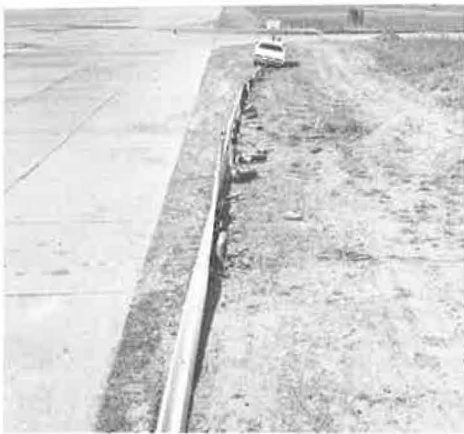
Figure 24. Position of vehicle and damage to guardrail and terminal after test 5.

In this (essentially head-on) test, a 2068-kg (4560-lb) 1970-model automobile impacted the turned-down terminal section at an angle of 5.5° and a speed of 89.0 km/h (55.3 mph). On impact, the vehicle depressed the rail in a manner similar to that of the vehicle in test 4. It then continued astraddle of the rail, exhibiting a low-amplitude, oscillatory pitching and rolling motion, and eventually stopped on the top of the rail approximately 57 m (188 ft) from the end anchor. The position of the vehicle and the damage to the guardrail are shown in Figure 24. Twenty-six posts were split, broken, or bent over. The maximum average 0.050-s longitudinal deceleration was approximately 3 g and the peak values were all below 5.5 g. The extensive damage to the undercarriage of the vehicle is shown in Figure 25. The repairs to the guardrail consisted of replacing 26 posts and eight 7.6-m (25-ft) sections of rail.

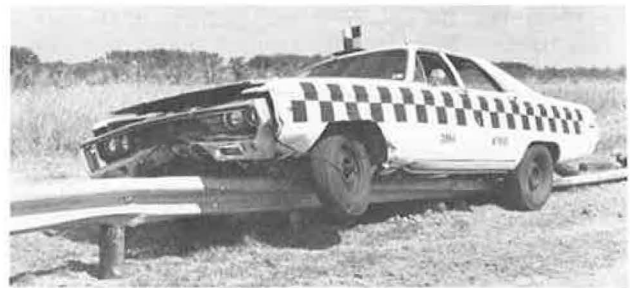
Figure 25. Vehicle after test 5.

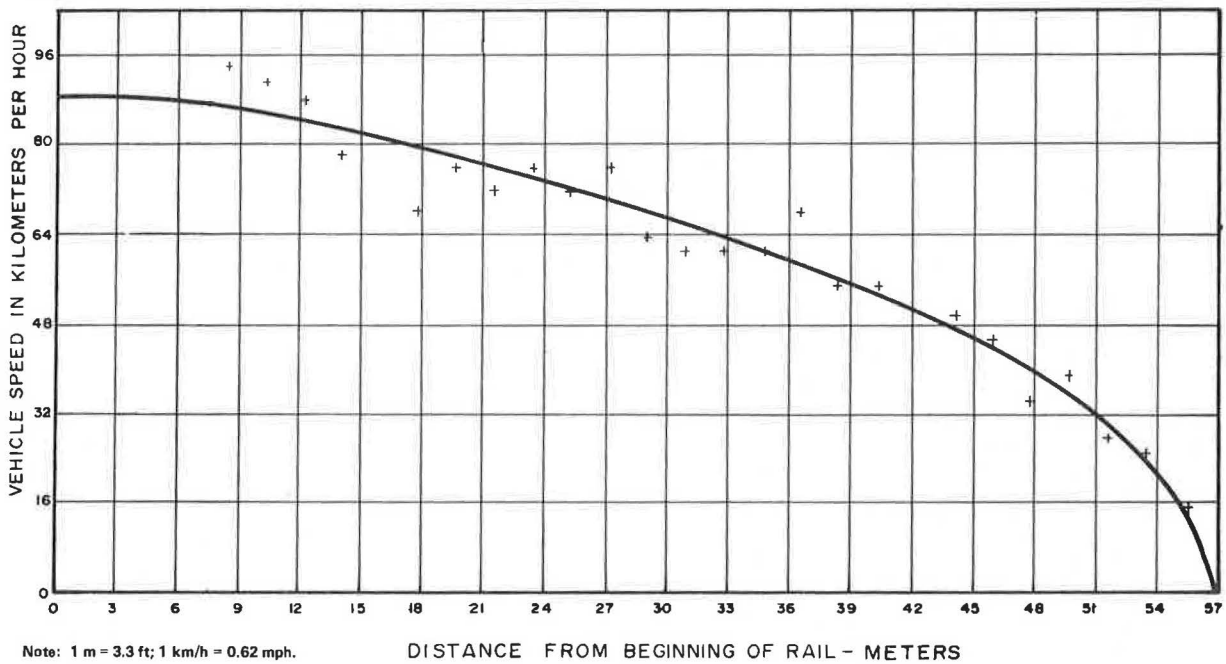
Figure 26. Vehicle speed versus distance from beginning of guardrail (test 2189-4).

In some installations, e.g., bridge abutments and other fixed obstacles, the approach length of guardrail may be less than the 57 m (188 ft) traveled by this test vehicle. If a vehicle became captive at the end of the rail, it could impact the obstacle from which it was being protected. To obtain some indication of the potential severity of such impacts, a curve of velocity versus distance traveled by the test vehicle was developed from the documentary movie film and is given in Figure 26. To avoid the possibility of such head-on impacts, guardrail terminals should be flared away from the roadway.
