# Crash Test Performance of a Guardrail Median Barrier and Temporary Construction-Zone Crash Cushion

Bruce O. Young, Energy Absorption Systems, Incorporated, West Sacramento, California Robert M. Davis, Aerojet Services Company, Sacramento, California

The GuardRail Energy Absorbing Terminal (G-R-E-A-T) and G-R-E-A-T Construction Zone (G-R-E-A-T<sub>oz</sub>) are restorable attenuator systems developed to cushion both the narrow stationary and construction zone hazards. Both systems conform to the test standards for crash cusions outlined in Bronstat and Michie (4). Because the G-R-E-A-T is often used in bidirectional traffic, an additional test, for a wrong-way side-angle impact, was determined necessary to establish its performance suitability. This report describes the units, the test series, and the test results.

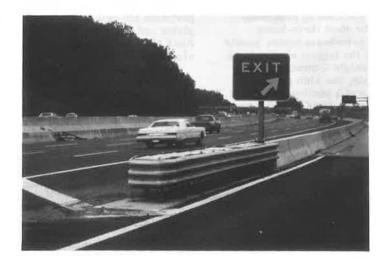
Figure 3. G-R-E-A-T system installed at end of guardrail.

Restoration of the G-R-E-A-T and G-R-E-A-T. can be quickly achieved by pulling the unit out to its preimpact position and replacing the expended cart-ridges and shear pins. Refurbishment, in most cases, can be completed in approximately 30 min. Figure 3 shows the G-R-E-A-T system installed on the end of a guardrail.
