TRANSPORTATION RESEARCH RECORD 769

Roadside Hazards,
Traffic Barriers,
and Safety
Appurtenances

The Rural Mailbox: A Little-Known Roadside Hazard

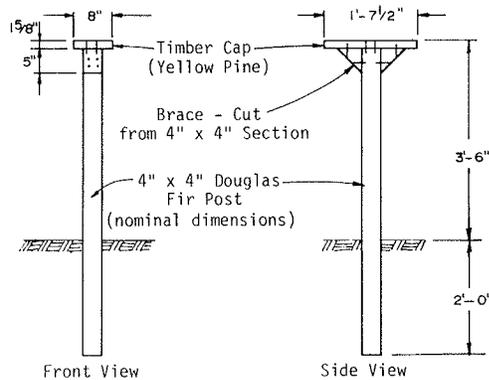
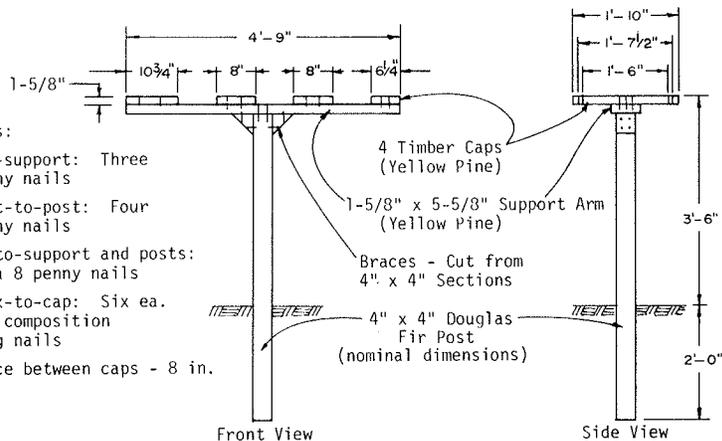
Figure 5. Installation details for wood-post mailbox supports.

SINGLE SUPPORT FOR #1-A MAILBOX (Tests 22 and 23)

Connections:

- 1) Cap-to-support: Three 16 penny nails
- 2) Support-to-post: Four 16 penny nails
- 3) Brace-to-support and posts: Four ea 8 penny nails
- 4) Mailbox-to-cap: Six ea. 1½ in. composition roofing nails
- 5) Distance between caps - 8 in.

SINGLE SUPPORT FOR MULTIPLE MAILBOXES (Test 24)

Figure 5 shows the installation details. Although the post was similar in these tests, the arrangement, size, and attachment of the mailbox differed.

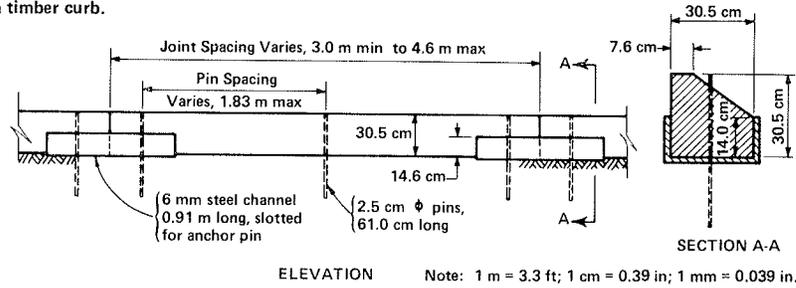
Figure 1. Details of 30.5x30.5-cm timber curb.

* For testing purposes, this 30.5 x 40.6 cm curb is made of 30.5 x 30.5 cm timbers, with two 5.1 x 30.5 cm planks fastened to each with four 13 mm x 15.2 cm lag bolts with washers.

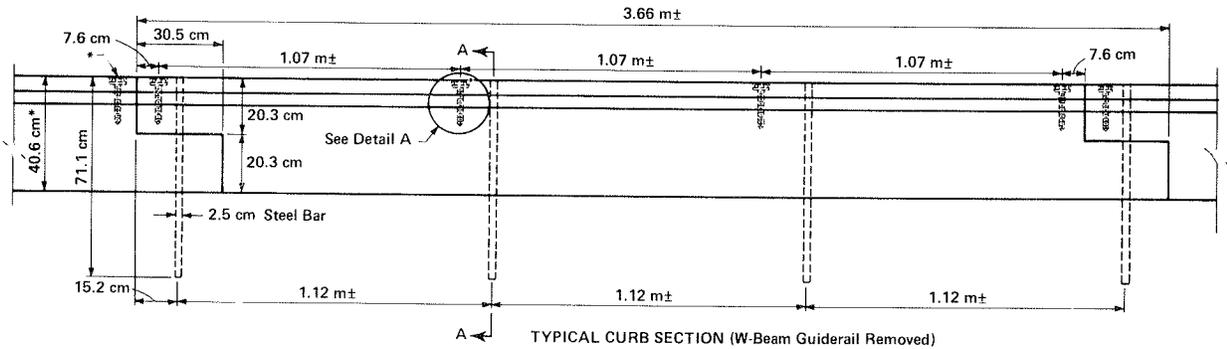
Figure 2. Details of W-beam timber curb.

**W-beam guiderail section, 10 or 12 gage, 31.1 cm high, mounted 13 mm down from top of curb, bolted to curb with 9.5 mm x 8.4 cm lag bolts.

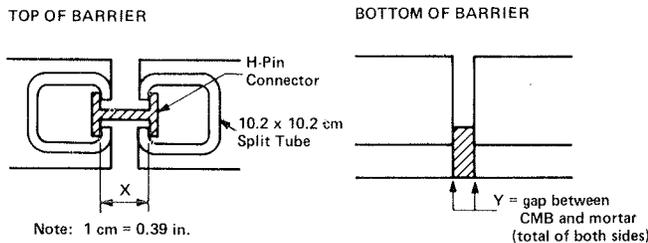
Figure 4. Joint movement in CMB.

Notes: 1 cm = 0.39 in.
Impact between joints 3 and 4.

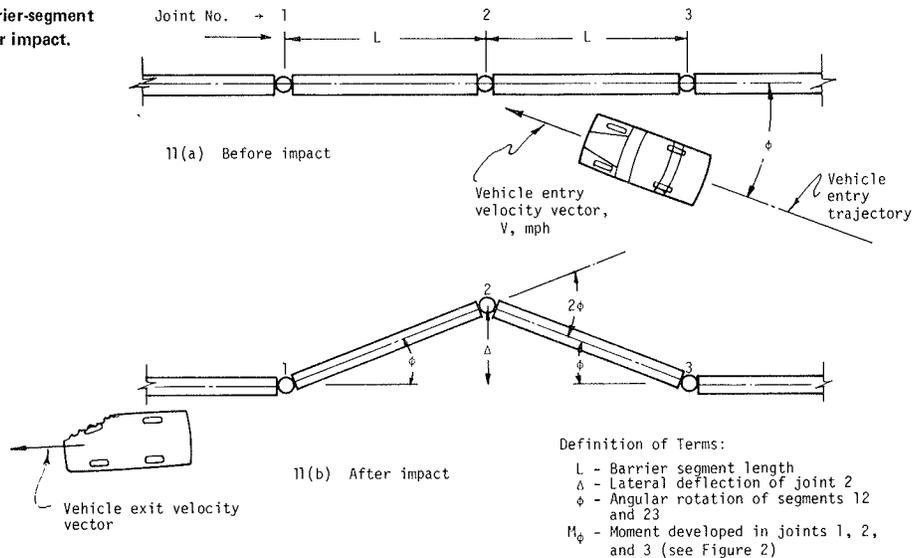
Figure 11. Idealized barrier-segment positions before and after impact.

Figure 11 shows that joints 1 and 3 go through an angular deformation of ϕ while joint 2 goes through 2ϕ .

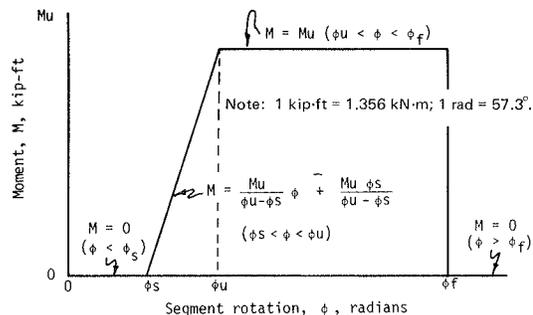
Figure 12. Joint moment versus rotation.

The values of E_{m1} , E_{m2} , and E_{m3} can be determined from the following integrals (or numerically from Figure 12): $E_{m1} = \int_0^\phi M d\phi$, $E_{m2} = \int_0^{2\phi} M d\phi$, and $E_{m3} = \int_0^\phi M d\phi$, where ϕ = maximum rotation caused

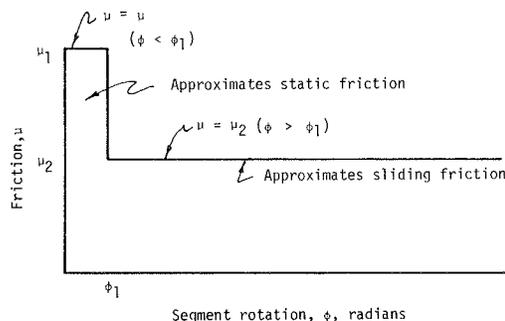
Figure 13. Barrier-support media friction versus barrier-segment rotation.

The work done in sliding the barrier segments can be computed by multiplying barrier-segment weight by the amount of friction developed in any interval of sliding movement and summing all these differential portions of work. This value is approximated by the following equation, which can be solved numerically by referring to Figure 13:

W_i = weight per unit length of the barrier (kip/ft),
 μ = coefficient of friction associated with any movement of the barrier (Figure 13), and
 L = length of a barrier segment (ft).

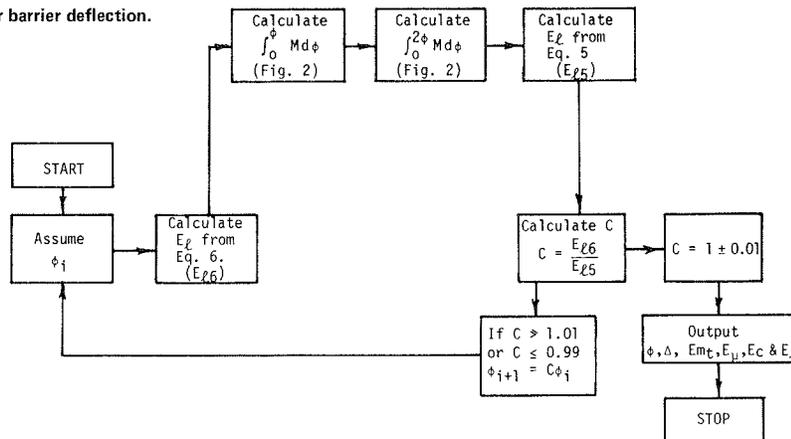
Figure 15. Flow diagram to solve for barrier deflection.

reasonable first estimate of ϕ is chosen. Figure 15 shows a flow chart that illustrates the determination of barrier deflection.

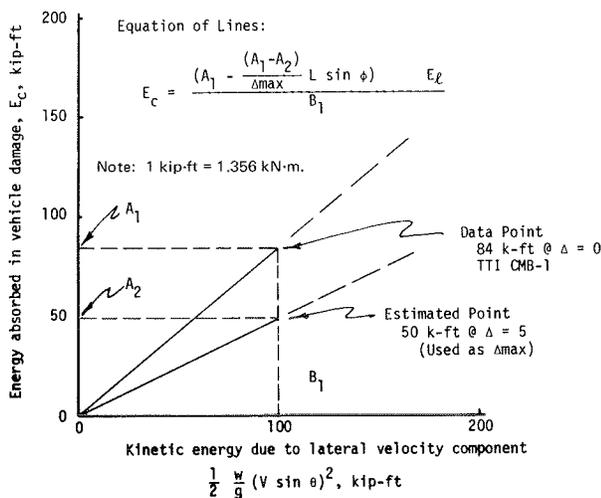
Figure 14. Estimating work done in deforming vehicle structure.

where A_1 , A_2 , and B_1 are constants used in determining E_C (kip·ft) (Figure 14) and $\Delta \max$ is the maximum functional barrier deflection (ft).

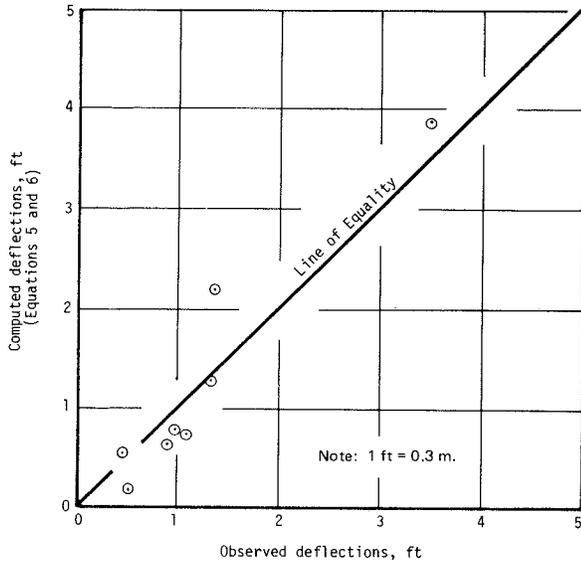
Figure 16. Computed versus observed deflections.

Table 1 compares deflection values observed in these tests with values computed by the analytic method. Figure 16 shows that a reasonable correlation is achieved. It was further indicated by the analytic method that the speculated performance of a 6.10-m (20-ft) segment length with a 122-kN·m (90-kip·ft) ultimate moment would be inadequate at an energy level corresponding to performance level 4 [a school bus impacting at 15° and 96.6 km/h (60 miles/h)]. The analysis does indicate that a 9.14-m (30-ft) long barrier segment with a moment capability corresponding to the Welsbach joint design [184.4 kN·m (136 kip·ft)] would perform adequately at performance level 4. The barrier is predicted to deflect approximately 0.61 m (2 ft) during the school-bus impact. Based on comparisons with a fairly small number of tests, it appears that the energy analysis gives reasonable, if perhaps slightly conservative, results. At the higher levels of kinetic energy, the analysis gives deflections slightly greater than those observed in tests.

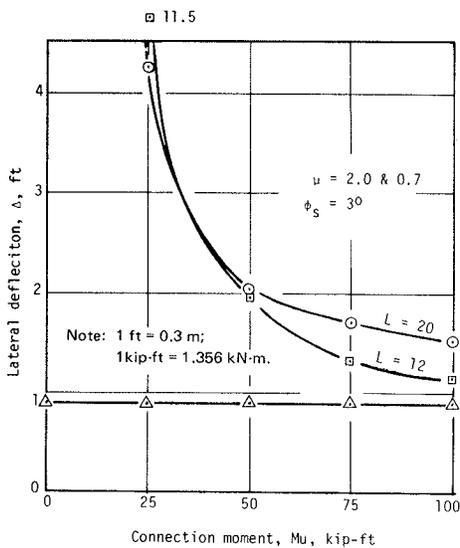
Figure 17. Lateral deflection versus connection moment.

Figure 17 shows a fairly low sensitivity to connection moment between 67.8 and 135.6 kN·m (50 and 100 kip·ft) for segment lengths of 3.66 or 9.14 m (12 or 30 ft). When connection moments are less than 67.8 kN·m, sensitivity increases (deflection increases rapidly) between 33.9 and 67.8 kN·m (25 and 50 kip·ft) for barrier lengths of 3.66 and 6.10 m (12 and 20 ft). Barrier segments 9.14 m (30 ft) long are not very sensitive to connection moment at the level 3 test conditions.

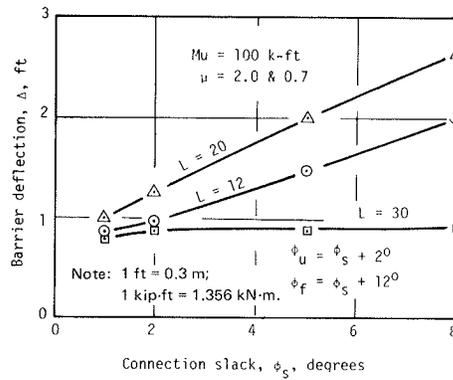
Figure 18. Barrier deflection versus connection slack.

Sensitivity to connection slack--that is, the amount one segment can rotate with respect to an adjacent segment before significant yaw moment is produced--lessens as segments become longer. Figure 18 shows an increase in deflection from 0.30 to 0.61 m (1-2 ft) as connection slack goes from 2° to 8° for a segment length of 3.66 m (12 ft); for a 9.14-m (30-ft) segment length, this sensitivity is reduced to an increase of only 14 percent [0.21-0.27 m (0.7-0.9 ft)] as connection slack increases from 2° to 8°.

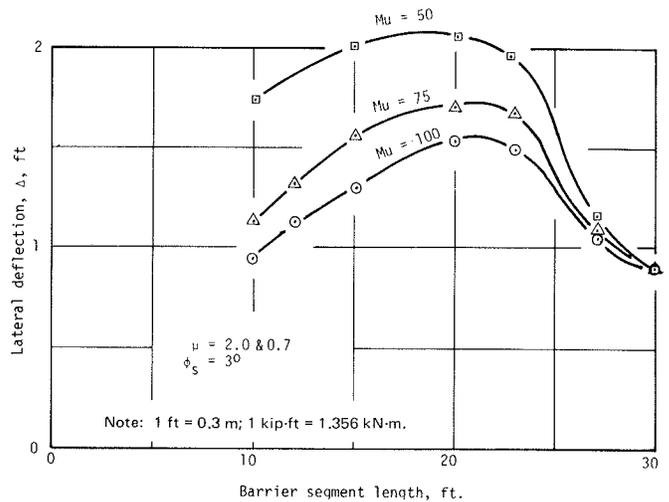
Figure 19. Lateral deflection versus barrier-segment length.

A fascinating, if perhaps predictable, phenomenon occurs when the influence of barrier-segment length is determined for different values of connection moment capacity. Figure 19 shows that barrier deflection first increases with segment lengths up to a maximum of about 6.10 m (20 ft) and then decreases for segment lengths longer than 6.10 m. This phenomenon becomes less pronounced for smaller values of moment capacity and disappears entirely for a zero moment capacity. At zero moment capacity, deflection becomes continuously smaller as segment lengths increase. The reason for this is the conflicting influences of moment capacity and friction. When joint moment capacities are high, the influence of relatively large joint rotations at fairly small deflections produces significantly higher energy absorption for short segment lengths. In contrast, as segments become longer--6.10-9.14 m (20-30 ft)--the joint rotation at a given deflection becomes smaller and the influence of barrier energy absorption attributable to friction becomes dominant.

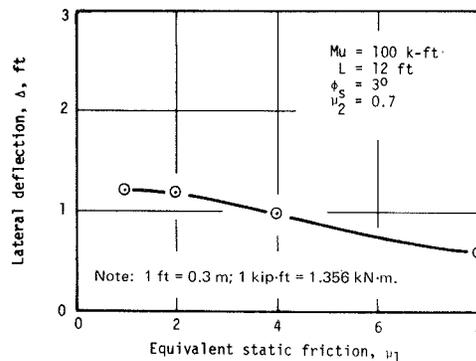
Figure 20. Lateral deflection versus equivalent static friction.

The influence of static and sliding friction on barrier deflection is shown in Figures 20 and 21, respectively. The influence of positive connection techniques, such as the dowels provided by California on some temporary installations, can be accommodated by selecting an appropriately high value of static friction. The influence of barrier mass, although perhaps academic at this stage, is shown in Figure 22. It is possible to increase the mass of portable CMBs by using heavyweight aggregate, but this is not likely to be economically justified.

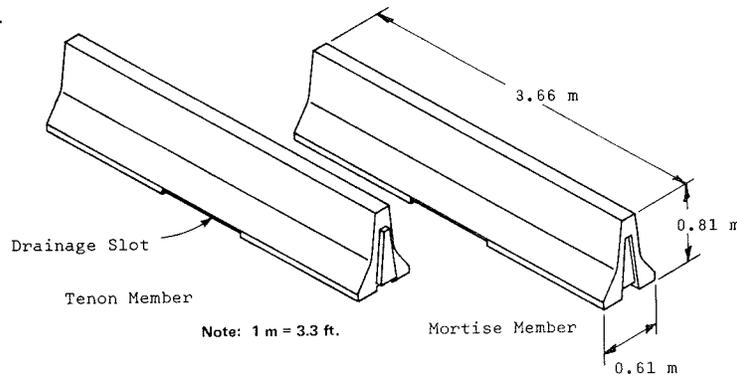
Figure 1. Precast concrete traffic barriers.

The PCTB units used on VA-44 had the New Jersey safety-shape profile. They were 0.61 m (24 in) wide, 0.81 m (32 in) high, and 3.66 m (12 ft) long

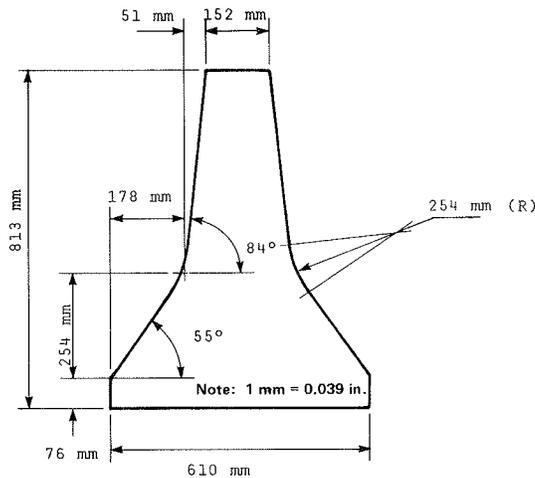
Figure 2. Profile of New Jersey "safety-shape" CMB.

Today's standard New Jersey barrier, often referred to as the safety-shape barrier, is 0.81 m (32 in) high and has a 0.61-m (24-in) base and a 0.15-m (6-in) top width (see Figure 2). It incorporates a 55° batter-curb face with an upper portion (stem) at 84° from the horizontal.

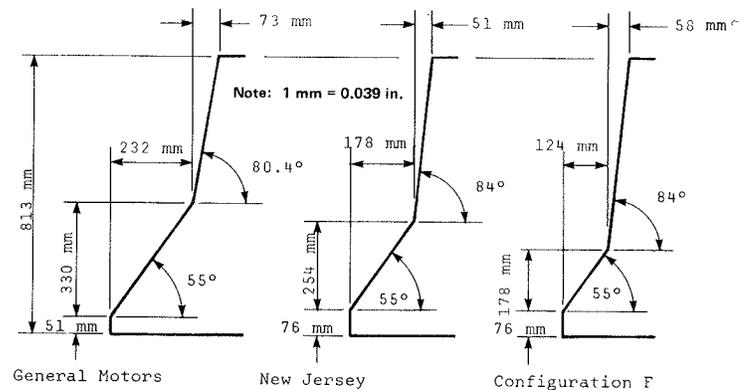
Figure 3. General Motors, New Jersey, and configuration F barrier profiles.

Crash tests have shown that the shape of the concrete barrier can significantly affect the performance of any impacting vehicle. Eight barrier profiles, including the General Motors, New Jersey, and configuration-F designs (see Figure 3), were evaluated by the Southwest Research Institute (SwRI). The tests indicated that all designs performed well in restraining vehicles from penetrating the barrier and most did not cause major damage to the impacting vehicles. However, the General Motors design did cause rollover of a subcompact vehicle at an impact speed of 92 km/h (57 miles/h) and an angle of 16°. Generally, those designs that incorporated a low batter-curb height (the configuration-F and New Jersey designs) were found to be least likely to cause rollover of subcompact cars (4). The batter-curb height is the vertical distance from the bottom of the barrier to the intersection of the 55° batter curb and the near-vertical portion of the barrier. Minicar crash tests performed in England by the Transport and Road Research Laboratory (TRRL) confirmed the crash test results obtained by SwRI. However, in a TRRL crash test, a minicar rolled over when it struck a New Jersey barrier at an impact speed of 113 km/h (70 miles/h) and an angle of 20°. The TRRL study also found that, when a 75-mm (3-in) overlay was placed in front of the New Jersey barrier, a minicar impacting at 113 km/h and 20° did not roll over. The overlay results in a batter-curb height of 254 mm (10 in), which is equal to that of the configuration-F design (5).

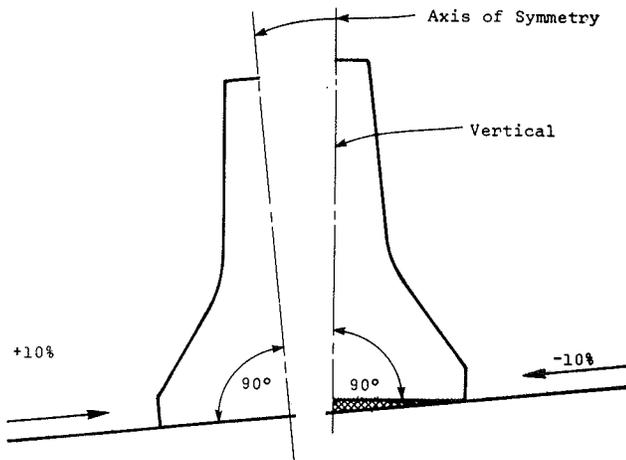
Figure 4. Preferred barrier orientation on superelevated surfaces.

In computer-simulated vehicle crashes conducted by SwRI, the orientation of the barrier axis of symmetry was identified as a factor that contributes to vehicle rollover. In that analysis, only +10 percent and -10 percent superelevations were used (see Figure 4). A subcompact vehicle rolled over when it struck a New Jersey barrier, the axis of symmetry of which was oriented perpendicular to a roadway surface with a -10 percent superelevation. After the analysis was completed, the researchers concluded that the preferred orientation of the barrier axis of symmetry is "perpendicular to the roadway when the traffic is going up the super and vertical when the traffic is going down the super" (4). The orientation of the barrier axis of symmetry should be considered when PCTBs are to be placed on a surface that slopes away from the roadway. If it is determined that the surface must be graded before installation of the barrier, it is important to ensure that (a) vertical support is provided across the full width of the barrier to reduce barrier roll and (b) the toe of the barrier is not placed below the approach surface level.

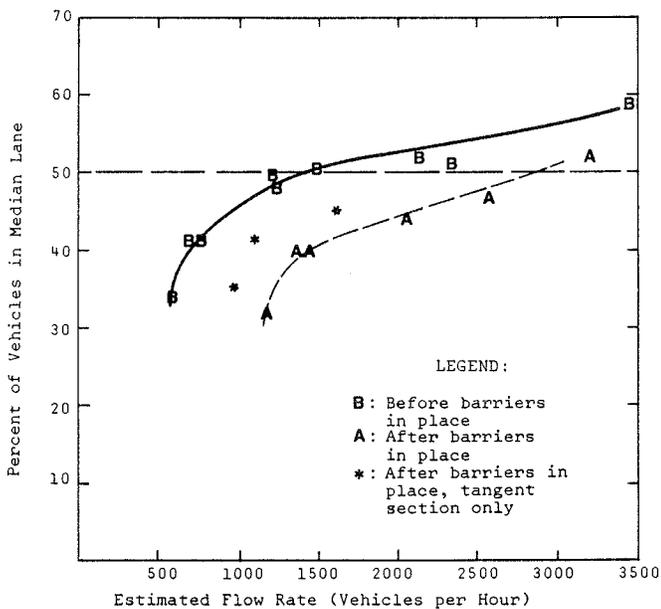
Figure 5. Lane distribution.

As expected, the distribution of traffic between the lanes changed with traffic volume. Figure 5 shows that at low traffic volumes drivers exhibited a definite tendency to stay out of the median lane when the barrier was present. As the traffic volume increased, however, a larger percentage of motorists chose the left lane, no doubt because of its higher speed even when the barrier was present. Figure 5 also shows that there was a larger percentage of vehicles in the median lane in the tangent section than in either curve section. This finding suggests that motorists feel relatively more comfortable traveling immediately adjacent to the barrier in tangent sections than in curved sections.

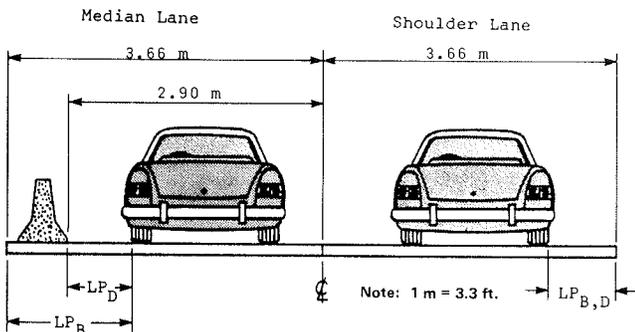
Figure 6. Lateral placement.

Lateral placements for all three sites are summarized in Table 2. In all cases, lateral placements were measured from the outside wheel of the vehicle to the edge of the pavement or to the bottom of the barrier, as shown in Figure 6.

LP_B = Lateral Placement Before Construction

LP_D = Lateral Placement During Construction

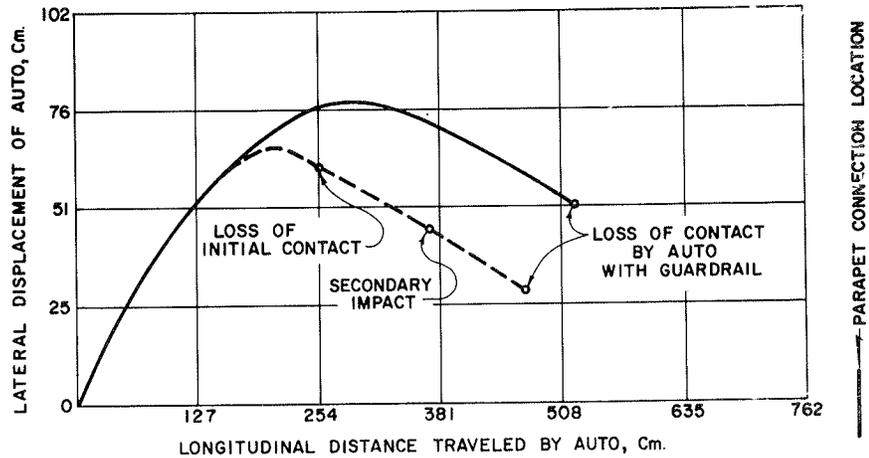
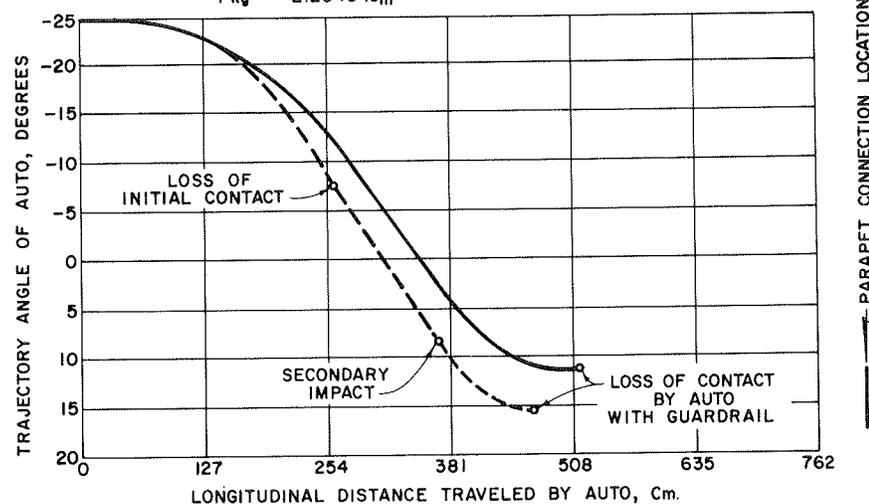
Figure 3. Trajectories of 1021-kg automobile under impact conditions of 64 km/h and 25°.

NOTE: ALL DATA POINTS ARE WITH RESPECT TO AUTO CENTER OF GRAVITY
 1 km/h = .6214 mph
 1 cm = .3937 in
 1 kg = 2.2046 lb_m

— EXISTING SYSTEM
 - - - STIFFENED SYSTEM

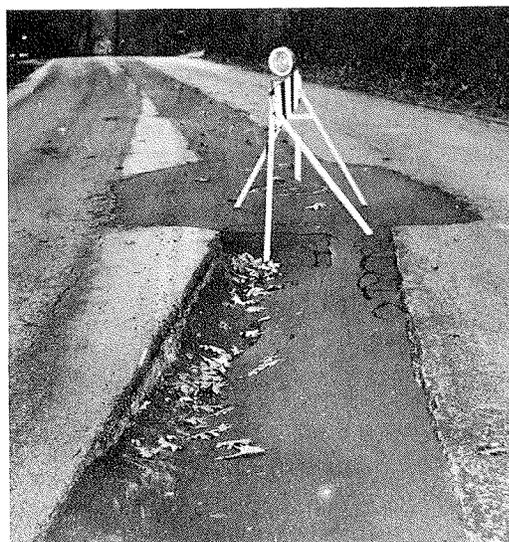
Figure 2. Failure of pavement over new installation of a sanitary sewer line that resulted in several accidents involving property damage and minor personal injury.

Such problems do not occur often at a given location and, after one or two return trips for repairs, the serious, hazardous failures no longer seem to occur. Yet, as Figure 2 indicates, poorly repaired pavement cuts sometimes create a serious problem that can result in serious accidents involving personal injury (3, p. B-1). It may be better in the long run to install all underground facilities in locations other than directly under the traffic lanes. On the other hand, proper methods of backfilling and pavement patching would eliminate this type of problem.

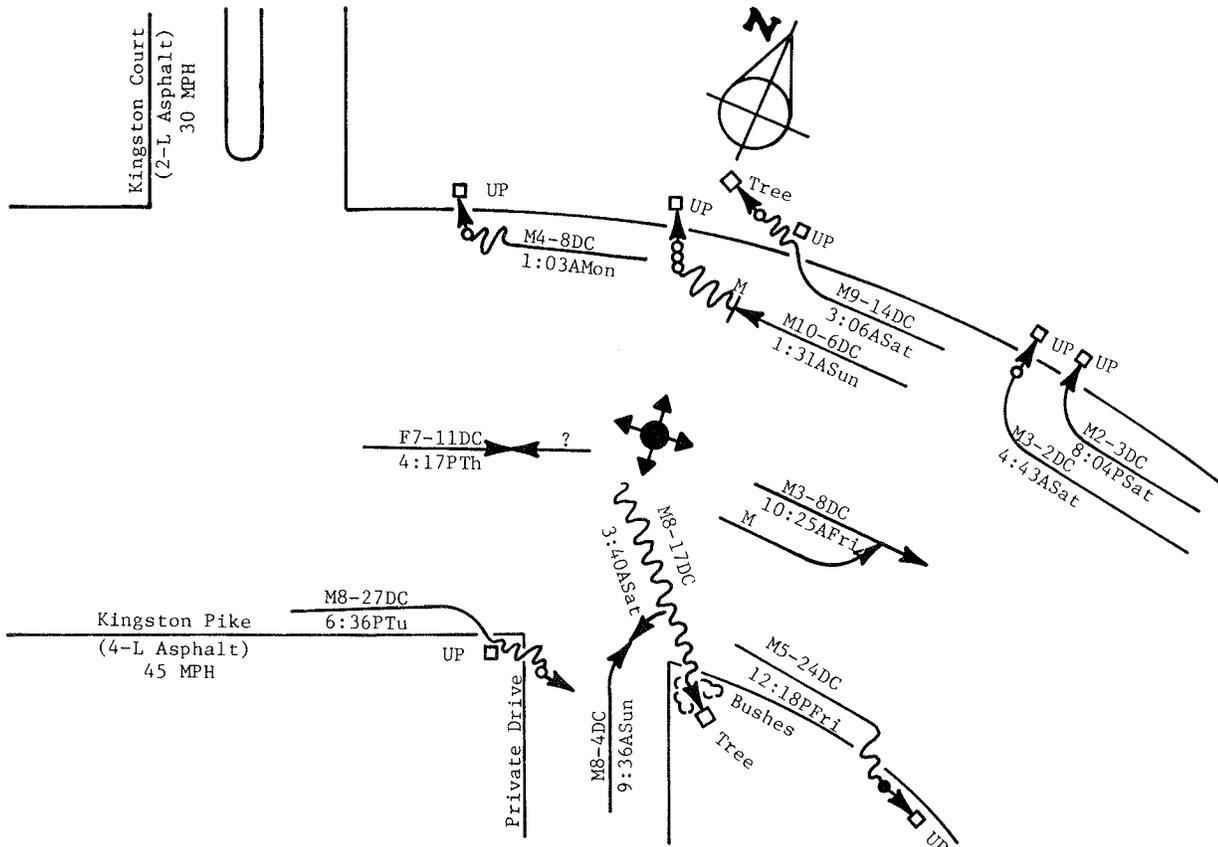
Figure 4. Typical collision diagram for a location that has a high incidence of conflicts between utility poles and vehicles.

purported to have a high incidence of accidents involving utility facilities. The collision diagrams prepared from police accident reports for that highway section bore out the suspicions (1). Figure 4 and the following table illustrate the accident data for the period from January 18 to October 14, 1968:

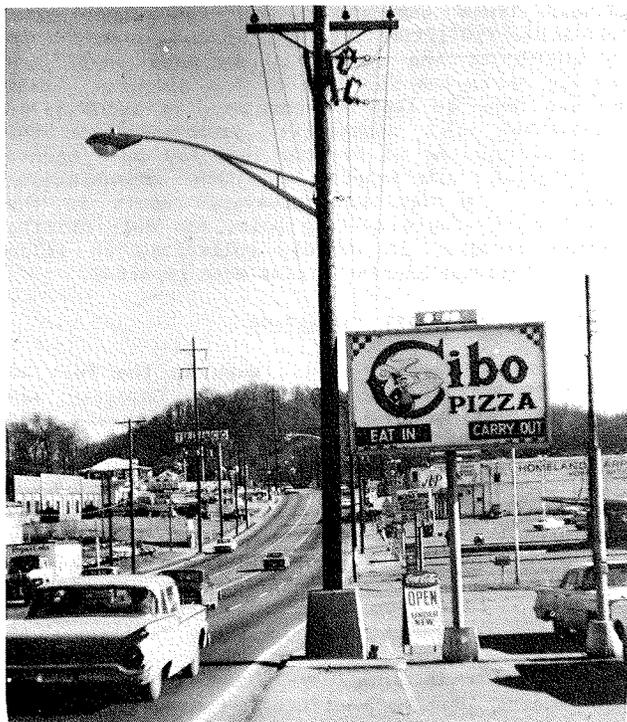
Figure 6. Protection of utility poles with heavy concrete encasements that created a much worse hazard for vehicles.

The utility companies were somewhat aware of the conflicts between vehicles and their facilities. In some cases, where particular poles were often struck, extra precautions had been taken to protect the facilities with heavy concrete barriers (see Figure 6), steel posts concreted in the ground, or other devices. Many of these barriers were placed along routes where posted speeds were 45 miles/h or higher. A utility pole is a fixed object that will break when struck with enough momentum, although usually not before destroying the striking vehicle and its contents. A concrete barrier is a fixed object that is almost indestructible (Figure 6).
