# Crash Tests of Box-Beam Upgradings for Discontinuous-Panel Bridge Railing

JAMES E. BRYDEN AND KENNETH C. HAHN

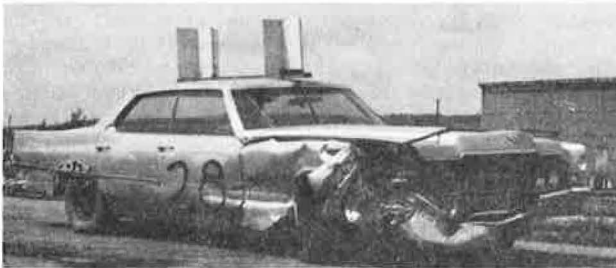
Figure 3. Barrier and vehicle damage resulting from test 28.

Vehicle damage was moderate; the bumper, grill, and right front fender and suspension were crushed and bent and there were dents in the right-side doors and right rear fender. The right front suspension was broken and the tire flattened; the vehicle could not have been driven from the scene. Barrier damage was limited to eight displaced posts (only one was bent 0.25 in) and two bent rail sections at the upper rail splice in the vicinity of impact (one blockout was crushed 2 in and one base plate was bowed 0.50 in), both on the first bridge-rail post. The maximum permanent deflection was 0.8 ft about 7 ft downstream of the impact point. Vehicle and barrier damage resulting from this test is shown in Figure 3.
