*TRANSPORTATION RESEARCH RECORD* 868

# Testing, Evaluation, and Upgrading of Safety Appurtenances

*TRANSPORTATION RESEARCH BOARD*

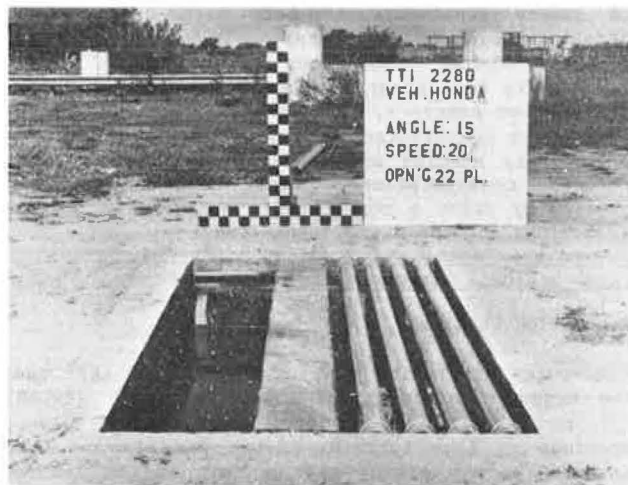
Figure 2. Test pit installation.

ings. The objectives of these tests were to determine preliminary values for (a) the maximum clear opening permissible on a nongrated culvert end and (b) the maximum spacing permissible when grates are necessary. All runs were live-driver tests at various speeds and encroachment angles. Figure 2 is a photograph of the test pit after installation. A total of 30 runs were made to determine the maximum clear opening. A test matrix for this series of tests is shown in Table 1. All tests were with a

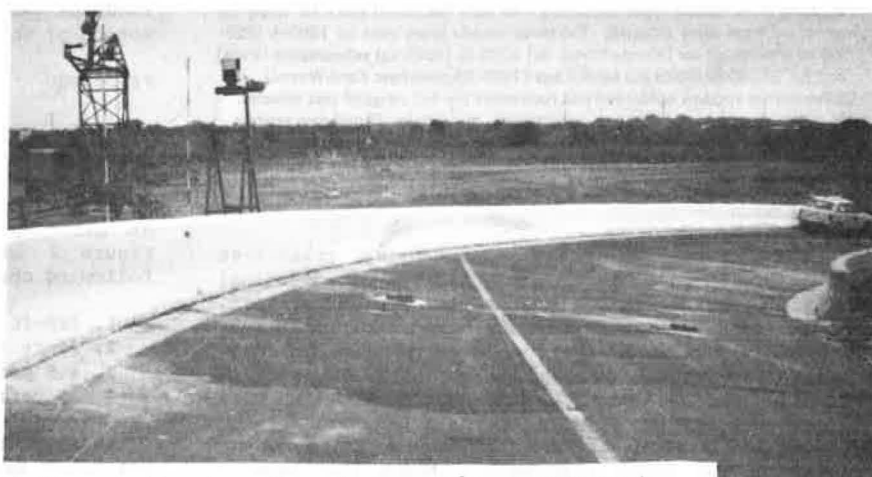
Figure 1. Barrier test installations.

(a) Vertical New Jersey shape parapet

(b) Perpendicular New Jersey shape parapet

(c) Tubular thrie beam retrofit

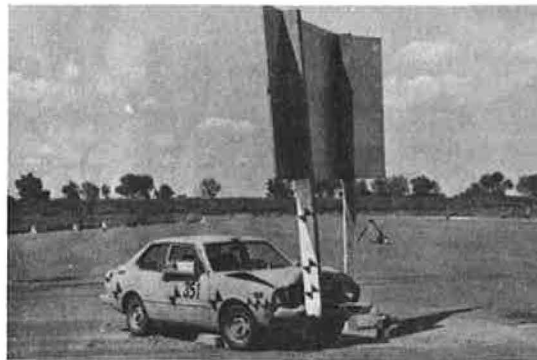
Figure 4. Test 351: final locations of test sign and vehicle after impact.

During impact, the post first split between the 2.5-in-diameter breakaway holes, and the split continued down below ground (see Figures 3 and 4). The post was torn off at the upper hole and the split stub below it was loaded because of two independent cantilevers that failed 10 in below ground. These two cantilevered post segments, which were 29.5 in long, stayed together and lodged beneath the

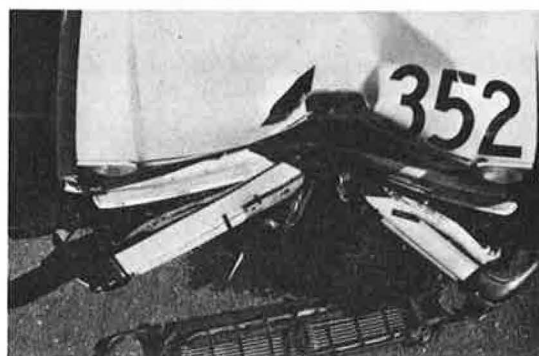
Figure 6. Test 352: crush at front of vehicle.

The impacted post failed the same way as the one in test 351 (see Figures 5 and 6). Again, a 28-in post segment separated from the post, lodged under the vehicle, and was dragged by the vehicle until it stopped. The upper part of the post, which was connected to the sign panel, was thrust up in the air while the vehicle passed underneath it and continued straight downstream.

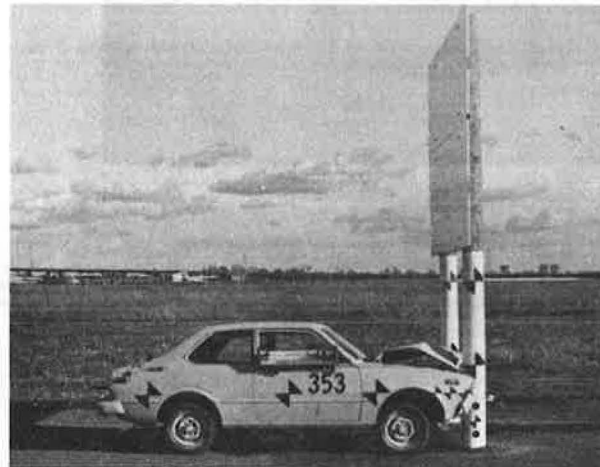
Figure 8. Test 353: final locations of test sign and vehicle after impact.

the vehicle except for scuff marks. The ground-line movement of the pole was 0.75 in (see Figures 7 and 8).

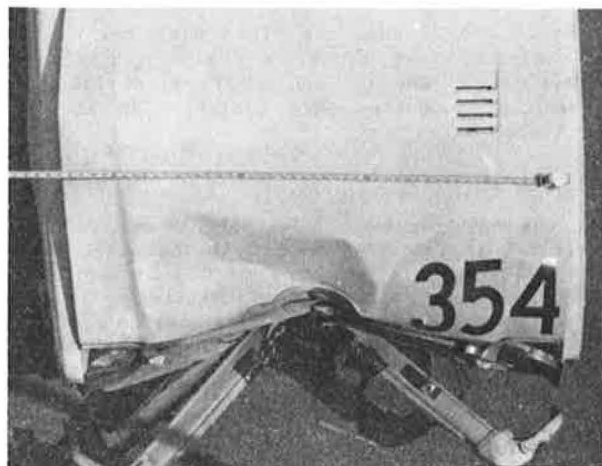
Figure 10. Test 354: crush at front of vehicle.

One of four hole patterns met the change-of-momentum requirements. This pattern was used in the timber poles for test 354. In test 354, the vehicle sheared off the pole and pushed it ahead 5.5 ft before stopping and rebounding to a point 1.75 ft beyond the original pole location (see Figures 9 and 10). The segment of the pole between the bored holes separated from the main pole and split into several pieces.

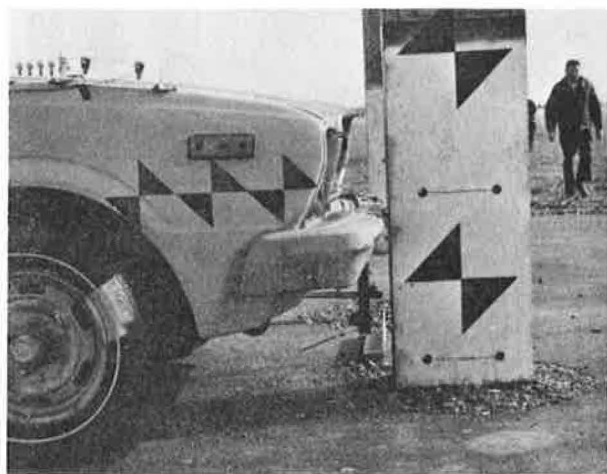
Figure 13. Test 355: test vehicle and box-section post before impact.

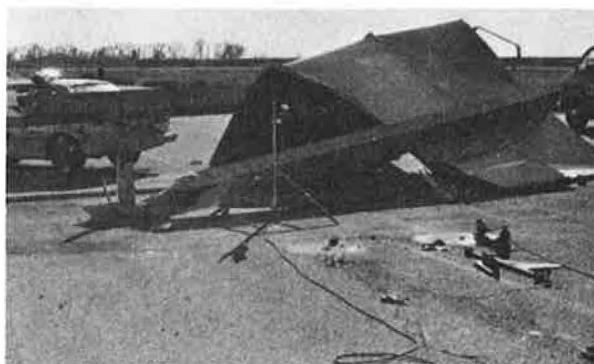
Figure 14. Test 355: final location of test sign and vehicle, looking downstream.
