# Construction Control by Monitored Geotechnical Instrumentation for New Terminal 46, Port of Seattle

BENGT H. FELLENIUS, ARTHUR J. O'BRIEN, AND FRANK W. PITA

Geotechnical instrumentation was used to monitor and control construction pore pressures and soil movement during major modifications to an existing container terminal (old terminal 46) for the Port of Seattle. There was concern that the construction work, which consisted of dredging, filling, and pile driving, might disturb the confined and sloping (5H: 1V) 25-ft-thick loose silt layer beneath the fill at the terminal. Construction control by monitored instrumentation was used because the topographic conditions at the site and the Port's economic and marine design parameters precluded conventional methods of preventing slope failure, such as total excavation of the silt and/or flattening the new fill slope. The instrumentation monitored the behavior of the confined silt layer to ensure that excess pore pressures and soil movements induced by the disturbance of the construction work were within acceptable limits. Two warning levels of observed excess pore pressure were established to control the construction sequence and ra

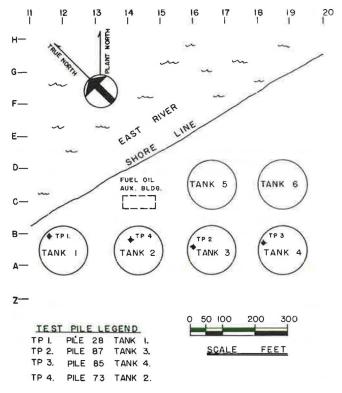
Figure 1. Test pile location plan.

The Power Authority of New York State recently constructed six 6 000 000-gal fuel oil storage tanks for the Astoria Generating Station No. 6 in Queens County, New York City. These tanks each measured 160 ft in diameter by 40 ft high. A fuel oil auxiliary building was also built at this time. All of these structures were designed to be supported on 150-ton-capacity piles. Figure 1 shows the job layout.
