# Design and Development of Self-Restoring Traffic Barriers

MAURICE E. BRONSTAD and CHARLES F. McDEVITT

#### ABSTRACT

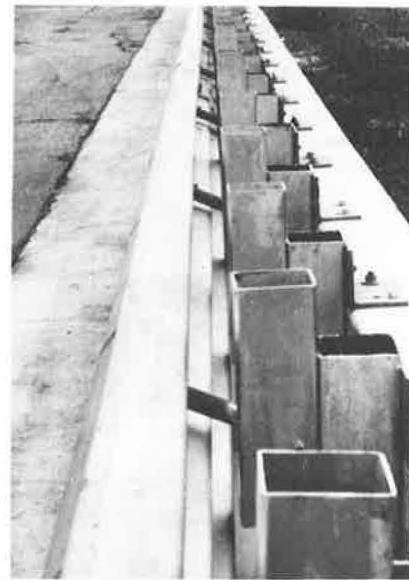
FIGURE 1 SERB bridge rail retrofit.

The retrofit system (as described in Figure 1) was installed on an existing narrow walk and parapet bridge rail. This existing installation is identical

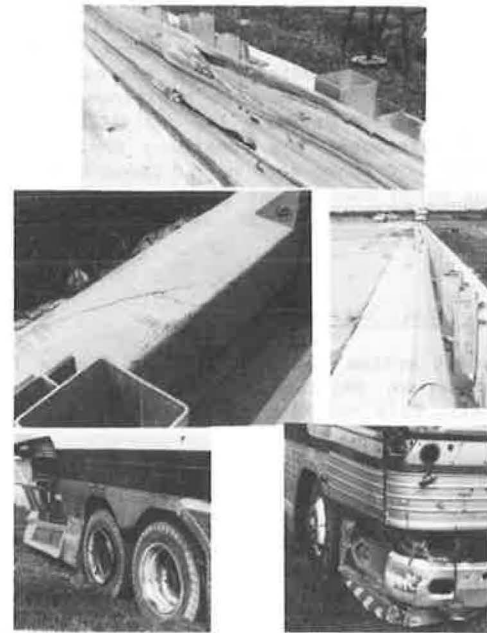
FIGURE 3 Photographs after test SRF-1.

As shown in Figure 3, barrier damage was moderate. Some cracking of the concrete parapet was noted. Damage to the vehicle (Figure 3) was most extensive in the areas of the passenger service door and right rear corner. All three outermost wheel rims on the right side were damaged, and one cargo door was torn away.

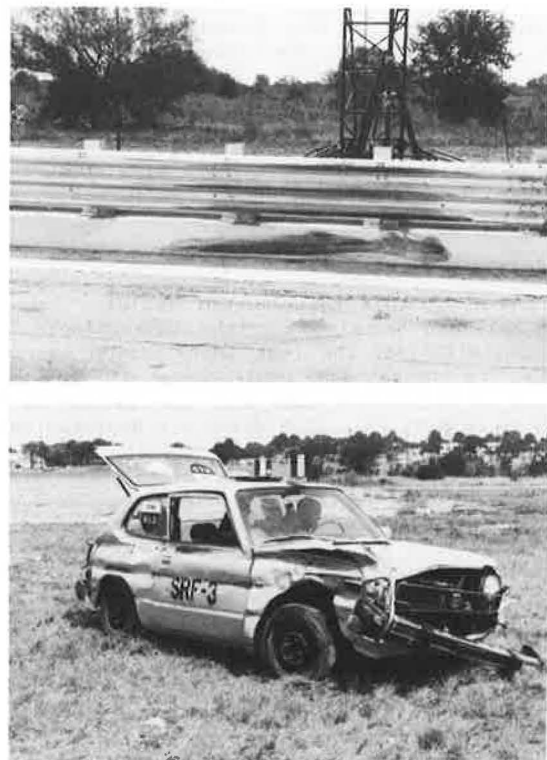
FIGURE 7 Photographs after test SRF-3.

There was no significant barrier damage or permanent deformation, although the tubular Thrie-beam was displaced rearward and upward during the impact. Some scraping of the beam and tire scuff marks on the curb were evident, as shown in Figure 7. Vehicle damage as shown in Figure 7 consisted of impact-side sheet metal and left bumper support failure. All tires remained inflated. There was some impact-side (right) door deformation due to dummy contact, and the right window was sheltered by the dummy.

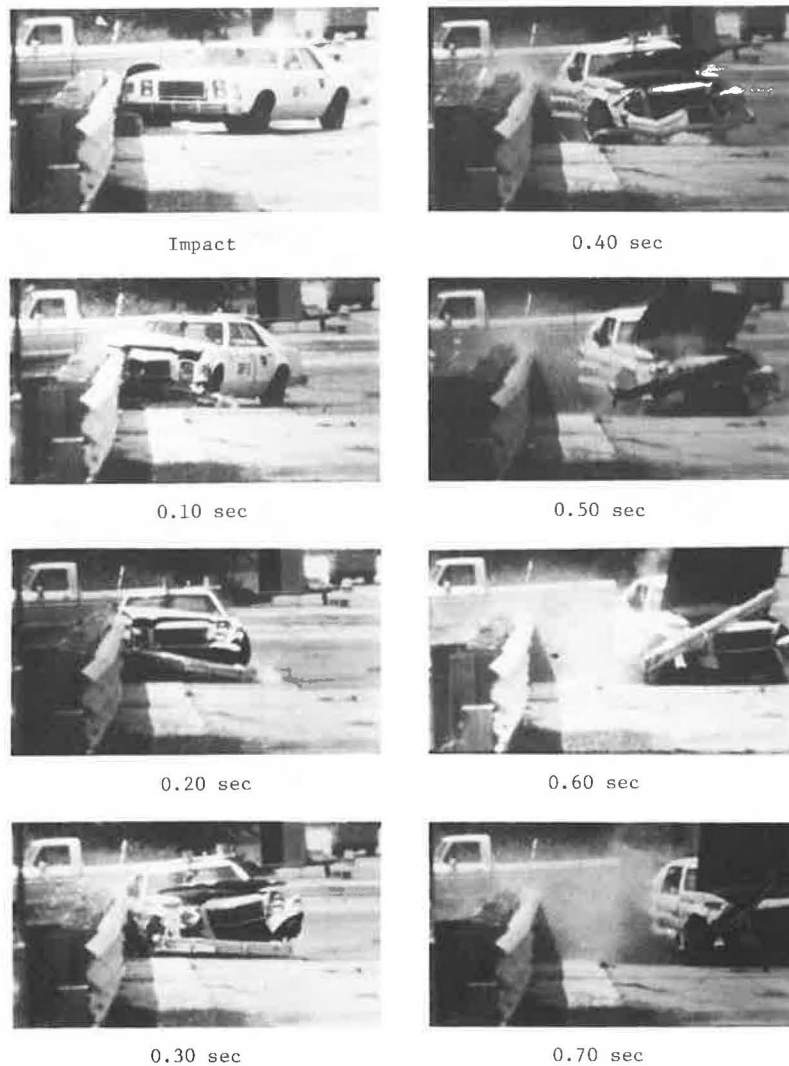
FIGURE 11 Test SRF-5 impact sequence.

The 1979 Ford LTD sedan weighing 4,450 lb (2018 kg) impacted the transition just upstream of post 5 (post 11 is the first bridge post). Impact conditions were 59.7 mph (96.1 km/h) and an angle of 25.2 degrees. As shown in Figure 11, there was no evidence of snagging, as the vehicle was smoothly redirected.

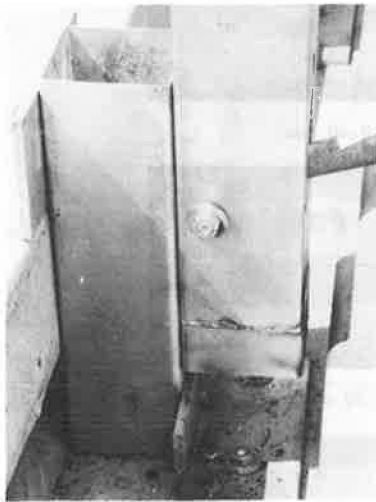
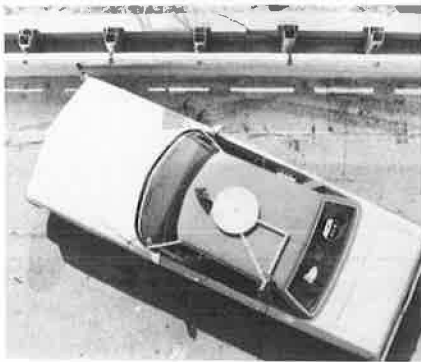
(a) Extended spacer

(b) Overhead view

FIGURE 13 Photographs before test SRF-6.

The purpose of this test was to evaluate a design change made to improve the articulation of the tubular Thrie-beam element. The spacers to which the beam is attached by the pivot bars were extended 3 in. (75 mm) below, as shown in Figure 13, to prevent the beam from being pushed under the spacer.

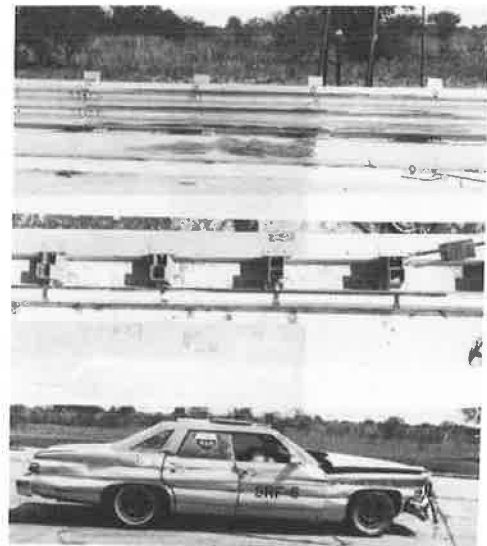
FIGURE 15 Photographs after test SRF-6.

As shown in Figure 15, there was no significant barrier damage; this is an obvious improvement over the results of test SRF-4 with the shorter spacer. Significant vehicle side and right front damage resulted (Figure 15). All tires remained inflated, and suspension damage was moderate.

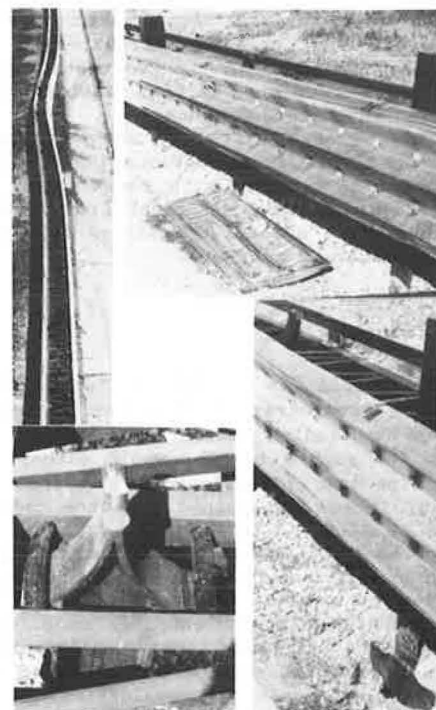
FIGURE 19 Photographs after test SMB-1.

Barrier damage was moderate, with damage to three Thrie-beam sections. Although not damaged, posts 14 through 27 were displaced rearward. Damage to the truss system consisted of several bent rollers (at post A) in the impact area. Photographs of the barrier damage are shown in Figure 19. Vehicle damage due to barrier impact was slight. There was sheet-metal damage on the right front corner, and along the right side the sheet metal was deformed. The battery compartment door was detached. All tires remained inflated during and after impact. There was no apparent damage to the running gear (see Figure 17) before a secondary collision with another barrier considerably downstream from the test barrier. This secondary collision caused rollover of the bus.

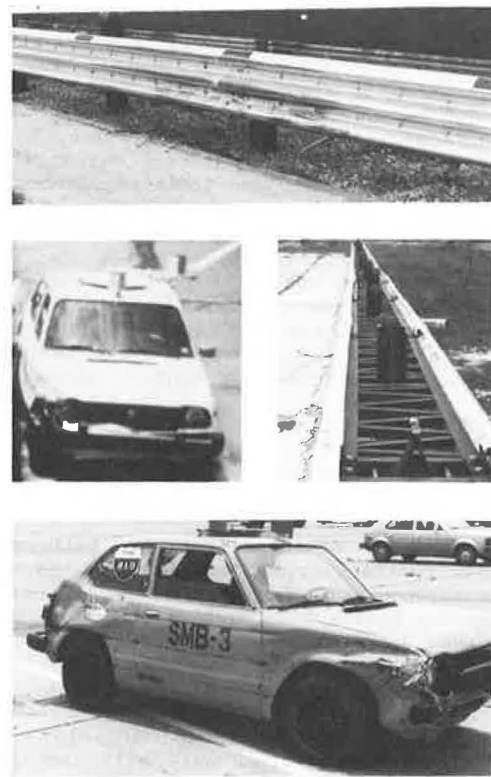
FIGURE 23 Photographs after test SMB-3.

The barrier was not structurally damaged; the system was fully restored, as shown in Figure 23. The sheet metal on the front corner and side was damaged (Figure 23). The bumper of the vehicle was subsequently damaged due to contact with another barrier.
