Effects of Sawed-Groove Texturing on Concrete Bridge Decks

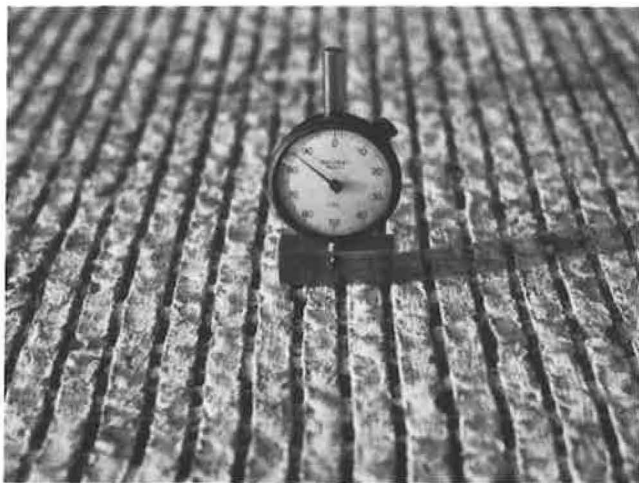
FIGURE 4 Measuring groove depth with a dial gauge.

Groove depths were measured with a dial depth gauge (Figure 4) previously used in New York on grooved surfaces (1,18,19). On transverse textures, grooves were measured at close intervals along the entire length of the left wheelpath of each test site, and mean groove depths (MGDs) were calculated. On longitudinal textures, grooves were measured over a 1-ft distance perpendicular to the centerline of the wheelpath at each sand-patch test location. Initial MGDs were used to assess compliance with the texture depth specified and will be discussed later.

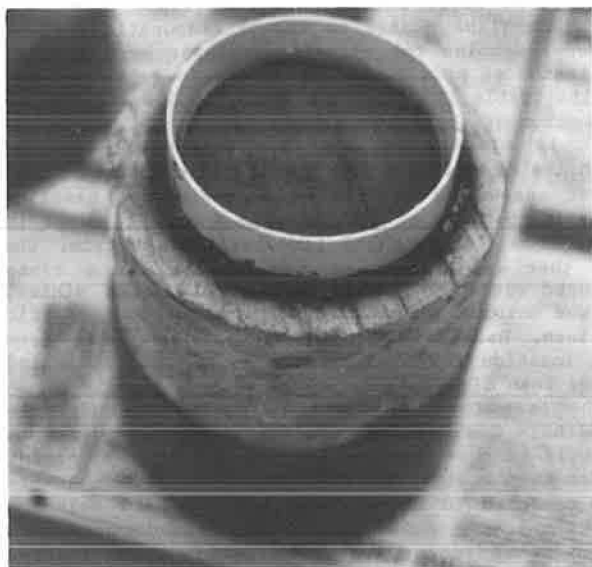
FIGURE 5 Chloride solution ponded on core surface.

For the ponding tests, dams consisting of 1-in.-high rings of 4-in.-diameter polyvinyl chloride (PVC) pipe were cemented to the core surfaces (Figure 5). The dams were filled with the 3 percent NaCl solution and maintained at a depth of 1/2 in. for the full 90 days, during which the rings were covered with glass plates to reduce evaporation. After 90 days, samples for chloride analysis were removed and tested as previously described. In reporting the results (Table 1), the zero depth level was taken as the bottom of the texture grooves.
