A summary of the elements of the sign-refurbishing procedures used in the Virginia districts is shown in Table 1. All districts use 4-ft aluminum panels for overlaying. These are sized in the shop to fit the sign to be refurbished and are faced with encapsulated lens background sheeting. Five districts use these panels to overlay their signs in place on the highway and attach the overlay panel to the old sign with rivets, two use rivets plus an adhesive, and one either replaces the entire sign or uses riveted overlays. One of the districts that uses an adhesive in addition to the rivets overlays the sign in place in the field, and the other brings the sign into the shop for overlaying. It is noted that two districts are trying the new System 5 method.

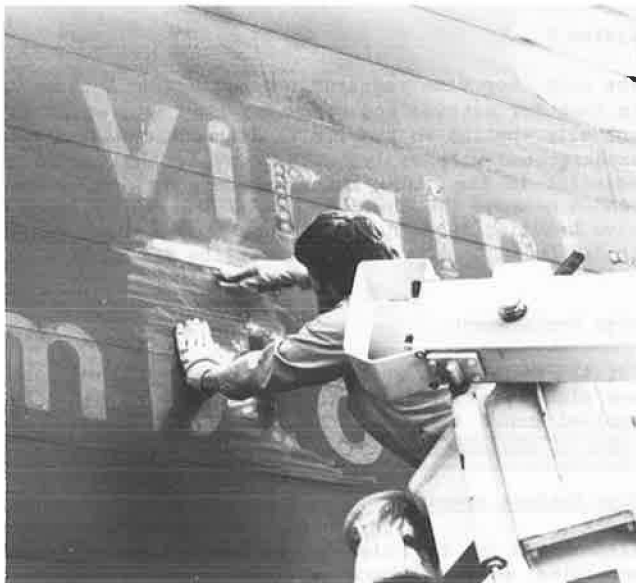
Figure 1 shows a sign being prepared for the application of System 5 material, which is limited to surfaces that are smooth, clean, and dry. For weathered surfaces that exhibit spalling, ply separation, delamination, or poor adhesion of the paste, all loose material should be removed by scraping and brushing before the System 5 material is applied.

FIGURE 1 Sign preparation for System 5 material.

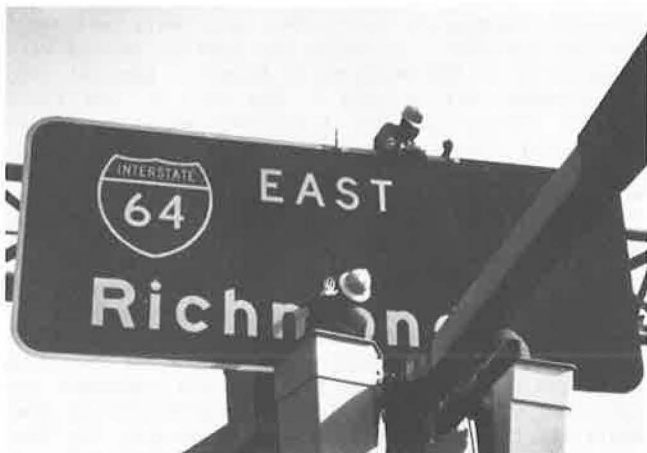
FIGURE 3 Riveting overlay panel to in-place sign.

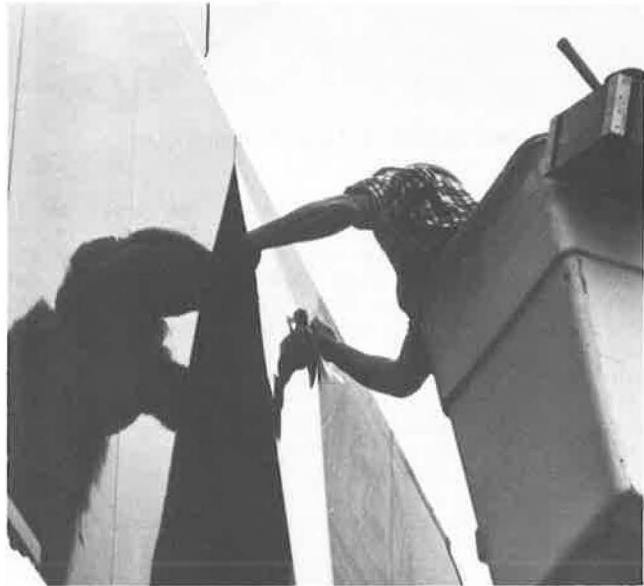
The System 5 material is backed with a pressure-sensitive adhesive and is attached by aligning the 2-ft sheets and pressing them onto the surface with a rubber roller or a soft cloth. No rivets are used in

this procedure. Figure 4 shows application of the System 5 sheeting. This procedure requires more field application time than that used for riveted overlays because additional time and care are required in preparing the old sign surfaces and aligning and applying the material. Data on shop and field manpower and time requirements are given later. It should be noted that although it is important to refurbish a sign as quickly as possible, workmanship is also important and special care should be taken in handling and applying the panels. For example, some problems were encountered when the System 5 sheeting wrinkled or captured air bubbles, primarily because the sheeting was improperly crimped or applied. There were also situations in which wind caused problems in application, especially for very high signs.

FIGURE 4 Applying System 5 sheeting.

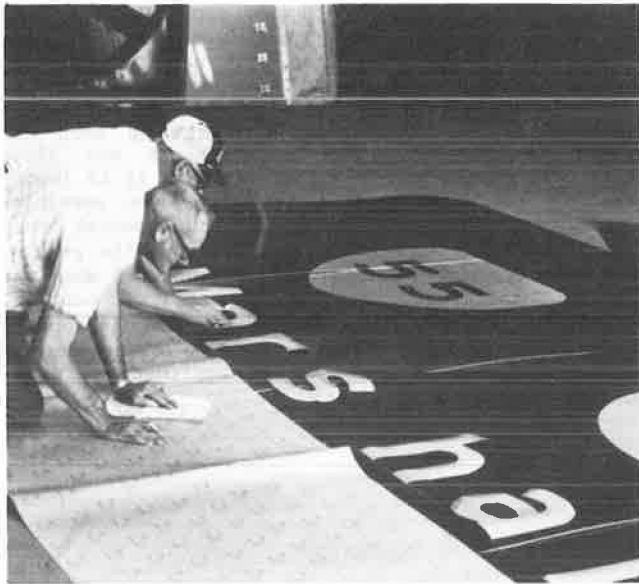
FIGURE 5 Shop application of directly applied copy.

Five of the eight districts use directly applied copy for riveted overlay panels; they find that this method is more convenient and cheaper than the alternatives. The directly applied copy is attached in the shop and under favorable conditions, because it can be easily positioned and there is no concern for work-site protection because of traffic. Figure 5 shows copy being aligned in the shop for overlay panels that are to be riveted. Fabricators using demountable copy cite the advantage of being able to change the message without changing the background; others using directly applied copy indicate that changing messages is not a problem. The districts using demountable copy report that the copy is removed from the sign, taken back to the shop, covered with reflective sheeting, brought back to the sign, and reattached. Unless spare letters are available and taken to the field, this process takes more time than using directly applied copy and renders the sign useless for guidance for longer periods of time. In some cases, the sign message may be gone for a day.

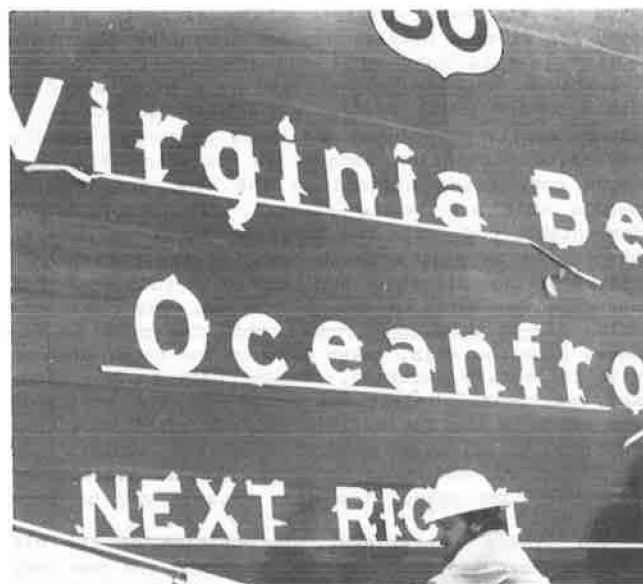
Figure 6 shows the application of the copy. It is difficult to get smooth edges when the copy is cut out of the System 5 materials in the shop. With tin snips, two cuttings were sometimes required to get the edges straight and flat. Also, machine pressing, or shearing the copy and border, created a concave area around the edges that made it difficult to get the copy and border to lie uniformly flat on the sign. After approximately 6 months, some deterioration, probably caused by irregular edges, around the edges of the copy and border was noted. Consideration should be given to ways of improving the quality of the copy and border, for example, an improved procedure for cutting in the shop or pre-cut copy and borders.

FIGURE 6 Applying copy to System 5 overlay.

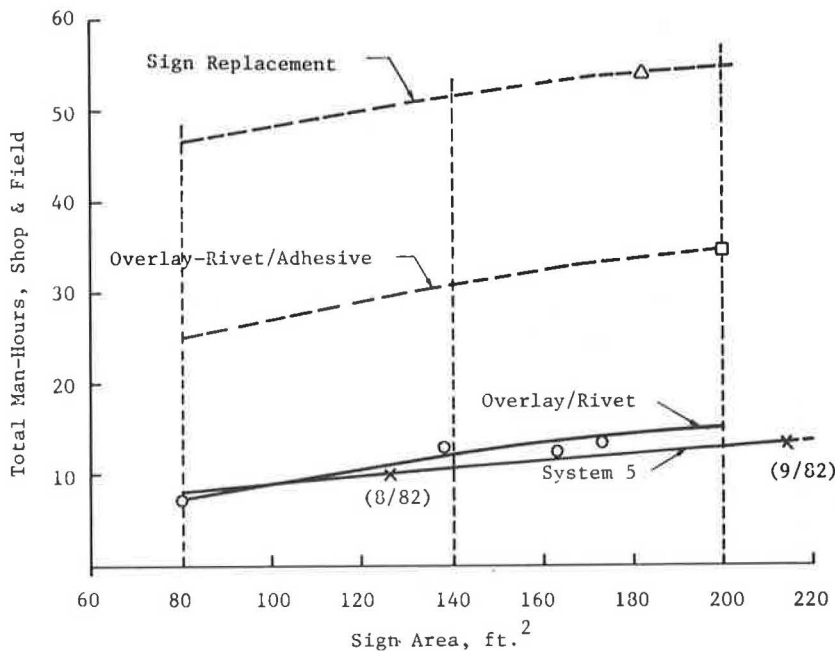
Figure 7 shows plots of the total man hours (shop and field) required for the methods of sign refurbishment versus the total area of the signs on the projects monitored. Sufficient data were available for the procedures in which the overlay panels were fabricated in the shop with directly applied copy and attached with rivets to the sign in the field and for the application of System 5 material in the field. For riveting and glueing in place and sign replacement, data were available for only one project each. In order to obtain estimates of the man hours for these refurbishing procedures with limited data and different sign sizes, lines were drawn through the single points with assumed slopes identical to those for the riveted overlay projects.

FIGURE 7 Total man hours for refurbishing procedures.

In considering the refurbishing procedures normally used by the department, it is obvious from the curves that the method of using riveted overlay panels attached in place requires the least number of man hours for completion. Overlaying in place by using rivets and glue takes significantly more man hours, whereas sign replacement requires substantially more man hours than either overlay method. On the basis of data gathered from the last two System 5 refurbishing projects, this new method requires slightly fewer total man hours than either of the riveting methods.

The labor costs for shop fabrication and field application were estimated by superimposing lines representing the three sizes of signs on Figure 7 and multiplying the resulting total man hours by the hourly wage. Labor costs for travel and work-site protection were calculated by assuming 1.5 hr per day for travel to and from the sites and an assumed 1.0 hr per sign for work-site protection. The cost of labor was taken from the Culpeper District and represents an average hourly rate with additives included.

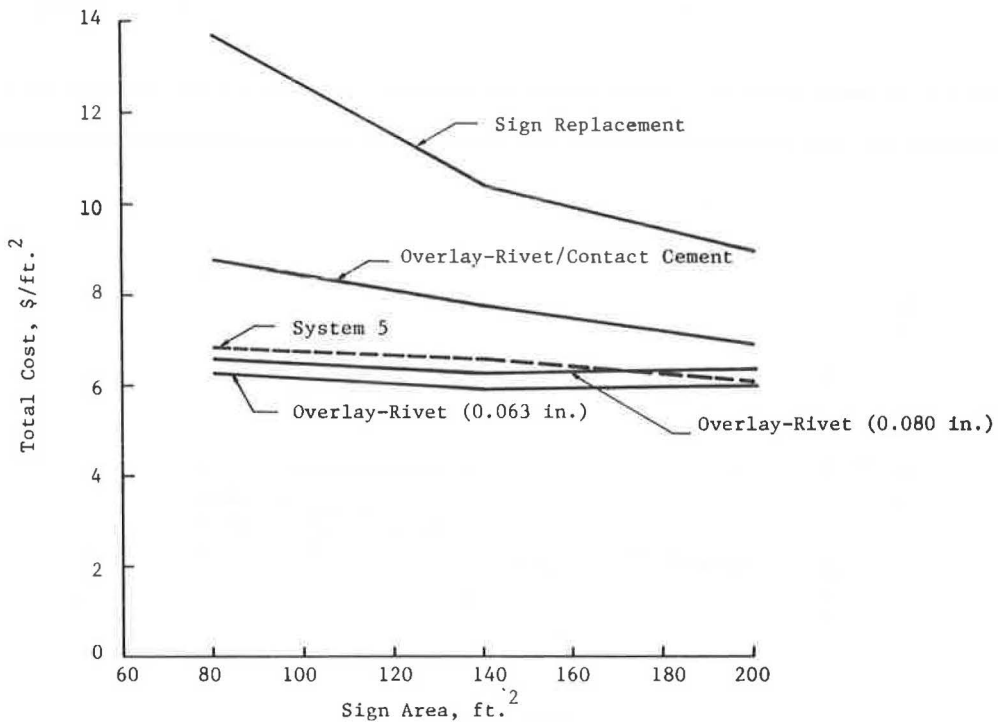
The total cost of refurbishing is given for each sign size and per square foot in Figure 8. Of the procedures normally used for sign refurbishing in Virginia, the most economical method used overlay panels fabricated in the shop with directly applied

FIGURE 8 Total cost of sign refurbishing.

The application of overlay panels (0.063 in.) with rivets and glue was more expensive, costing between \$0.89 and \$2.52/ft² more (depending on sign size) than when rivets alone were used. As might be expected, replacing a sign is significantly more expensive than overlaying.

The cost of using the System 5 material was higher than the riveted-in-place method of refurbishing for small and medium sign sizes, costing approximately \$0.61/ft² more than 0.063-in. aluminum

panels and \$0.29/ft² more than 0.080-in. panels. For large signs, the cost per square foot for System 5 material was approximately equal to that for the 0.063-in. panels and less expensive (\$0.25/ft²) than that for the 0.080-in. panels.

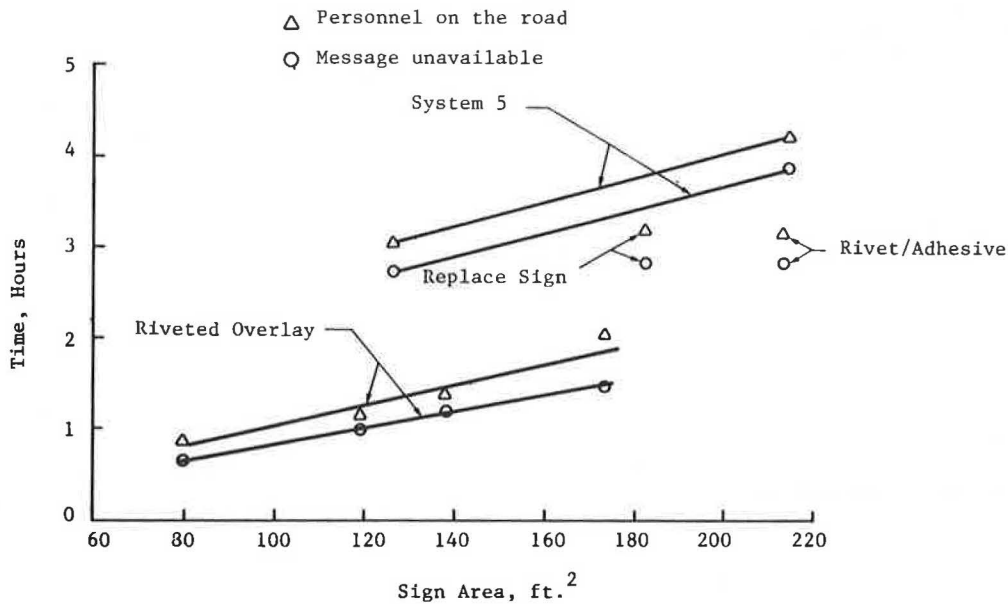
The length of time that the sign crew is on the highway refurbishing the sign and exposed to traffic and the length of time that the message is unavailable for guidance are shown in Figure 9. Both of these times are shortest for the riveted overlay with directly applied letters. The other methods require substantially more time, with the System 5 procedure requiring at least twice the time (1.5 to 2 hr) because the message is applied in the field. Although data are not available, use of demountable copy on riveted overlay panels (copy taken to the shop for sheeting application) would take more time on the highway and time during which the message was absent than use of riveted panels with directly applied copy.

FIGURE 9 Time for personnel on the road and message unavailability.
