## Roadside Barriers for Bridge-Pier Protection

Seven full-scale crash tests were conducted to evaluate a concrete bridge-pier protection barrier. This barrier consists of four concrete half-section safety-shape barriers placed in front of the pier and flaring back from the pavement edge. The end of the concrete barrier is protected by a 6 by 6-in. box-beam guiderail bolted to the concrete. The barrier was impacted at various points with either 1,800- or 4,500-lb sedans at 15 and 25 degrees and a speed of about 60 mph. The original design caused vehicles to roll over when the concrete barrier was impacted at 25 degrees near the first bridge pier. The design was modified by extending the box beam across the face of the barrier directly in front of the piers. This eliminated the rollover problem and strengthened the barrier, resulting in performance in compliance with the standards in NCHRP Report 230.

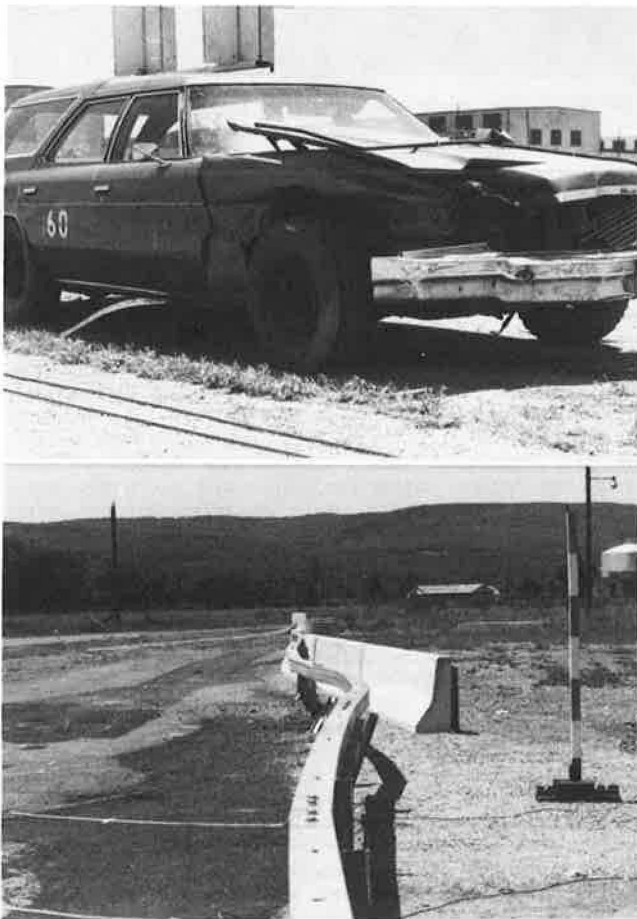
FIGURE 4 Test vehicle and barrier after Test 60.

the 4-ft clearance was adequate. The vehicle attained a maximum pitch of only 2 degrees and a roll to the right of 10 degrees. (Positive roll is clockwise, positive pitch is nose down, and positive yaw is counterclockwise with respect to the driver's attitude.) Redirection was smooth with an exit angle of 9 degrees and a very slight curve to the right. Damage to the vehicle was moderate, and damage to the box beam was limited to 2 rail sections and 15 posts. Total contact distance was 27 ft. Peak 50-msec average decelerations were 3.2 g longitudinal and 5.5 g lateral. Occupant impact velocities were 17.6 ft/sec longitudinal and 16.6 ft/sec lateral, below those recommended by NCHRP Report 230 for 60-mph, 15-degree impacts. Figure 4 shows the vehicle and barrier after the test. From these results it appears that the barrier performs well at this point.

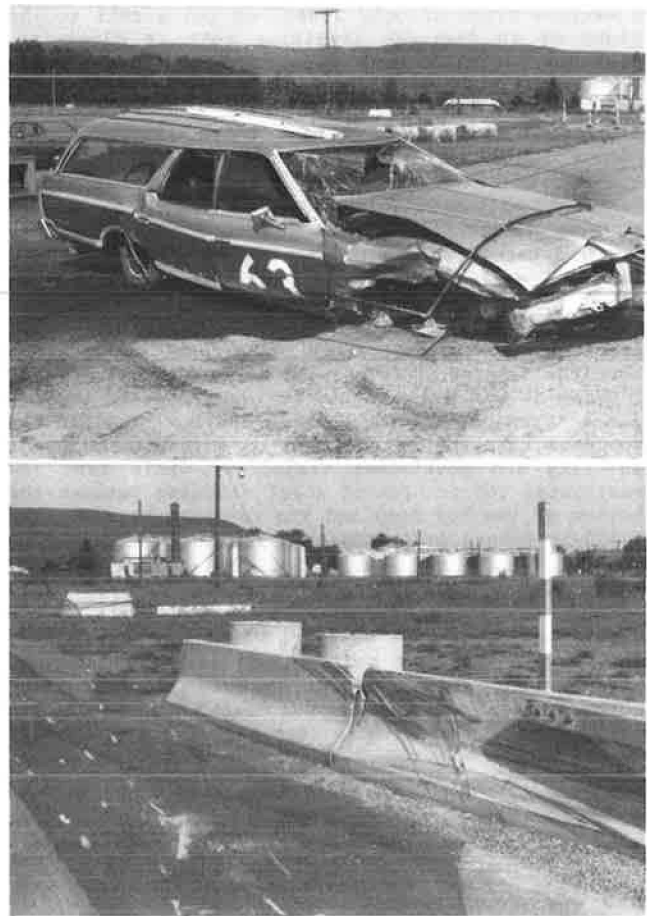
FIGURE 7 Test vehicle and barrier after Test 63.

Test 63 was intended to test the strength of the connection between barrier Sections A and B, just upstream from the first bridge column. The 4,730-lb Ford station wagon impacts 7.7 ft upstream from the joint at 57.1 mph and 26 degrees. The vehicle quickly climbed to the top of the concrete barrier while rolling 46 degrees counterclockwise. Tire marks at the top of the 4-ft-high simulated bridge columns confirmed that the vehicle would have sustained solid impact with full-height columns. Film measurements showed that the car penetrated about 1.5 ft behind the back of the concrete barrier, or 2 ft behind the barrier face. On leaving the barrier, the vehicle yawed 70 degrees to the left while still rolling away from the barrier. It then rolled sharply toward the right, and on contact with the ground rolled over completely on the right front corner before coming to rest. Peak 50-msec decelerations were 12.9 g longitudinal and 7.7 g lateral, with corresponding occupant impact velocities of 39.0 and 19.3 ft/sec. The vehicle was extensively damaged during the initial impact and subsequent rollover. Damage to the barrier was also extensive, as seen in Figure 7; there were cracks through both Sections A and B and the continuity connector was nearly broken out of the barrier. This test thus indicated that joint strength is marginal for such severe impacts. More important, contact with the columns, high decelerations, and vehicle rollover all confirm that the concrete safety-shape barrier is inadequate for high-angle impacts, especially when fixed objects are located immediately behind the barrier. The

vehicle and barrier after the test are shown in Figure 7.
