TRANSPORTATION RESEARCH RECORD 1024

# Application of Safety Appurtenances

TRANSPORTATION RESEARCH BOARD  
NATIONAL RESEARCH COUNCIL

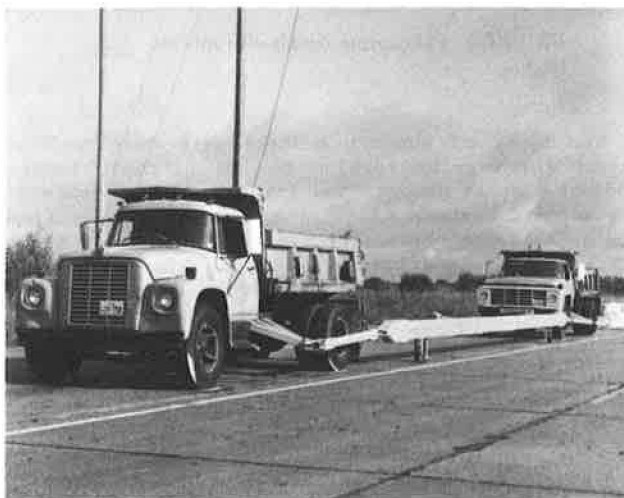
FIGURE 1 Truck-mounted portable maintenance barrier.

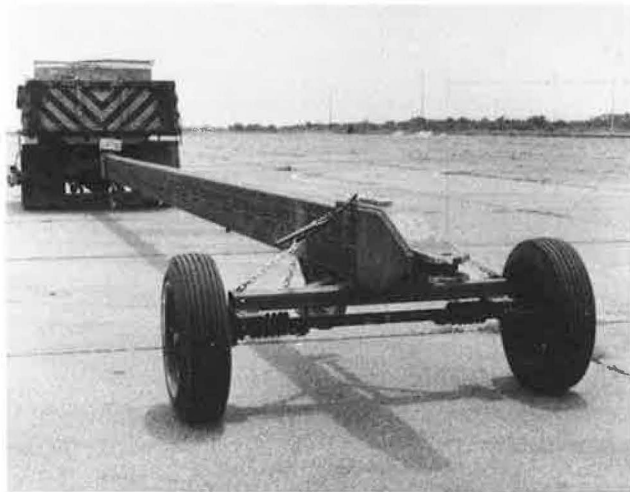
FIGURE 10 Barrier section on transport dolly.

The barrier section is towed to and from the work zone by using a detachable transport dolly (Figure 10). Fabrication details of the transport dolly frame are presented in Figures 11 and 12. The barrier section is loaded and unloaded onto the transport dolly by alternatively using the two barrier section screw jacks. An experienced crew of two men can load or unload the barrier section in 15 min or less. When not in use, the transport dolly is connected to an auxiliary hitch point on the rear of the front truck.

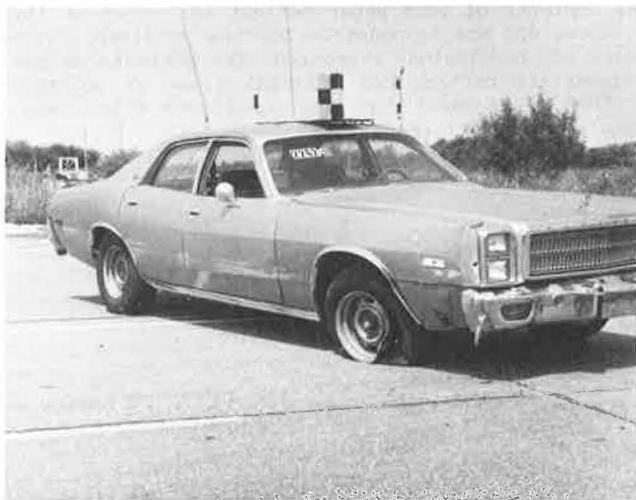
FIGURE 13 Damage to automobile in Test 3.

Damage to the impacting vehicles in all three tests consisted of sheet metal damage on the right side and damage to the right front tire and rim. Figure 13 shows the damage done to the vehicle in Test 3 (the most severe impact). The sheet metal damage was the result of contact between the automobile and the barrier section. The damage to the right front wheel occurred when it hit the barrier section support caster as the automobile slid along the barrier section. This occurred because the caster pivoted outward into the wheelpath as the barrier section underwent lateral deformation. This phenomenon occurred in all three tests; however, the failure of the tire and rim did not destabilize the impacting vehicles. It should be noted that following Test 3, the vehicle spare tire was mounted on the right front of the car, which allowed the vehicle to be operated at low speeds. In all instances the measured occupant risk values defined in NCHRP Report 230 were below recommended values.

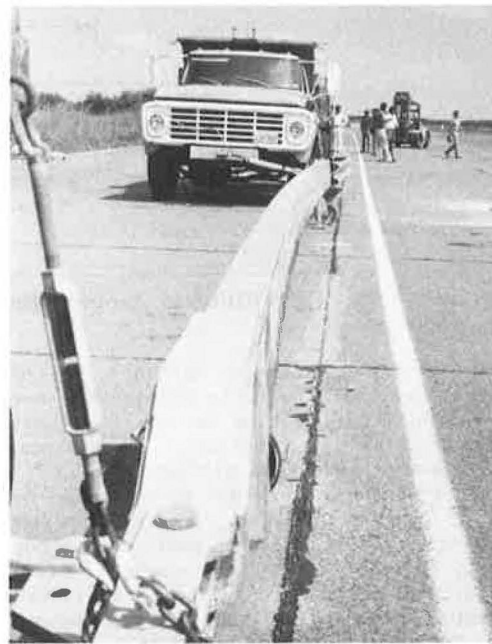
Figure 14 Accumulated damage to barrier section in Tests 1, 2, and 3.

The same barrier section was used in all three tests with no intermediate repair or straightening. The only damage experienced by the barrier was permanent lateral deflection. On completion of the third test the barrier section had an accumulated lateral deflection of 4 in. (10.2 cm), as shown in Figure 14. The permanent lateral deflection of the barrier section in no way interfered with transport of the barriers. The support trucks, hitches, and support members survived the tests with no damage.

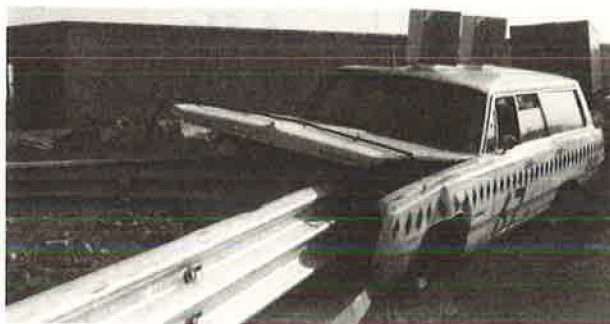
FIGURE 4 Results of Test 67.

to that point was about 4 ft, but after the snag the longitudinal load was so great that the W-beam broke in tension at the connection to the tapered section. The W-beam section, tapered transition, and thrie-beam approach section all disconnected from the posts as they were knocked down by the vehicle and rotated back about the first bridge post. The vehicle came to rest against the first bridge post (Figure 4). Peak 50-msec average decelerations were 9.9 g longitudinal and 4.4 g lateral, with occupant impact velocities of 30.8 ft/sec longitudinal and 14.8 ft/sec lateral. The vehicle was heavily damaged, and the entire transition railing was totally destroyed. In addition, the curb was broken and displaced by the impact in the transition area, and the first two bridge posts were bent. Tensile tests were performed on two W-beam samples after the failure. Yield strengths were 59,000 and 62,500 psi with elongations of 23 and 20 percent, both exceeding the specified minimums of 50,000 psi and 12 percent.

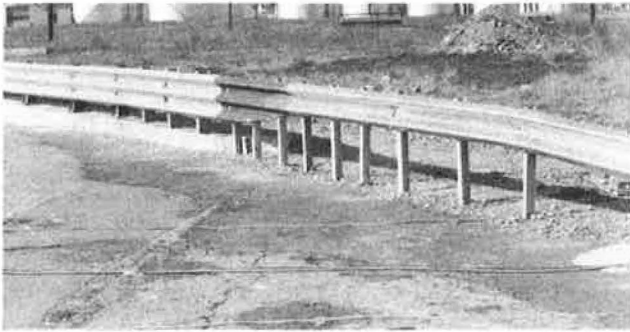
FIGURE 5 W-beam-to-thrie-beam transition evaluated in Test 68.

For Test 68, the length of the tapered transition was increased to 6 ft 3 in. between mounting bolt holes, with the lower corrugation taper increased to 3 ft (Figure 5). Light posts were again used behind the transition piece spaced at 2 ft 1 in. The increased taper length was intended to reduce the severe snag encountered in Test 67, but it was not successful. The 4,500-lb Ford station wagon impacted at 59.5 mph and 24 degrees 4.6 ft upstream from the tapered section. The vehicle again snagged on the end of the lower corrugation after beginning to redirect. The front wheel and suspension were again trapped between the bottom of the thrie beam and the top of the curb, and the vehicle came to rest against the first bridge post. The rail did not break, but all the posts in the transition area were bent over, and the rail was deflected 2.5 ft. The vehicle traveled 23.4 ft from impact to rest. Peak 50-msec average decelerations were 9.2 g longitudinal and 4.2 g lateral. Occupant impact velocities were 25.6

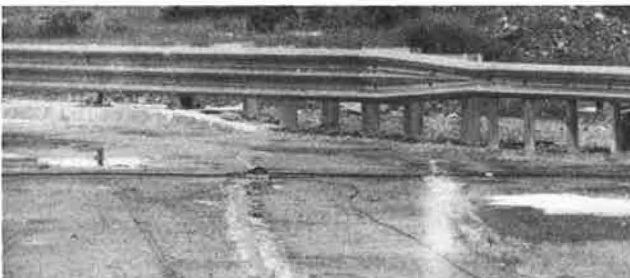
FIGURE 6 Symmetrical transition evaluated in Test 69.

After Test 68, it became clear that the termination of the lower corrugation presented an insurmountable snag point, and the entire transition was redesigned to include the symmetrical tapered section shown in Figure 6. In this section the middle corrugation drops out and the upper and lower ones continue. This has been adopted as a standard by the American Road and Transportation Builders Association (ARTBA) (8). Because the 8-in. decrease in section depth was split equally between top and bottom, a total height adjustment of 4 in. was required in the top-of-barrier elevation. Sufficient tolerance in the splice bolt holes permitted the tapered section to be tipped up about 1 in., and the remaining 3 in. was gained by lowering the top of the W-beam over one section length. Standard height to the top of the W-beam has since been decreased to 30 in., thus simplifying this connection. As in previous tests, S3x5.7 posts were used with the W-beam and at the beginning of the 6-ft 3-in. tapered section. Mid-length and at the downstream end of the taper, W6x9 posts were substituted to stiffen the transition, and 6-in.-deep blockouts were added to reduce contact with the posts and help maintain rail height during deflection. Finally, the vertical curb radius was replaced with a ramped curb end that terminated the curb 6 ft upstream from the bridge.

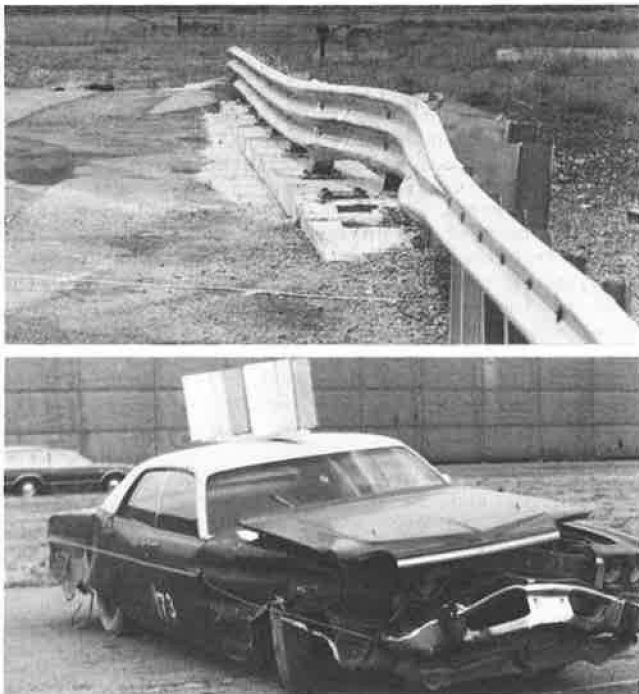
FIGURE 8 Vehicle and barrier after impact on guiderail-bridge-rail transition, Test 73.

attaching the first bridge rail to the anchor plate sheared off, permitting that post to deflect back about 1 ft. The welds at the second post cracked but did not separate. There was some concern that this failure at the first post may have helped to reduce the pocketing experienced in the previous test. However, it appears that pocketing would have simply occurred at the second bridge post if deflection of the approach rail had been excessive. It thus appears that the backup rail section and closer post spacing increased transition stiffness enough to prevent pocketing. Performance of the entire bridge-approach rail was now considered satisfactory with both small and large cars.

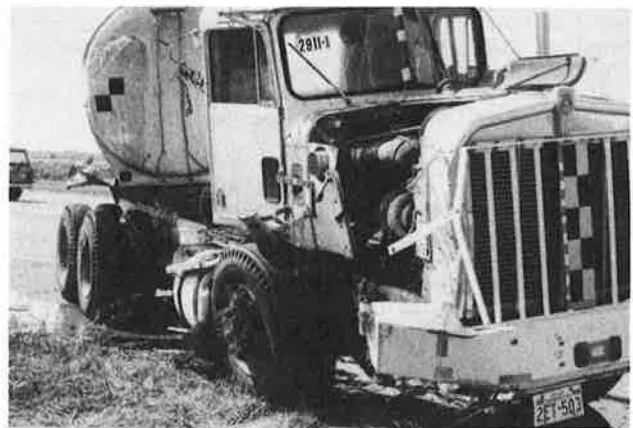
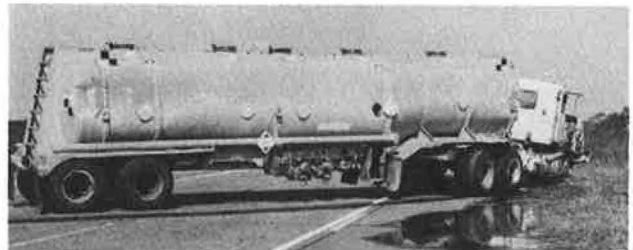
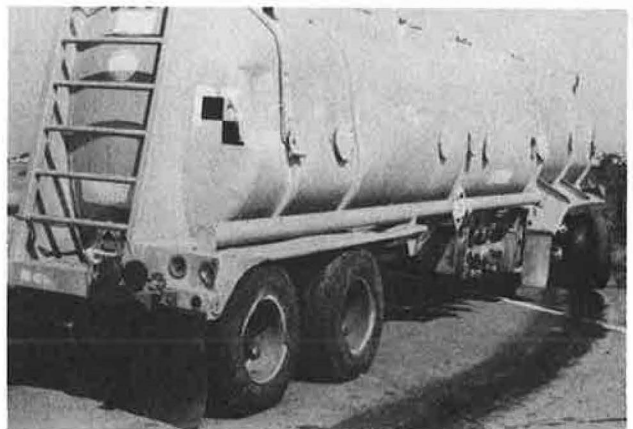
FIGURE 8 Tank truck weighing 80,000 lb after test.

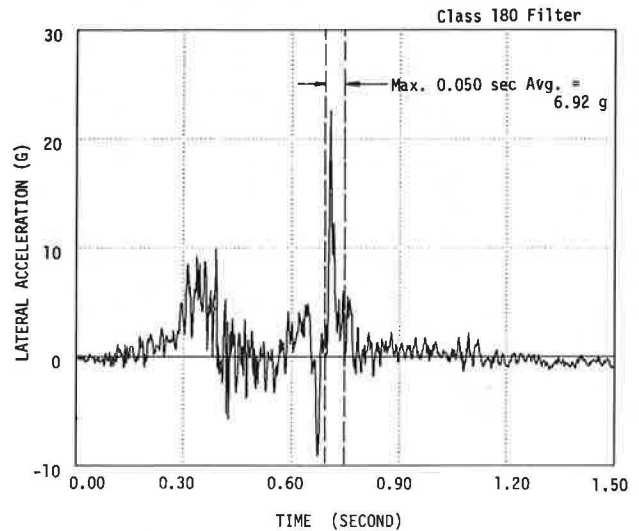
FIGURE 14 Trailer lateral accelerometer trace of test.

The truck was equipped with roll, pitch, and yaw rate gyroscopes and x, y, and z accelerometers located above the tractor tandem wheels. Graphs of the filtered data from this instrumentation are presented in Figures 11-15.

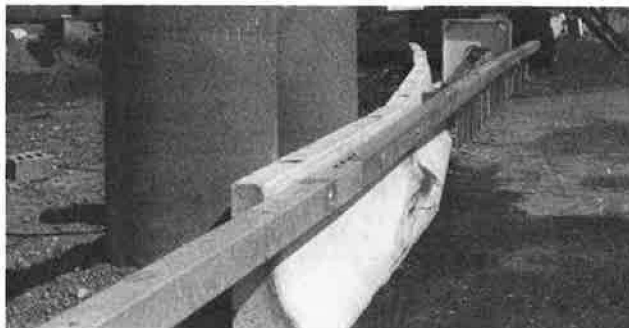
FIGURE 2 Pier-protection barrier for Tests 76 and 77: extending the box beam across Section A.

For Tests 76 through 78 the columns were precast concrete culvert pipe 33 in. in diameter and 8 ft long. The pipes were placed on end with their bottoms about 1 ft below grade, and the excavation was carefully backfilled with compacted soil. The pipes were filled with soil to increase their mass. Changes to the barrier design for the final three tests (Figures 2 and 3) included (a) an earth backfill behind the concrete barrier in place of the heavy posts, (b) continuation of the box beam across Section A, and (c) addition of a 6-in. blackout between the concrete barrier and box beam at Section B.

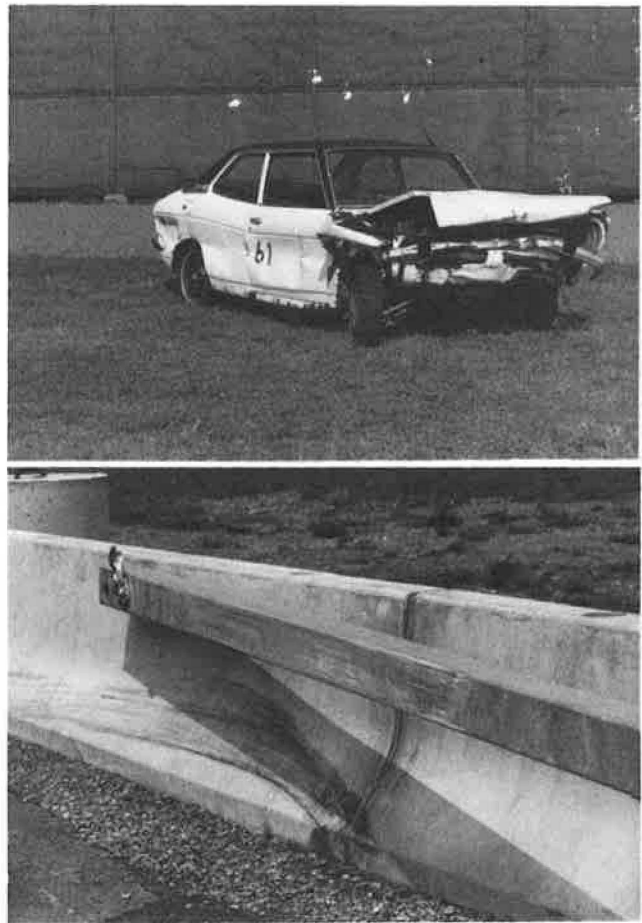
FIGURE 5 Test vehicle and barrier after Test 61.

Test 61 was intended to evaluate barrier performance at the connection between the box beam and the concrete barrier. In addition to determining impact severity and postimpact trajectory, this test investigated the problem of wheel snagging between the bottom of the box beam and the concrete barrier. The 1,600-lb Subaru sedan impacted 12.2 ft upstream from the end of the box beam at 59.0 mph and 14 degrees. The vehicle redirected smoothly with an exit angle of only 4 degrees and followed a curved path to the right back toward the barrier. Virtually no pitch or yaw was observed, and maximum roll was only 5 degrees toward the barrier. Vehicle damage (Figure 5) resulting from the impact was light, although the vehicle was subsequently damaged in a secondary

impact with a chain-link-fence arrestor system. Minor sheet-metal snagging occurred on a hex-head bolt used to connect the box beam to the concrete barrier. Peak 50-msec average decelerations were 4.6 g longitudinal and 8.2 g lateral. Occupant impact velocities were 12.2 ft/sec longitudinal and 19.9 ft/sec lateral compared with NCHRP Report 230 recommended maximums of 30 and 20 ft/sec, respectively. This test was thus considered successful.

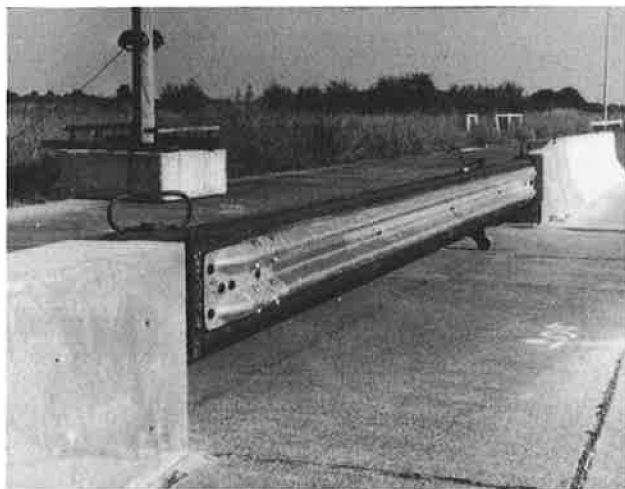
FIGURE 1 Emergency opening system.

The connections and supports of the EOS were designed by using the applicable standards (2,3) to transmit and contain the peak loads obtained in the computer simulation. The details of the EOS design have been presented elsewhere (4). The system consists of a 30-ft-long steel beam section, which is pinned at each end to a 30-ft-long modified CMB. A 3.25-in. (8.3-cm) diameter steel pin in quadruple shear transfers the load at each end of the EOS through tongue plates to a base plate bolted to the CMB. Further details of the system, in both as-tested and modified configurations, are available elsewhere (4).

An EOS for an AVL was developed and crash tested. The system, as shown in Figures 1 and 2, consisted of two steel box tubes mounted on top of each other. The steel beams were supported by pin connections to modified CMB sections. Factors considered in the development of the EOS were ease of operation and ability to redirect errant vehicles.

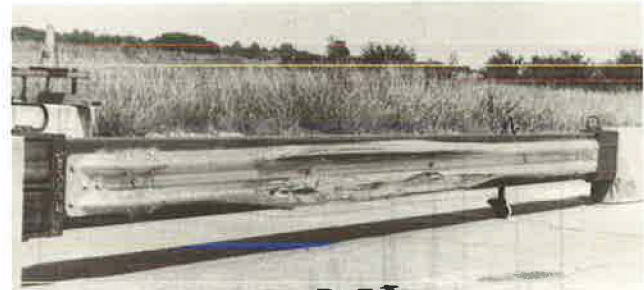
FIGURE 10 Test installation after Test 2.

The damage incurred by the test vehicle and installation is shown in Figures 9 and 10. The vehicle sustained sheet metal damage to the left front fender. The EOS damage included the W-beam on the vehicle impact side of the gate, which had to be replaced, and noticeable flexural cracking in the CMB sections. The permanent beam deflection was 1.63 in. (4.1 cm). The gate could still be opened after this test, which was considered very successful based on the safety performance of the system.

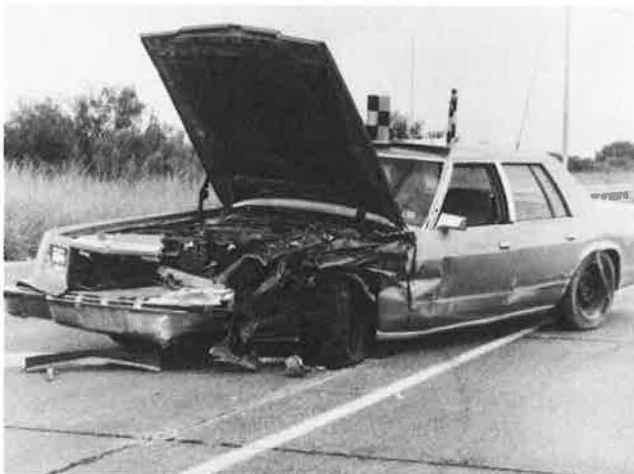
FIGURE 12 Test vehicle after Test 3.

Damage incurred by the vehicle and test installation for Test 3 is shown in Figures 12 and 13. The test vehicle was severely damaged in this test when it snagged on the downstream CMB section. The permanent deflection of the gate was 23.88 in. (60.66 cm). The gate section of the EOS sustained damage to the W-beam on the impact side of the tubes, which had to be replaced. The downstream CMB section was severely damaged because of flexural cracking and failure of one of the anchor rods in the concrete. The upstream CMB section was also severely damaged because of flexural cracking. In addition, the gate could not be opened because the metal tubes were binding about the pin connections. However, this test was still considered a success because of the barrier's safety performance and because the vehicle did not penetrate the barrier. The damage to the barrier would be minimized if proper anchorage were achieved, and although the

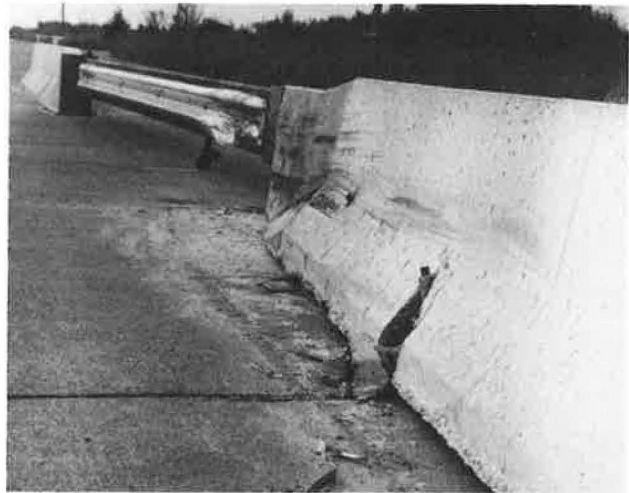
FIGURE 13 Test installation after Test 3.

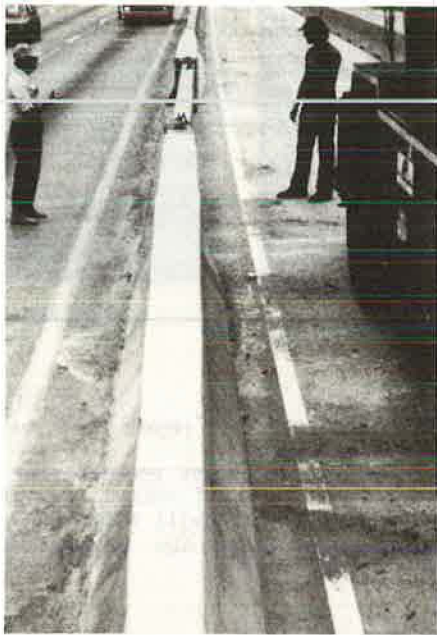
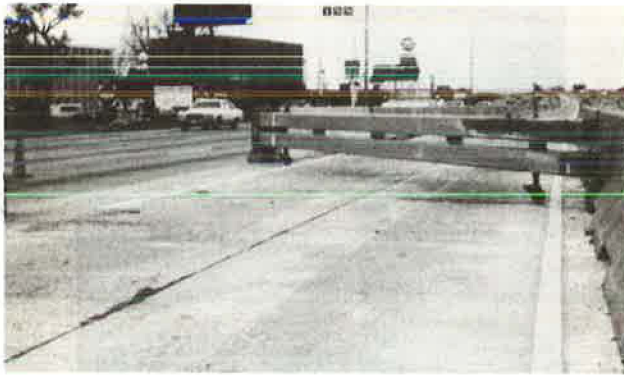
FIGURE 14 EOS as implemented.

At the writing of this paper the concepts and modified designs presented here are being implemented on the I-45 AVL project in Houston, Texas (Figure 14).

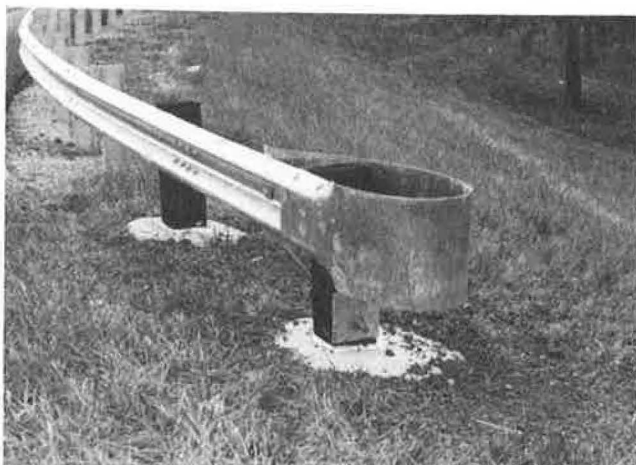
FIGURE 1 BCT end treatment (Kentucky's Type 4).

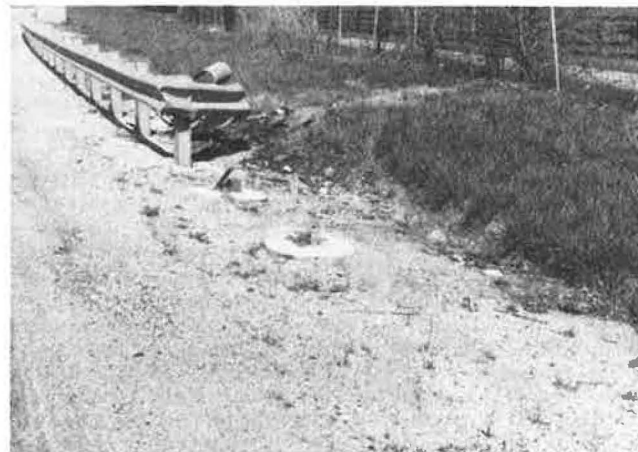
FIGURE 3 Proper performance of BCT end treatment.

able performance, as shown in Figure 3. This BCT was constructed by using the 4.5-degree simple curve as the method to achieve the desired offset.
