Performance and Rehabilitation of Timber Bridges

WILLIAM J. McCUTCHEON, RICHARD M. GUTKOWSKI, and RUSSELL C. MOODY

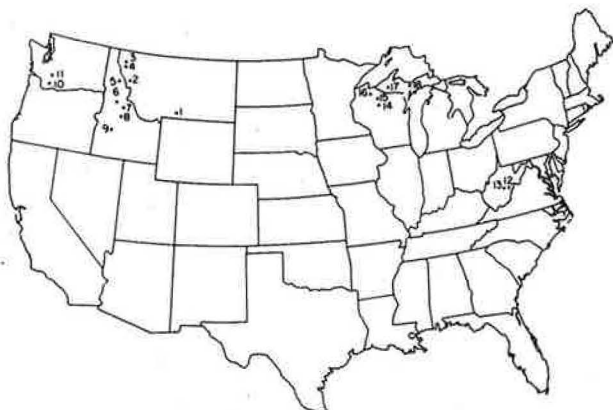
FIGURE 1 Eighteen bridges were inspected across the northern United States.

To address the first two objectives previously stated (determining structural performance and moisture patterns), eighteen bridges were inspected during the summer of 1983. The bridges, which were distributed across the northern United States (Figure 1), included a variety of types and sizes (Figure 2) and were from 7 to 17 years old. The determination of methods for rehabilitating nail-lam decks, was addressed through a literature survey and extensive discussions with bridge engineers throughout the Forest Service.
