Comparison of Concrete Pavement Rehabilitation Techniques in Ohio Demonstration Program

KENNETH MILLER, K. MAJIDZADEH, A. ABDULSHAFI, AND K. KALOUSH

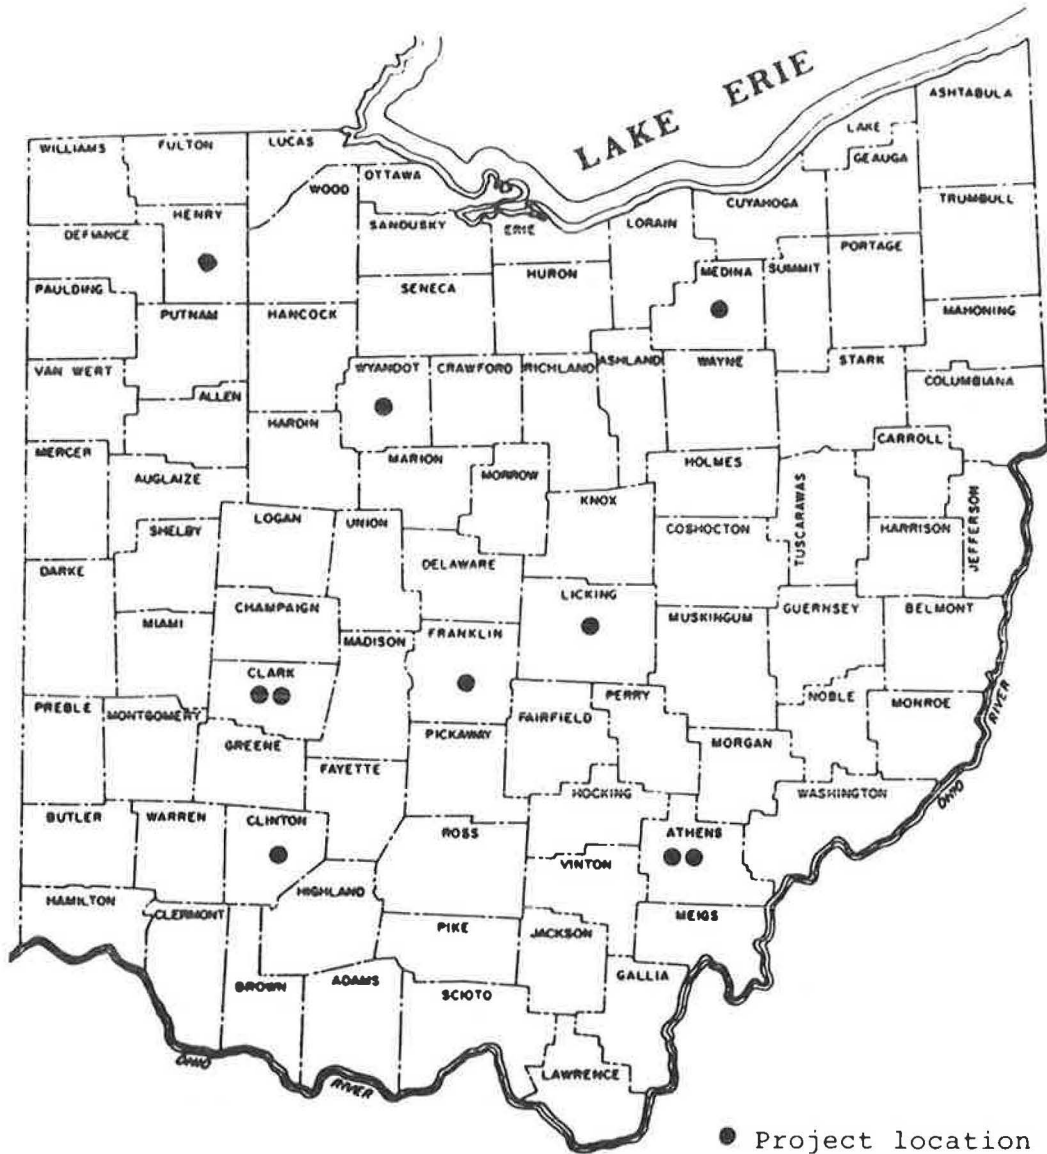
FIGURE 1 Project locations: Ohio Pavement Rehabilitation Demonstration Program.

Project	Rehabilitation Strategy
CLA-70-20.92	Undersealing and necessary joint repairs. Ten-in. mesh-doweled pcc overlay with 60 ft joint spacing.
CLI-71-4.26	Undersealing all joints. Nine-in. mesh-doweled pcc overlay with skewed joints spaced at 27 ft.
ATH-33-13.31	Eight-in. plain pcc with skewed joints at variable spacing.
FRA-70-0.02	Undersealing and joint repairs. Composite overlay, 3-in. AC on 9-in. plain pcc, slurry seal bond breaker and saw-seal joint in overlay EB.
ATH-33-10.41	CPR. Full-depth and bonded pcc repairs of failed areas. Adding tied pcc shoulders and resealing all joints and cracks.
MED-271-0.35/ SUM-271-0.00	Undersealing, joint repairs, tied pcc shoulder, 3-in. AC overlay. Saw-seal joints in overlay.
WYA-23.0.20	Crack and seat existing pcc, and 6-in. AC overlay.
CLA-70-5.76	Crack and seat existing pcc, and 7-in. AC overlay.
LIC-70-9.55 EB	Remove existing AC overlay, crack and seat pcc pavement, and 9-in. AC overlay.

HEN-24/9.61	Minimum joint repair, 6-in. AC overlay.
