# Field Performance of Bonded Concrete Overlays

GERALD F. VOIGT, MICHAEL I. DARTER, AND SAMUEL H. CARPENTER

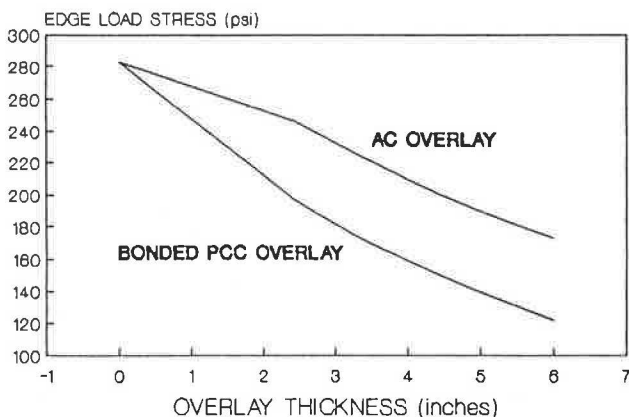
FIGURE 1 Comparison of free edge stress for bonded concrete overlay and equivalent thickness of asphalt concrete overlay.

The addition of a few inches of portland cement concrete to the existing slab results in reduced critical stresses and deflections in the slab system (1, 3). A 1-in. bonded concrete overlay has approximately the same structural benefit in reducing stresses as 2.5 in. of asphalt concrete (4). The effectiveness of bonded concrete overlays versus equivalent thicknesses of asphalt concrete is shown in Figure 1. Typically, the critical tensile stress is located along the outside edge at the bottom of the existing slab under an edge wheel load. When the existing slab and the concrete overlay act together under load, tensile stress is reduced. Under load, reduced tensile stress means reduced fatigue damage per load application and extended pavement life.

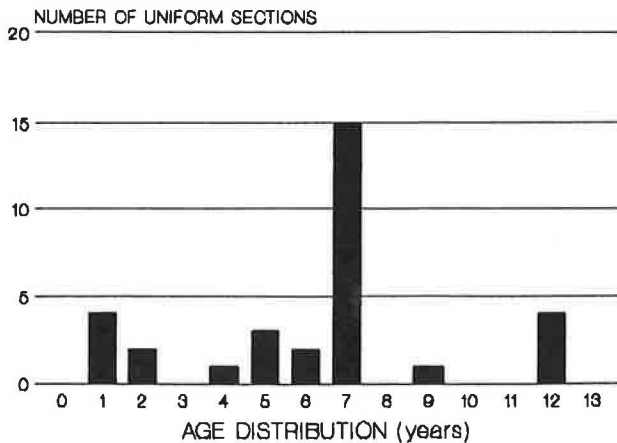
FIGURE 3 Histogram of the age distribution of bonded concrete overlays in the data base.

Before distresses are quantified on a general basis, an overall description of the bonded overlay sections should be given to keep the results in perspective. The age of the overlays, at the time they were surveyed, ranged from just over 1 yr to 12 yr. A histogram of the age distribution of the overlays is presented in Figure 3. A considerable number of sections have been in service for 7 years, including the seven sections in Clayton County, Iowa. The thicknesses of the overlay sections may significantly influence the level of distress. Figure 4 shows the distribution of the overlay thicknesses over the bonded overlay sections. A description of the general design features for each overlay design section is given in Table 3.

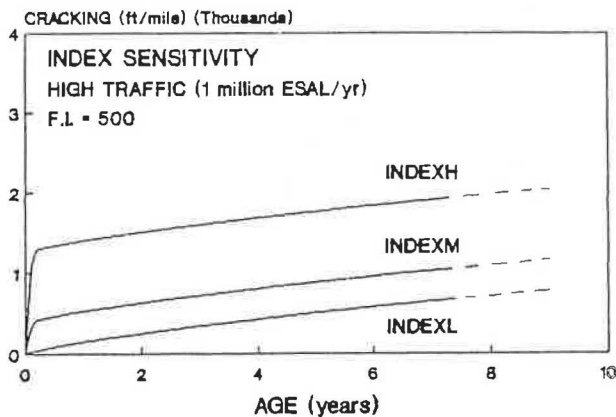
Sensitivity of the cracking equation is shown in Figure 6. It is interesting to note the influence of the cracking index on the amount and occurrence of reflective cracking. As would be expected, the existing cracking reflects through the overlay very rapidly after placement, within the first 2 years as predicted by the model. The amount of cracking exhibited on the

FIGURE 6 Sensitivity of the bonded overlay cracking model to cracking index.

overlay is almost entirely governed by the index (amount) of existing cracking.

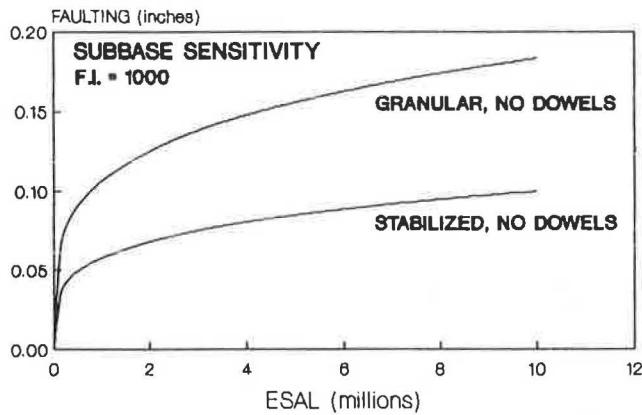
FIGURE 8 Sensitivity of the faulting model to the subbase type.

Sensitivity of the faulting model is illustrated in Figure 8. The functional form of the model is very similar to that obtained from a much larger data base of original jointed plain and jointed reinforced pavements in NCHRP Project 1-19 (COPEs) (13). Faulting starts out rapidly and then levels off. Comparison of predicted bonded overlay faulting and new pavement faulting is shown in Figure 9.

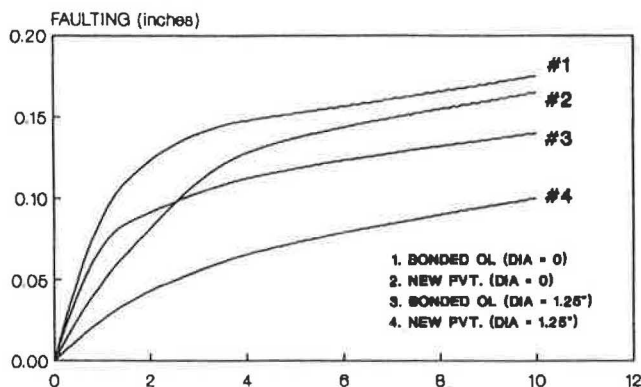
FIGURE 9 Comparison of predicted bonded overlay faulting to new pavement faulting.
