## Evaluation of the Effectiveness of Crash Cushion Delineation

F. THOMAS CREASEY, CONRAD L. DUDEK, AND R. DALE HUCHINGSON

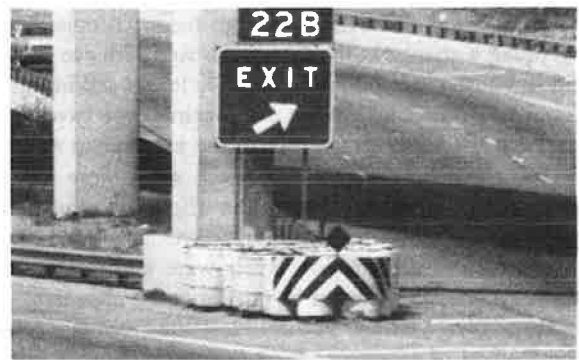
FIGURE 1 Existing delineation treatment at Site 1 (Interchange Ramp A).

This location, referred to as Interchange Ramp A, is the exit ramp for all US-54 traffic from westbound I-10. The existing delineation treatment consisted of a black-and-white chevron-patterned wraparound nose panel and a Type 1 diamond-shaped object marker as specified by the *Manual on Uniform Traffic Control Devices* (MUTCD) (3) (Figure 1). There were three crashes involving repairs at this location between May 1983 and July 1985.

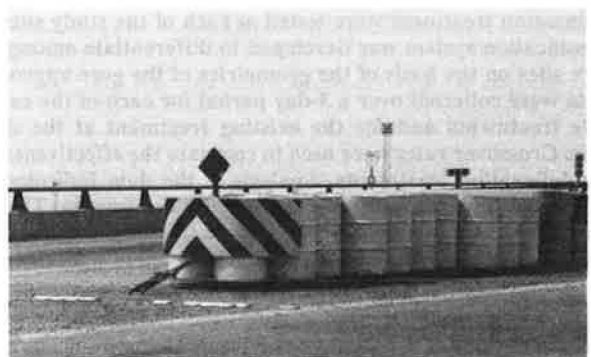
FIGURE 2 Existing delineation treatment at Site 2 (Interchange Ramp A-F).

toward New Mexico and the westbound (left-hand) split heading toward Juarez, Mexico. The existing delineation treatment consisted of a black-and-white chevron-patterned wraparound nose panel, an MUTCD Type 1 object marker in the front, and two MUTCD Type 2 object markers, one vertical and one horizontal, in the rear (Figure 2). The crash cushion installation at this site was struck twice in 1985 (records of repairs that may have been made before then were not available).

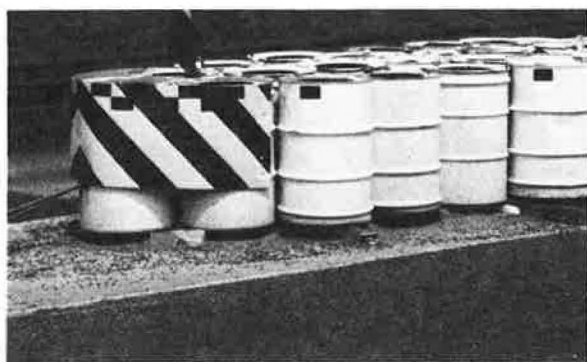
FIGURE 3 Existing delineation treatment at Site 3 (Copia Street).

This location, referred to as the Copia Street Ramp site, is a left-hand entrance ramp from the frontage road onto I-10 eastbound. The existing delineation consisted of a black-and-white chevron-patterned wraparound nose panel, an MUTCD Type 1 diamond-shaped object marker, and two rows of small rectangular yellow reflective-tape sections arranged in a checkerboard pattern (Figure 3). The crash barrels at this site were repaired five times between July 1982 and July 1985.

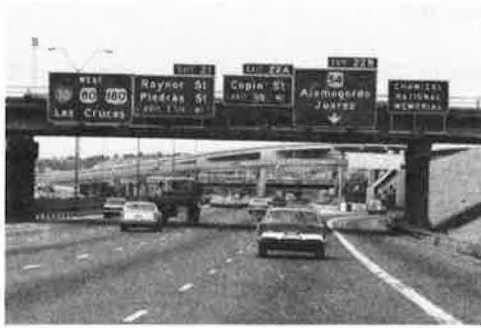
**FIGURE 10** Driver perspective while approaching Site 1.

A driver’s perspective while approaching Site 1 is shown in Figure 10. Similar perspectives of approaches to Sites 2 and 3 are shown in Figures 11 and 12, respectively.

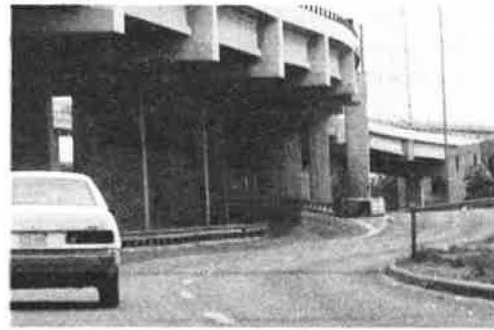
**FIGURE 12** Driver perspective while approaching Site 3.

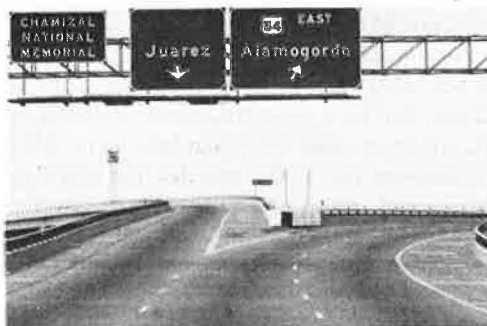
**FIGURE 11** Driver perspective while approaching Site 2.

For both nighttime and daytime data, it is evident from Table 5 that significantly more crossovers were occurring in a left direction than in a right direction. Referring back to Figure 11, it may be noted that the left fork leads to Juarez, Mexico, a large traffic generator, and that vehicles in the right lane at Site 1 have only about 1,500 ft to move into the center or left lanes. Unless adequate advance signing exists, the drivers may be trapped in the right lane headed for New Mexico. It is surmised that a large number of drivers (146) made a crossover to the left because of (a) the Type IIIa geometrics, (b) the congestion, (c) inadequate advanced lane directions, or (d) a combination thereof. Number of lanes available in a left-hand exit may also be a factor in some applications.
