# Use of Time-Lapse Movie Photography in Landslide Monitoring

EDWIN P. BELKNAP AND JOHN B. GILMORE

**In this paper is described the use of time-lapse movie photography to monitor the Muddy Creek landslide near Paonia, Colorado, during a 7-week period in the spring of 1986. Problems encountered in installation and operation of the equipment are discussed, and improvements in techniques and camera equipment are suggested.**

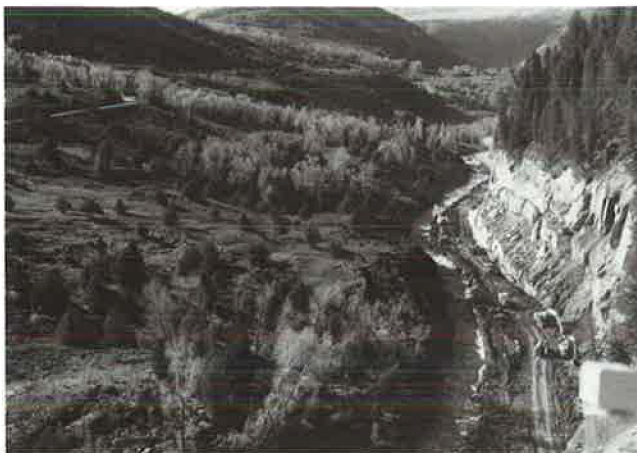
FIGURE 4 Field of view from high camera location; protective box is visible in lower right corner.

To obtain an adequate field of view, it was necessary to locate the cameras above and at some distance from the portion of the slide being photographed. Two sites were selected on the cliff west of the highway, which had previously been cut and benched north of the area where the roadway grade was being raised. One camera was positioned on one of the cut benches and the other was placed several hundred feet west and higher on the slope. Both were pointed south, which avoided problems with the rising or setting sun, and both were centered on the same scene with the high camera providing a wider field of view than the lower one (Figure 4).
