Establishing a Minimum Functional Reflectance for Raised Pavement Markers

ROGER W. MCNEES

In this paper, the causes of reduction in reflectivity of reflective raised pavement marker (RPM) and reflective raised traffic button (RTB) systems, and a procedure to evaluate the effectiveness of these two types of marker systems, are discussed. All marker systems lose 95 percent of their reflectivity in the first 6 months after installation. Approximately one-half (50 percent) of their initial brightness is lost in the first 25,000 impacts and an additional 20 percent in the next 175,000 impacts. The major cause of loss of reflectivity in RPMs is the actual loss of the marker because of improper installation and the nature of the road surface on which the marker is placed. (Asphalt surfaces result in a greater loss of markers than portland cement concrete surfaces.) Those markers that remain on the roadway lose reflectivity because of abrasion and moisture seeping between the lens and the reflector. The major problem of ceramic markers is loss of reflectivity. Ceramic button markers generally are not dislodged from the pavement surface because of their shape. The major losses of reflecti

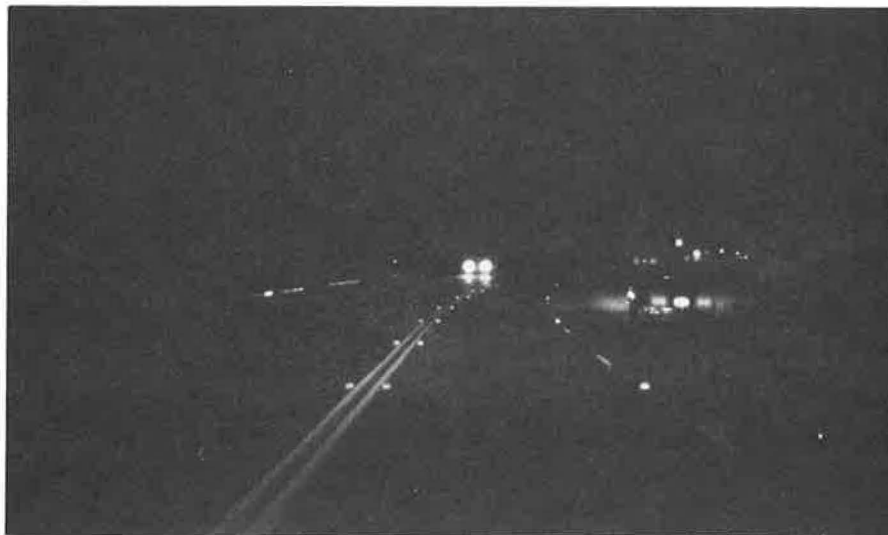
FIGURE 4 Photograph judged representative of Site 2.

The subjects selected the photograph shown in Figure 4 as representative of Site 2. This photograph depicted a highly effective marker system on a rural multilane curved road. Both centerline and lane line markers were visible and highly effective. A χ^2 of 36.75, indicating a high degree of significance at this site with respect to the photographs, was obtained.

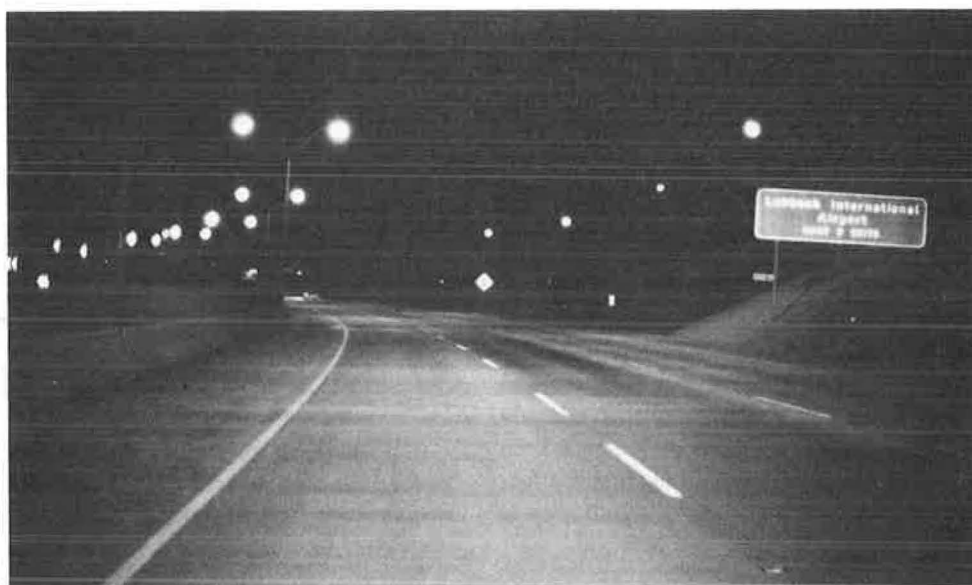
FIGURE 5 Photograph judged representative of Site 4.

Site 4 had a greater spread of responses than both Sites 1 and 2. Fewer than 50 percent of the subjects selected the photograph shown in Figure 5 as most representative of the site. The site was classified as urban because of its traffic characteristics more than its lighting characteristics. The roadway was relatively dark, with little ambient lighting.
