An Analysis of Visual Field Inspection Data of 900 Pipe-Arch Structures

GERALD H. DEGLER, DAVID C. COWHERD, AND JOHN O. HURD

Approximately 50 percent of the structural plate corrugated metal pipe structures under the jurisdiction of the Ohio Department of Transportation are of the pipe-arch configuration. Because these structures have experienced numerous problems, the Ohio Department of Transportation established a research project to identify and determine the causes of these problems. The initial phase of this project involved a field inspection of 890 pipe-arch structures. The inspection was conducted by each of the 12 Ohio Department of Transportation district offices. The inspection consisted of a visual examination plus limited dimensional measurements. Specific areas that received a rating included (a) the amount of structure distortion, (b) the occurrence and severity of multiplate and bolt erosion and seepage, (c) the occurrence and extent of cracking of the multiplates, (d) the condition of the pavement over the structure, and (e) the condition of the channel bottom. A statistical analysis of the field data was performed to determine the dominant modes of structure fai

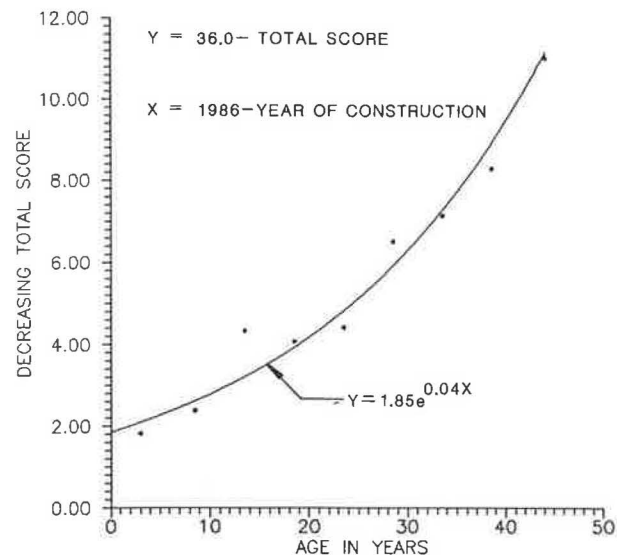
FIGURE 9 Decrease in total composite score with structure age.

Illustrated in Figures 7, 8, and 9 are the relationships of age to metal, plate, and total composite score. It should be noted that although an exponential curve fit was used to describe the relationships in Figures 8 and 9, a linear curve could also have been used because the coefficient of determination for a linear relationship was only slightly lower. It is interesting to note that the decrease in the total composite score with age (see Figure 9) indicates that a newly installed structure has, on the average, a score of 34 (a decrease of 2). This could possibly be explained by the experience of some structures with shape problems during installation.
