Flood-Hazard Zonation in Arid Lands

H. W. HJALMARSON

Potential flood hazards in arid southern and western Arizona stem from different geomorphic and hydrologic characteristics and can be grouped into zones. The zonation is based on the physical features of the terrain, the sources of flooding, the expected frequency of flooding, and the expected erosion and sediment deposition. Various combinations of these factors create differing degrees of hazard. Distributary flow areas have stream channels that convey only a small fraction of the 100-year peak discharge and channels that can completely fill with sediments during a single flood. A basic understanding of the common and different flood hazards of areas in southwestern Arizona can lead to effective flood-plain management and design of hydraulic structures.

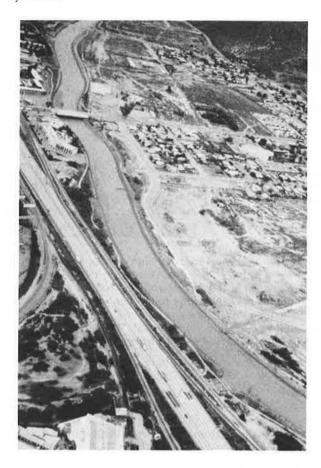
FIGURE 3 View looking downstream at the entrenched channel of the Santa Cruz River at Tucson, Arizona. Floodwater of the 100-year flood is confined within the channel of the reach. Lateral erosion of the channel banks is restricted by massive soil-cement banks. Interstate 10 is located to the left of the 200-foot-wide by 20-foot-deep river channel. Since 1914, the channel has widened about 100 feet and deepened about 15 feet.

Zone 1 includes a variety of trenched and untrenched channels. Floodwater that is confined within a vertical walled arroyo only a few hundred feet wide can spread over an unchanneled valley for several miles downstream (figs. 3 and 4). Runoff that enters the desert-plain areas crosses progressively more alluvium where there is a great potential for infiltration (fig. 5). Burkham (2) found that the amount of loss along channels in the Santa Cruz River basin is related to the length of reach and the infiltration capacity of the channel.
