# ODOT Experience with Silica-Fume Concrete

Two bridge-deck-overlay projects placed in 1984 and 1987 are the basis for Ohio's specifications on the use of silica fume; they are reviewed along with a full-depth silica-fume structure placed in 1987. Data on mixing, placing, curing, compressive and flexural strengths, resistance to freezing and thawing, and permeability are presented. An assessment of these results shows that Ohio's 15 percent by mass of cement silica-fume requirement could be reduced, retaining high compressive and flexural strengths, good resistance to freezing and thawing, and favorable permeability characteristics. At present silica-fume-modified concrete appears to be a satisfactory and cost-competitive method of extending the life of bridge decks.

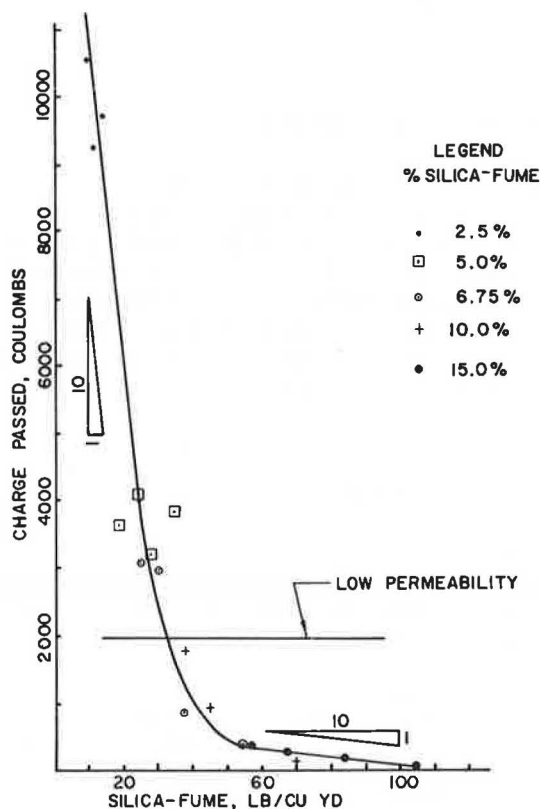
FIGURE 1 Chloride permeability vs. silica-fume content using an HRWR.

Shortly after the first overlay placement, ODOT's laboratory ran permeability tests on cylinders made from concrete mixtures of varying silica-fume content (3). The testing was performed according to the procedure found in FHWA report RD 81/119 (AASHTO T 227), and these results (Table 3) are then depicted graphically (Figure 1).

It is also of interest to note Figure 1, which is a plot of rapid permeability results, taken from Table 3. Placing a horizontal line at 2,000 coulombs (considered low permeability), it can be seen that the required percentage of silica fume could be lowered and still produce favorable results. Even at 7-10 percent silica-fume content, a rating of low permeability is achieved.
