Delineation of Urban Freeway Gore Area Crash Cushions in Texas

F. THOMAS CREASEY, GERALD L. ULLMAN, AND CONRAD L. DUDEK

The objectives of this study were to identify and document current delineation practices for urban freeway gore area crash cushions in Texas and to evaluate the long-term effectiveness of experimental crash cushion delineation treatments. The treatments examined were implemented as part of a previous research study in 1982. A survey of the Texas State Department of Highways and Public Transportation (SDHPT) found that most districts used some type of delineation on steel drum crash cushions but varied considerably as to the type and amount used—from small object markers to nose and/or back panels and flashing lights. A problem cited by the districts was that there are currently no standards or guidelines in Texas for delineating crash cushions in freeway gore areas. Experimental treatments investigated in a previous study in Houston were reevaluated to determine their long-term effectiveness. The results indicated that treatments installed several years ago had retained their effectiveness in reducing crash cushion repairs over time. Delineation of steel drum cr

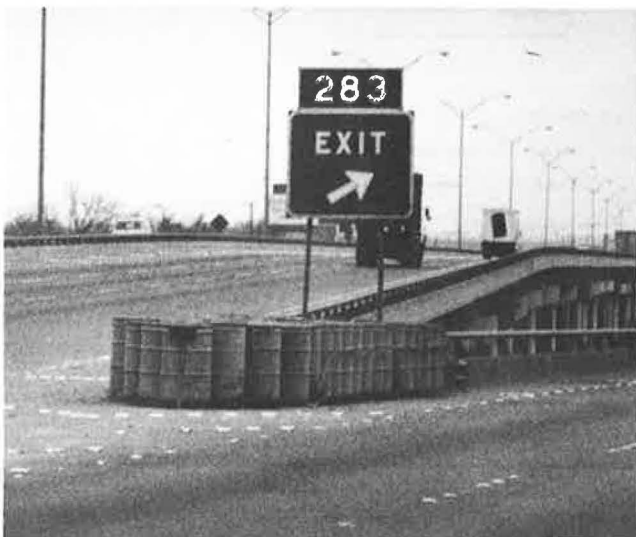
FIGURE 1 Type 2 object marker at front of crash cushion.

Table 1 presents a summary of the different types of delineation used for gore area crash cushions on urban freeways and the number of districts using each type. The most common delineation treatments include object markers—type 1 and type 2, as described in the *Texas Manual on Uniform Traffic Control Devices (8)*—and chevron-patterned reflective nose panels mounted on the front of the cushions. Examples of these treatments are shown in Figures 1 and 2. Colors used

Another problem identified was that no specific guidelines exist as to when, how much, or what type of delineation should be used. The wide variety of treatments and combination of treatments shown in Figures 1 through 4 are evidence of this. Finally, there has been little communication among districts regarding the results of delineation techniques and devices

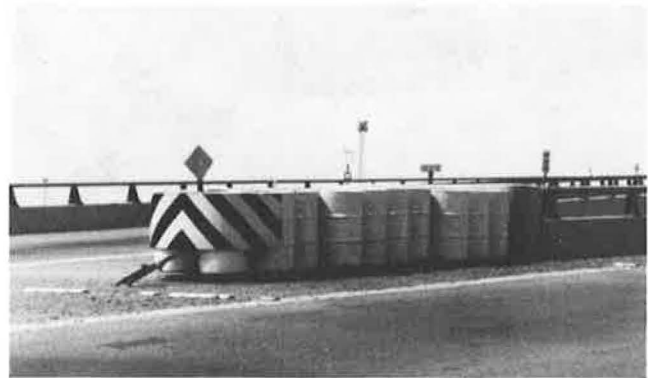
FIGURE 2 Chevron nose panel and type 1 object marker.

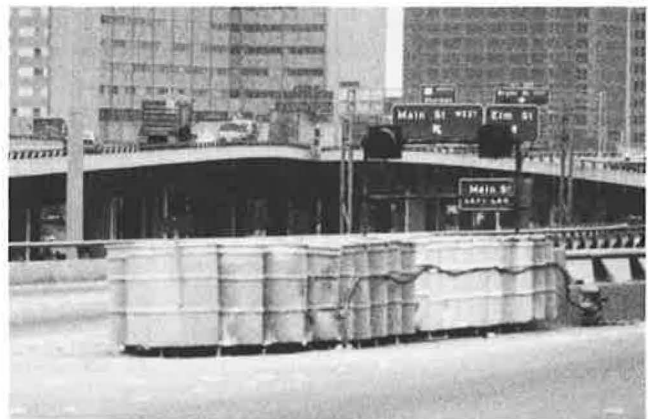
FIGURE 3 Type 2 object marker with supplemental flashing lights.

In some cases, the nose panel is supplemented with a back panel to add conspicuity and increase the effective sight distance to the gore area. Flashing lights have also been installed at some gore areas in the Houston, Dallas, and Ft. Worth districts. At some relatively high accident locations, several types of delineation have been combined to further increase the conspicuity of the crash cushions. Examples of these supplemental delineation treatments are shown in Figures 3 and 4.

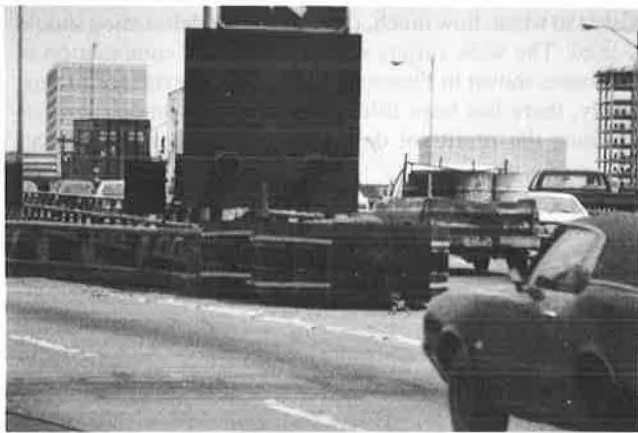
FIGURE 4 Nose panel supplemented with back panel, flashing lights, and chevron alignment signs.

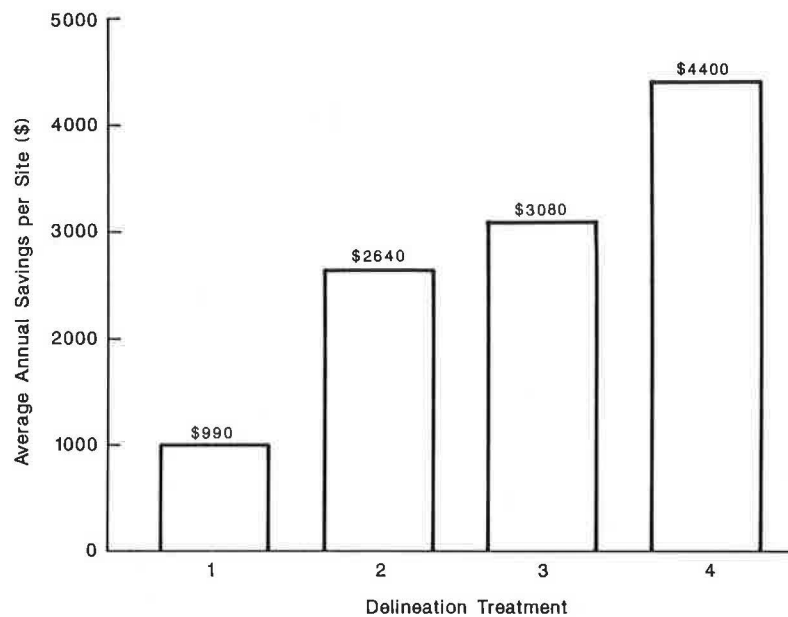
FIGURE 9 Estimated average annual savings in crash cushion repair costs.

Using an average repair cost of \$880, the average annual savings in repairs for the various treatments were estimated to range from \$990 to \$4,400 per year (see Figure 9). This estimate includes only the labor and material costs for the actual repair of the crash cushion; it does not include the average cost to motorists who collide with steel drum crash cushions. The values in Figure 9 show that all treatments did result in some yearly cost savings. These values should not be used to compare the relative effectiveness among treatments, as predelineation repair frequencies varied dramatically from site to site.

Using a cost estimate of \$880 per repair (labor and materials) for steel drum crash cushions, the estimated average annual savings for the delineation treatments ranged from \$990 to \$4,400. Delineation of the crash cushions at the eight study sites is considered to have been cost effective. Total savings at the eight sites, accumulated from the installation of the delineation treatments through 1986, are estimated to be approximately \$88,000, based on previous cost estimates. When compared with the savings, installation and maintenance costs of the treatments were considered to be negligible.
