Vehicle Impact Testing of Lightweight Lighting Standards

ROGER L. STOUGHTON, ABBAS ABGHARI, JOHN P. DUSEL,
JACK L. HEDGEcock, AND DORAN L. GLAUZ

This paper presents the results of seven full-scale vehicular crash tests on 35-ft-high breakaway lighting standards with 20-ft-long mast arms and compares them with the recommended crash test criteria in *NCHRP Report 230* and with the new 1985 AASHTO specifications for structural supports. The test devices consisted of an aluminum lighting standard with cast aluminum breakaway couplings, a lightweight steel lighting standard with cast aluminum breakaway couplings and a triangular slip base, and a typical California Department of Transportation (Caltrans) type 31 lighting standard with a triangular slip base. The lighting standards tested met the requirements of *NCHRP Report 230* with minor exceptions. The 1985 AASHTO specifications for breakaway bases, however, were met in all seven crash tests. Although the die-cast aluminum coupling proved to be an effective breakaway device when impacted by 1,800-lb cars, excessive porosity and lack of compliance with Caltrans specifications preclude the use of these couplings as a standard Caltran

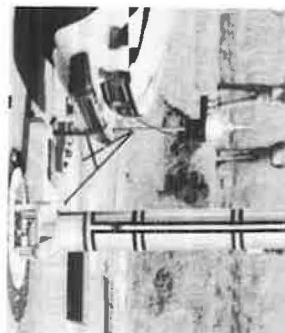
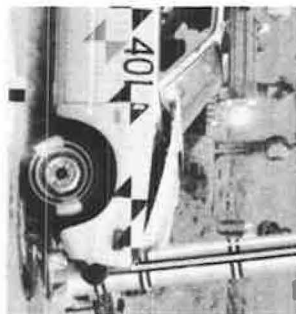
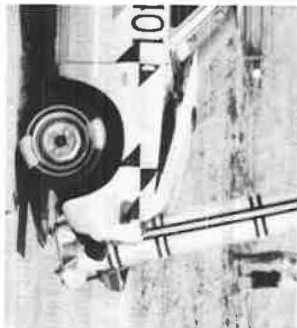
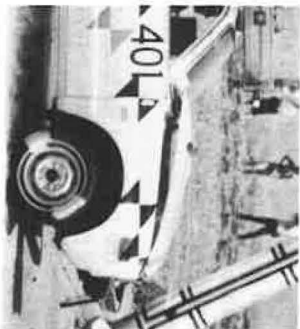
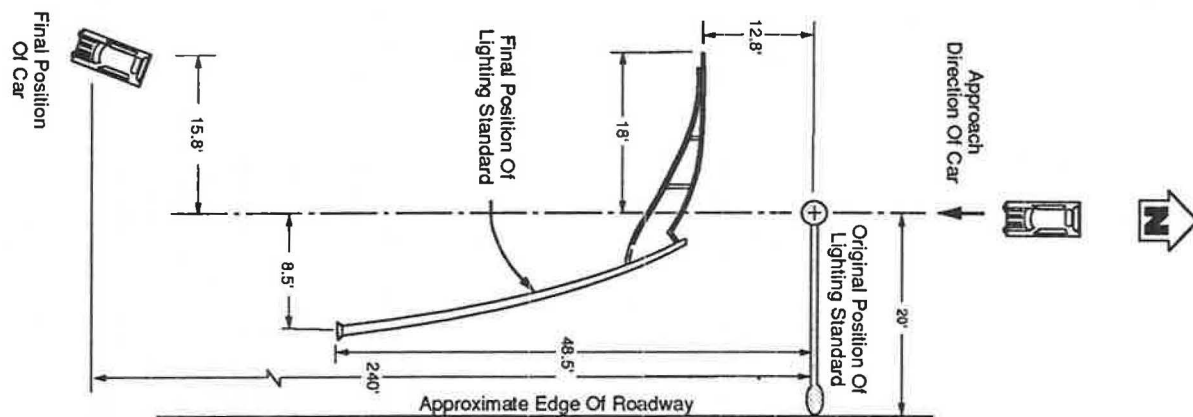
FIGURE 1 Test 401 data summary sheet.

TEST NO..... 401
 DATE..... August 25, 1982
 TYPE OF LIGHT STD..... Modified Type 31
 POLE MATERIAL..... Aluminum
 POLE DIMENSIONS..... 35'-0" x 10" O.D. x 8" O.D.
 POLE BASE SLEEVE..... 0.257" x 2'-0" High
 MOUNTING HEIGHT..... 37'-0"
 PROJECTED LENGTH OF MAST ARM..... 20'-0"
 TOTAL WEIGHT..... 394 Lb.
 BREAKAWAY DEVICE..... Aluminum Couplings

VEHICLE..... 1979 Honda Civic
 VEHICLE WEIGHT..... 2055 Lb.
 (Including dummy & instrumentation)
 DUMMY RESTRAINT..... None
 IMPACT VELOCITY..... 58.6 Mph
 IMPACT LOCATION..... 12" Right of centerline
 OCCUPANT IMPACT VELOCITY LONG..... 9.4 fps
 VEHICLE DAMAGE (measured at bumper ht.)..... 11-1/4"
 VEHICLE ACCELERATION (max. 50 msec avg.)
 LATERAL..... -0.80 g's
 LONGITUDINAL..... -3.80 g's
 VERTICAL..... -0.85 g's
 HEAD INJURY CRITERION..... 1.8

A summary of the results of test 401 and the photos taken before, during, and after the impact are shown in Figure 1. A 1979 Honda Civic test vehicle impacted the base of the aluminum pole 12 in to the right of the centerline of the front bumper (a 3-in deviation from the desired quarter point location of 15 in to the right of centerline) at 58.6 mph. The couplings sheared off as intended, and the vehicle pushed the pole base up in the air so that it cleared the car, which decelerated in a fairly straight line without any significant yaw. The surface of the aluminum pole at the impact point of the front bumper was not dented or deformed. The top of the pole, however, swung and impacted the asphalt pavement, destroying the end cap and bending the back of the top edge of the pole. This caused the truss-type mast arm to buckle severely in two places. (The pole was reusable, however, for crash test 402.) The luminaire came off of the end of the mast arm shortly after initial impact and was badly damaged. The final position of the vehicle after it was braked remotely and the final location and the schematic damage of the lighting standard are shown in Figure 1. As shown, the lighting standard rotated 180° and came to rest well out of the way of traffic in the imaginary outside lane.

In all three tests (401, 402, and 403) with aluminum couplings, the couplings fractured as expected, with the bottom two-thirds remaining intact on the anchor bar studs. Cracks initiated in the root of the "V" notches at the top of the couplings and progressed downward until they reached a location near the base of the top stainless steel stud. The two stainless steel studs on the upstream side of the lighting standard, which remained in the holes in the shoe base at the bottom of the aluminum pole, impacted and bent the two downstream anchor bar stubs, which were directly in their path. A schematic of the vehicle approach direction and the anchor bar stubs after the impact in test 401 are shown in Figure 4. This direction offers the highest shear resistance as required by *NCHRP Report 230*. This condition would not normally be present because of the typically skewed approach angle of an errant vehicle.

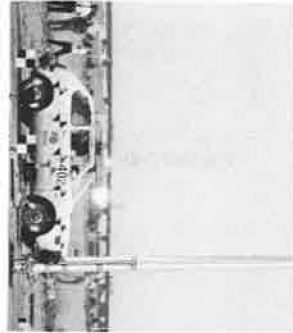
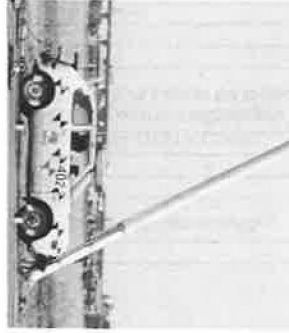
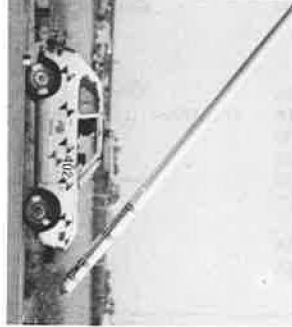
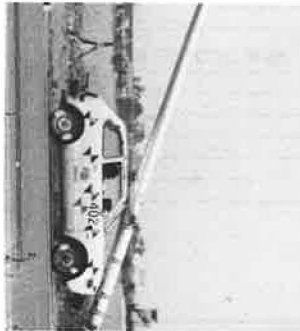
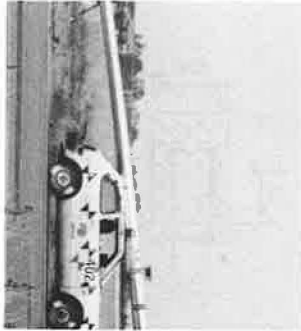
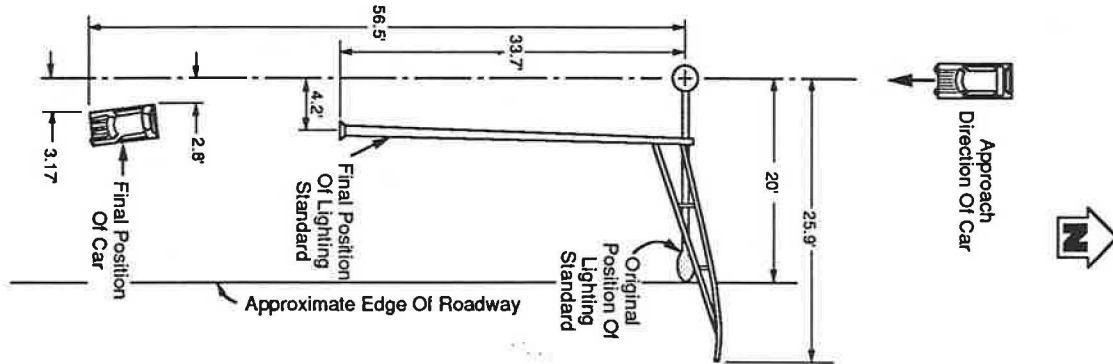
FIGURE 2 Test 402 data summary sheet.

TEST NO..... 402
 DATE..... October 13, 1982
 TYPE OF LIGHT STD..... Modified Type 31
 POLE MATERIAL..... Aluminum
 POLE DIMENSIONS..... 35' x 10" O.D x 8" O.D.
 POLE BASE SLEEVE..... 0.257" x 2'-0" high
 MOUNTING HEIGHT..... 37'-0"
 PROJECTED LENGTH OF MAST ARM..... 20'-0"
 TOTAL WEIGHT..... 394 Lb.
 BREAKAWAY DEVICE..... Aluminum Couplings

VEHICLE..... 1979 Honda Civic
 VEHICLE WEIGHT..... 2015 lb.
 (Including dummy & instrumentation)
 DUMMY RESTRAINT..... None
 IMPACT VELOCITY..... 19.6 Mph.
 IMPACT LOCATION..... Center of the Front Bumper
 OCCUPANT IMPACT VELOCITY..LONG..... 10.4 tps
 VEHICLE DAMAGE (measured at oumper ht.)..... 11-1/4"
 VEHICLE ACCELERATION (max. 50 msec avg.)
 LATERAL..... -0.22 g's
 LONGITUDINAL..... -3.19 g's
 VERTICAL..... -0.74 g's
 HEAD INJURY CRITERION..... 0.8

The summary of the results of test 402 and the photos taken before, during, and after the impact are shown in Figure 2. The 1979 Honda Civic test vehicle impacted the aluminum pole at the center of the front bumper at 19.6 mph. Upon impact, the couplings sheared off and the vehicle pushed and bumped the pole along in front as it decelerated. The pole was pushed over slowly, and it rolled on the roof as the vehicle barely passed under the pole shoe base. The vehicle traveled in a nearly straight line after impact, drifting slightly to the left with virtually no yaw. As with test 401, the aluminum pole sustained no damage from the impact of the vehicle's front bumper. The top of the pole, however, swung down and impacted the asphalt pavement, damaging the end cap and top edge of the pole tube and fracturing the upper cast aluminum mast arm clamping band. The mast arm did not buckle as it did in test 401. The luminaire broke into pieces and scattered over a large area, well into the imaginary traffic lanes. Figure 2 shows the final position of the vehicle after it was braked remotely and the final location and schematic damage of the lighting standard. As shown in the figure, the lighting standard came to rest with the mast arm projecting about 6 ft (assuming a 20-ft distance from the pole to the roadway edge) into the outside traffic lane.

In tests 402 (19.6 mph), 404 (19.9 mph), and 407 (23.7 mph), the pole did not kick up high enough to clear the car but rolled over the roof and then slid off. It seemed that the lighting standards tested were too heavy for an 1,800-lb car at 20 mph. In test 402, the pole dented the roof of the car, and the final position of the lighting standard projected 5.9 ft into the traffic lane. In test 407, the rear window was shattered as the pole rolled off the roof. Although no significant damage was done to the passenger compartment, part D was not strictly satisfied in these tests. It should be noted that the pole caused more damage to the car in test 407 than in test 404, even though the lighting standard in test 407 was lighter

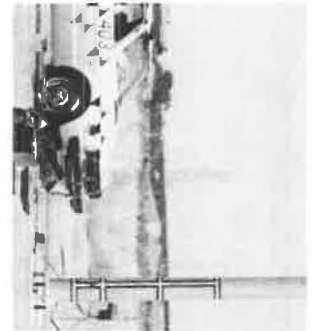
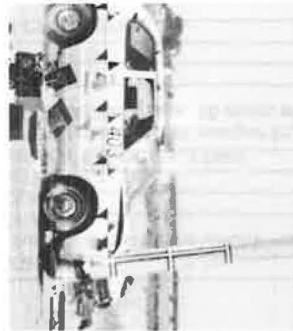
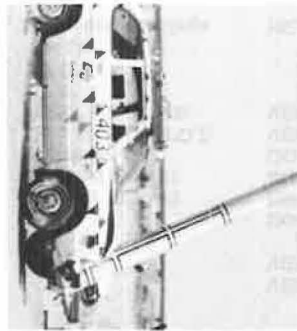
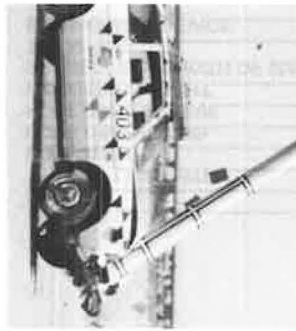
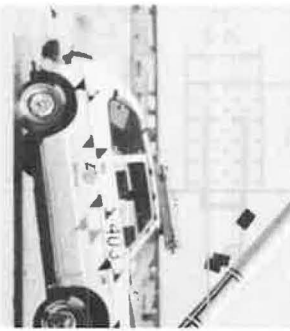
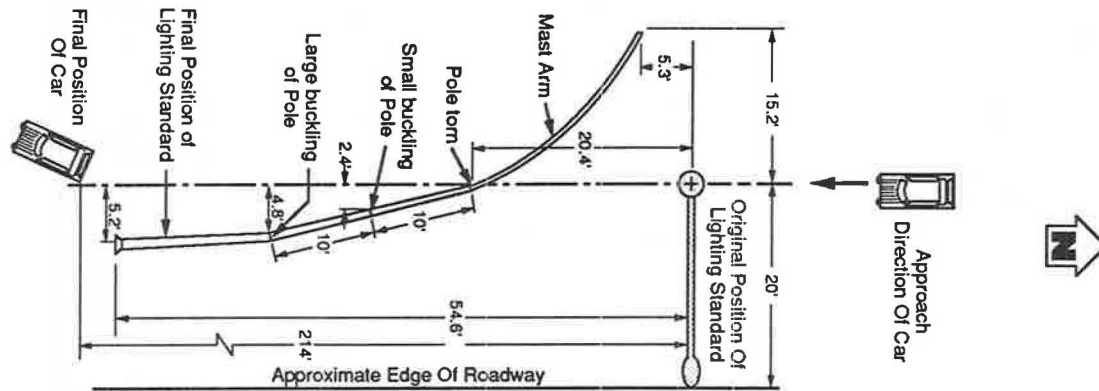
FIGURE 3 Test 403 data summary sheet.

TEST NO..... 403
 DATE..... July 20, 1983
 TYPE OF LIGHT STD..... Modified Type 31
 POLE MATERIAL..... Galvanized Steel
 POLE DIMENSIONS..... 35'-0" x 10 1/16" O.D. x 5 3/8" O.D.
 POLE BASE SLEEVE..... 0.1345" x 2'-0" High
 MOUNTING HEIGHT..... 40'-3"
 PROJECTED LENGTH OF MAST ARM..... 20'-0"
 TOTAL WEIGHT..... 651 Lb.
 BREAKAWAY DEVICE..... Aluminum Couplings

VEHICLE..... 1979 Honda Civic
 VEHICLE WEIGHT..... 2035 lb.
 (Including dummy & instrumentation)
 DUMMY RESTRAINT..... None
 IMPACT VELOCITY..... 59.1 Mph.
 IMPACT LOCATION..... 9 1/2" Right of Centerline
 OCCUPANT IMPACT VELOCITY LONG..... 12.4 fps
 VEHICLE DAMAGE (measured at bumper ht.)..... 14-1/4"
 VEHICLE ACCELERATION (max. 50 msec avg.)
 LATERAL..... -2.13 g's
 LONGITUDINAL..... -5.78g's
 VERTICAL..... 1.13 g's
 HEAD INJURY CRITERION..... 8

A summary of the test results and photos taken before, during, and after the impact are shown in Figure 3. The test vehicle, a 1979 Honda Civic, first impacted the base of the thin-walled steel lighting standard 9 $\frac{1}{2}$ in (15 in desired) to the right of the centerline of the front bumper at 59.1 mph. The vehicle solidly impacted the pole and sheared off the couplings at the base of the top stainless steel studs. Shortly after the initial impact, the base plate on the lighting standard pole hooked under the Honda's deformed front bumper, and the whole front end was lifted about 1 ft off the ground by the moving mass of the pole. As the car continued to travel downstream, the base plate on the bottom of the pole unhooked from the front bumper. The pole continued moving upward well over the car's roof, while the car proceeded in a nearly straight line beneath the pole. The steel pole was badly buckled, and it was torn at the mast arm-to-pole connection plates. There was also a slight dent in the pole where the initial bumper contact had occurred. The luminaire was totally demolished, with some debris falling into the imaginary outside traffic lane. The final position of the vehicle after it was braked remotely and the final location and damage of the lighting standard are shown schematically in Figure 3.

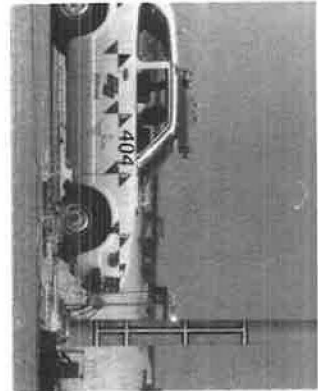
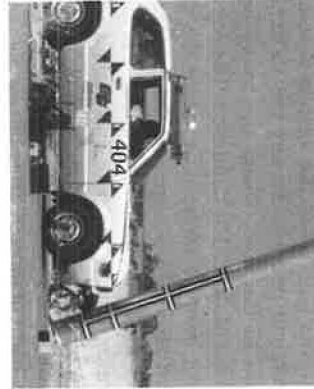
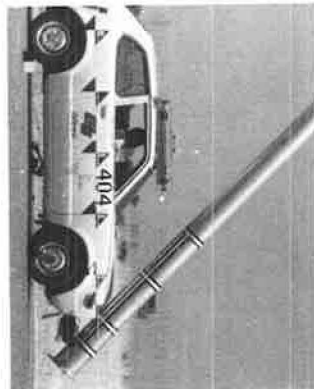
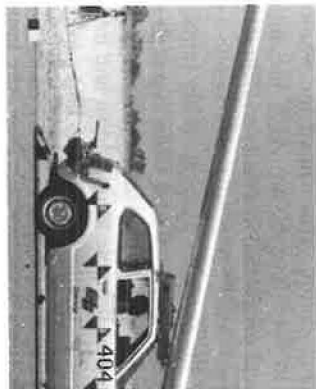
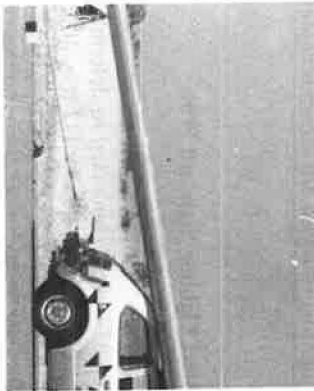
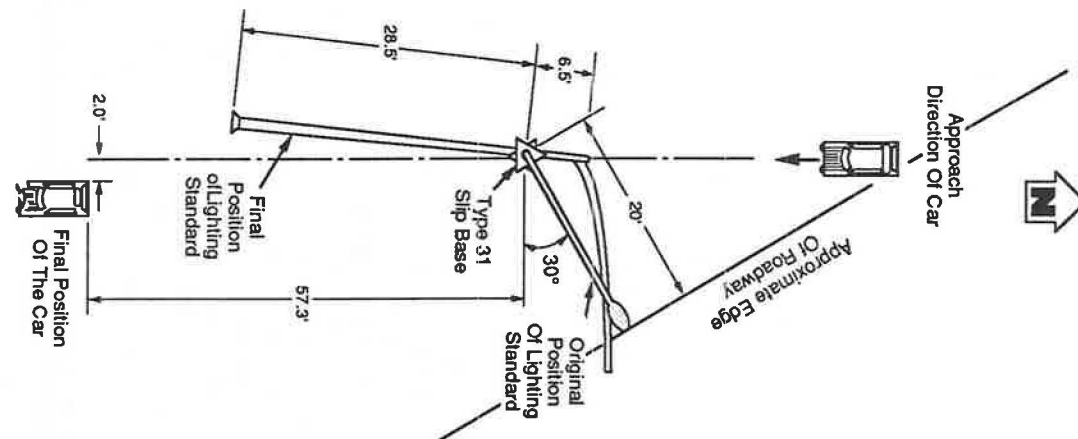
FIGURE 5 Test 404 data summary sheet.

TEST NO.....	404
DATE.....	July 26, 1984
TYPE OF LIGHT STD.....	Caltrans Type 31
POLE MATERIAL.....	Galvanized Steel
POLE DIMENSIONS.....	35'-0" x 10.78" O.D. x 6" O.D.
POLE BASE SLEEVE.....	None
MOUNTING HEIGHT.....	37'-0"
PROJECTED LENGTH OF MAST ARM.....	20'-0"
TOTAL WEIGHT.....	883 Lbs.
BREAKAWAY DEVICE.....	Type 31 Triangular Slip base

VEHICLE.....	1979 Honda Civic
VEHICLE WEIGHT.....	2015 lb.
(Including dummy & instrumentation)	
DUMMY RESTRAINT.....	None
IMPACT VELOCITY.....	19.9 Mph.
IMPACT LOCATION.....	Center of the Front Bumper
OCCUPANT IMPACT VELOCITY LONG.....	8.5 fps
VEHICLE DAMAGE (measured at bumper ht.).....	11"
VEHICLE ACCELERATION (max. 50 msec avg.)	
LATERAL.....	-0.87 g's
LONGITUDINAL.....	-5.44 g's
VERTICAL.....	-0.81 g's
HEAD INJURY CRITERION.....	10

A summary of the results of test 404 and the photos taken before, during, and after the impact are shown in Figure 5. The test vehicle impacted the base of the pole at the center of the front bumper. The impact speed was 19.9 mph (20 mph was desired). Upon impact, the slip base broke away and the car slowly pushed the pole base forward, where it bounced on the ground and then rolled over the car's hood and roof. The top of the pole swung down and hit the asphalt, then the pole and mast arm came straight down on top of the foundation without any rotation. While the vehicle decelerated, it proceeded in a straight line without any yaw. The surface of the lower section of the pole, where the initial bumper impact occurred, was not dented or deformed. The top of the pole sustained minor damage where it impacted the asphalt pavement. The mast arm did not appear to be damaged and was still attached to the pole, projecting about 1 ft into the imaginary outer traffic lane. (The pole and mast arm were able to be reused in test 405.) Immediately upon impact, the luminaire head shook loose from the pole tip and fell into the traffic lane. It was badly damaged after hitting the ground. Figure 5 shows the final position of the vehicle after it was braked remotely and the final location and schematic damage of the lighting standard.

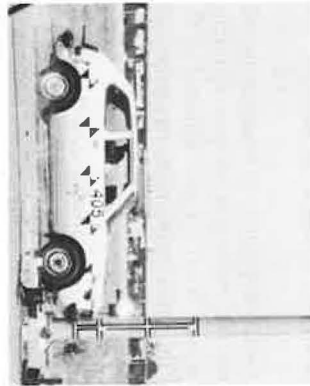
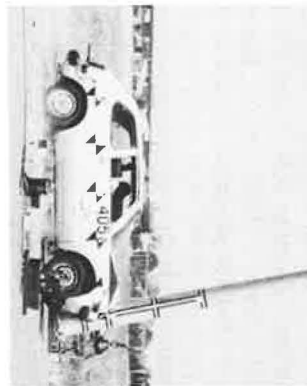
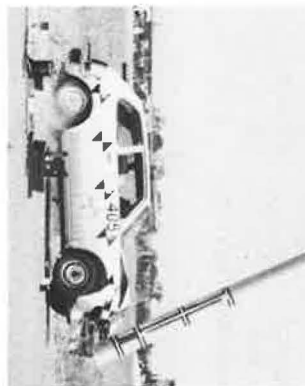
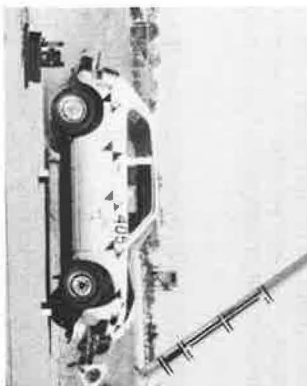
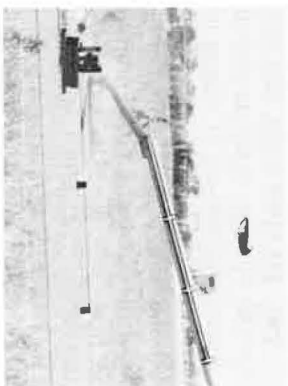
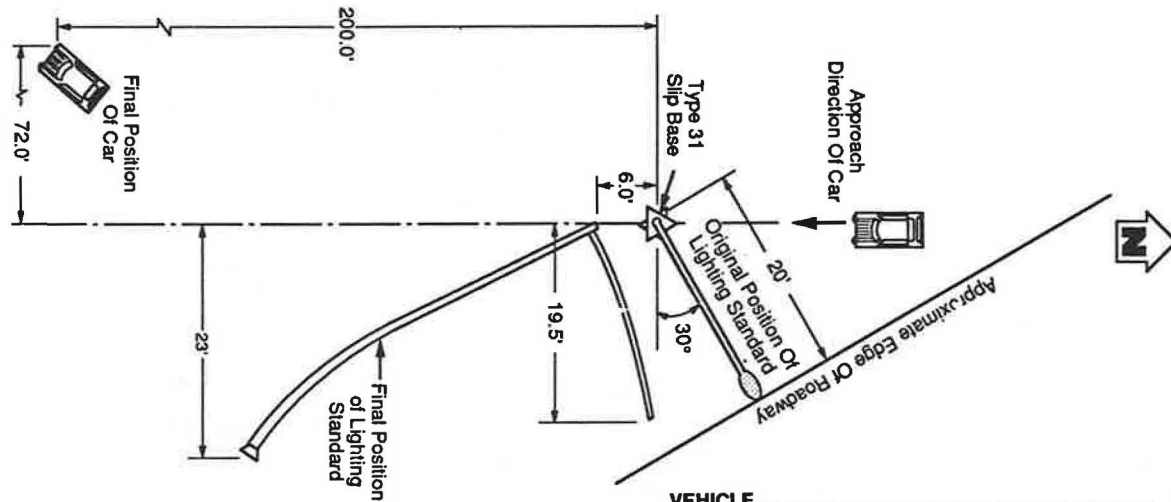
TEST NO.....	405
DATE.....	May 23, 1985
TYPE OF LIGHT STD.....	Caltrans Type 31
POLE MATERIAL.....	Galvanized Steel
POLE DIMENSIONS.....	35'-0" x 107/8" O.D. x 6" O.D
POLE BASE SLEEVE.....	None.
MOUNTING HEIGHT.....	37'-0"
PROJECTED LENGTH OF MAST ARM.....	20'-0"
TOTAL WEIGHT.....	883 Lb.
BREAKAWAY DEVICE.....	Type 31 Triangular Slip base

VEHICLE.....	1979 Honda Civic
VEHICLE WEIGHT.....	2050 lb.
(Including dummy & instrumentation)	
DUMMY RESTRAINT.....	None
IMPACT VELOCITY.....	53.9 Mph.
IMPACT LOCATION.....	13-5/8" Right of Centerline
OCCUPANT IMPACT VELOCITY LONG.....	12.4 fps
VEHICLE DAMAGE (measured at bumper ht.).....	13-5/8"
VEHICLE ACCELERATION (max. 50 msec avg.)	
LATERAL.....	-1.64 g's
LONGITUDINAL.....	-7.24g's
VERTICAL.....	1.36 g's
HEAD INJURY CRITERION.....	8

The summary of the results of test 405 and the photos taken before, during, and after the impact are shown in Figure 6. The test vehicle first impacted the pole near its base, 13-5/8 in to the right of the centerline of the vehicle's front bumper (1-3/8 in to the left of the desired quarter point location). The impact speed was 53.9 mph. The car yawed immediately after impact, and both the right front and the right rear tires ran over the foundation and lower slip base plate assembly, which was bolted to the foundation. This caused the whole right side of the Honda to vault into the air. After the initial 40° clockwise yaw, the car proceeded in a fairly straight line. The lower section of the galvanized steel pole sustained no damage from the impact of the vehicle's bumper. After impact, the pole base was quickly accelerated and kicked up high so the decelerating Honda was able to pass underneath without further contact. The top of the pole swung down and impacted the asphalt pavement, breaking the end cap and denting the back edge of the pole top. This also bowed the pole and the mast arm. Just after the car hit the pole base, the luminaire housing exploded from the shock. The final position of the vehicle after it was braked remotely and the final location and damage of the lighting standard are shown schematically in Figure 6.

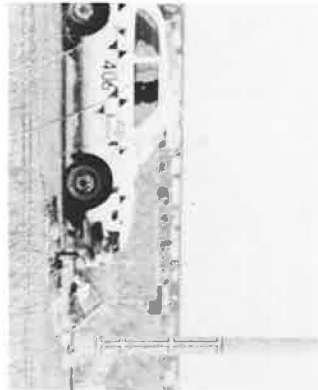
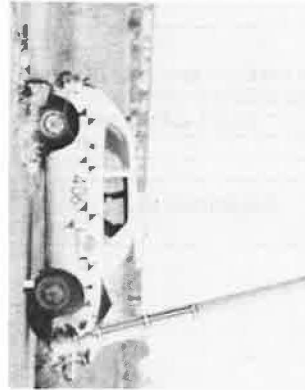
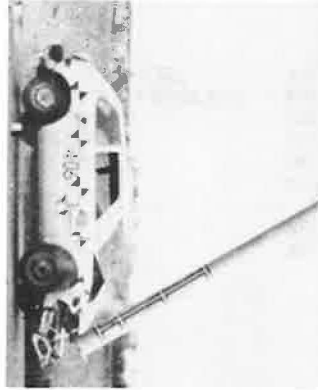
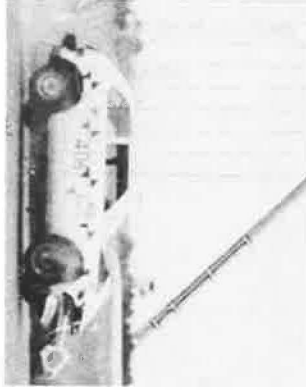
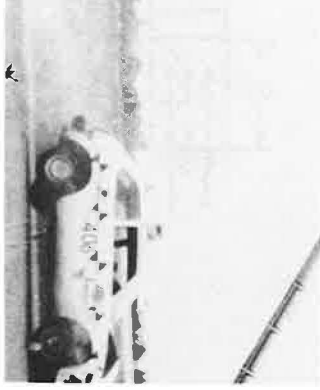
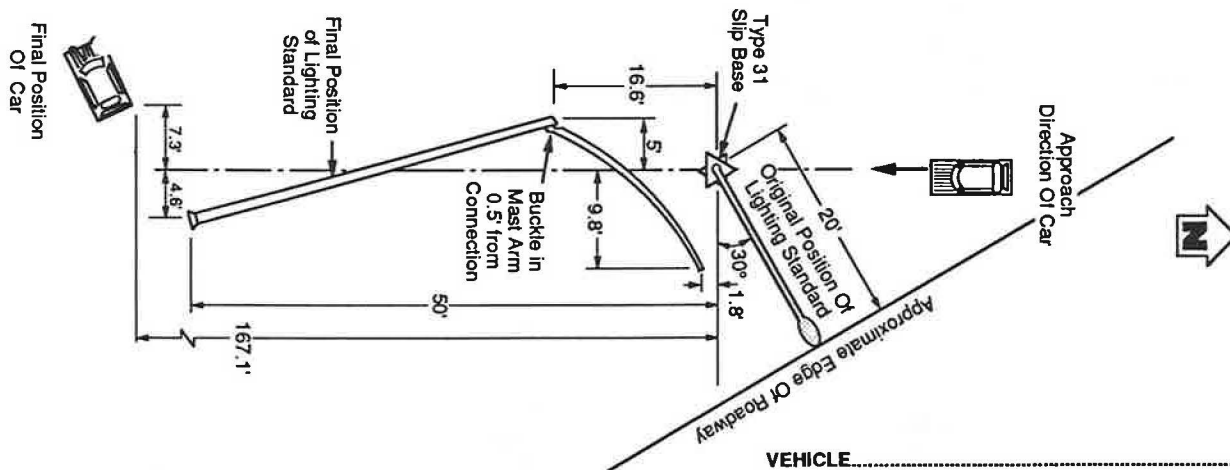
FIGURE 7 Test 406 data summary sheet.

TEST NO.....	406
DATE.....	May 8, 1987
TYPE OF LIGHT STD.....	Modified Type 31
POLE MATERIAL.....	Galvanized Steel
POLE DIMENSIONS.....	33'-0" x 10" O.D. x 5-3/8" O.D.
THICKENED POLE BASE.....	2'-0" x 10" O.D. x 0.25"
MOUNTING HEIGHT.....	39'-3"
PROJECTED LENGTH OF MAST ARM.....	20'-0"
TOTAL WEIGHT.....	627.4 Lb.
BREAKAWAY DEVICE.....	Type 31 Triangular Slip base

VEHICLE.....	1979 Honda Civic
VEHICLE WEIGHT.....	2015 lb.
(Including dummy & instrumentation)	
DUMMY RESTRAINT.....	None
IMPACT VELOCITY.....	58.8 Mph.
IMPACT LOCATION.....	18-3/4" Right of Centerline
OCCUPANT IMPACT VELOCITY LONG.....	13 fps
VEHICLE DAMAGE (measured at bumper ht.).....	15-1/8"
VEHICLE ACCELERATION (max. 50 msec avg.)	
LATERAL.....	-1.49 g's
LONGITUDINAL.....	-7.16 g's
VERTICAL.....	-1.64 g's
HEAD INJURY CRITERION.....	7

A summary of the results of test 406 and the photos taken before, during, and after the impact are shown in Figure 7. The vehicle impacted the pole 18¾ in (15 in desired) to the right of the centerline of the front bumper at 58.6 mph. Upon impact, the pole base was pushed up and over the roof of the decelerating vehicle without contacting the roof. As in test 405, both the right front and right rear tires of the Honda ran over the lower slip base assembly, which was bolted to the top of the foundation. This lifted the whole right side of the car into the air just after the right rear tire cleared the foundation. The off-centered hit caused a substantial clockwise yaw (approximately 30°) just after impact; however, the car seemed to straighten out after traveling a short distance. The surface of the pole where the initial bumper impact occurred was not dented or deformed. After impact, the pole tip and the mast arm swung down and impacted the asphalt pavement, breaking the end cap and flattening the back edge of the pole top. The mast arm buckled approximately 6 in from the mast arm-to-pole end plate, and the main pole had a slight permanent bow about 15 ft from its tip. At the initial impact of the car and the pole base, the luminaire exploded from the impact shock at the end of the mast arm. Various parts of the luminaire then came raining down outside the imaginary traffic lanes. Figure 7 illustrates the final position of the vehicle after it was braked remotely and the final location and the schematic damage of the lighting standard.

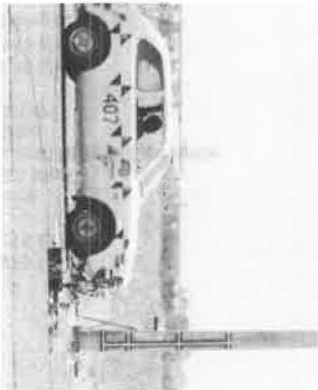
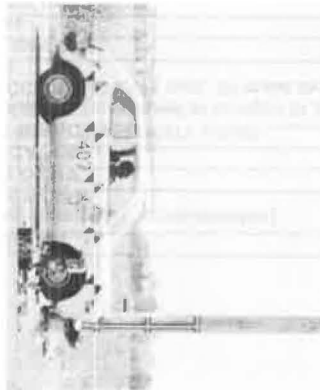
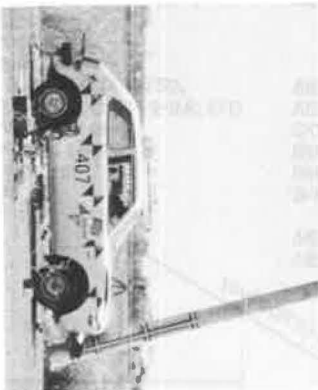
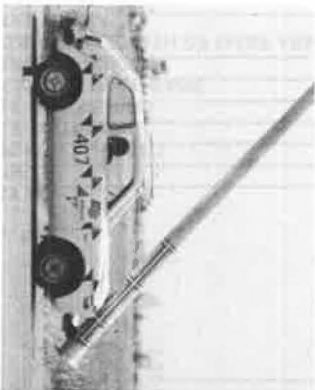
VEHICLE 1979 Honda Civic
 VEHICLE WEIGHT 2005 Lb.
 (Including dummy & instrumentation)
 DUMMY RESTRAINT None
 IMPACT VELOCITY 23.7 Mph.
 IMPACT LOCATION 3" Right of Centerline
 OCCUPANT IMPACT VELOCITY LONG. 8.6 fps
 VEHICLE DAMAGE (measured at bumper ht.) 12-7/8"
 VEHICLE ACCELERATION (max. 50 msec avg.)
 LATERAL -0.54 g's
 LONGITUDINAL -5.73 g's
 VERTICAL -1.63 g's
 HEAD INJURY CRITERION 2

than that used in test 404 (639.4 versus 883 lb) and the speed was more in test 407 (23.7 versus 19.9 mph). In other words, damage to the car roof can be worse at lower speeds. Also, the luminaire debris fell into the outer traffic lane in all tests except tests 401 and 406. In an actual accident, this type of debris could cause some damage to traffic in the outside lane. Thus, none of the tests completely satisfied the structural adequacy criterion: either there was some damage to the passenger compartment from the falling pole, or the lighting standard and luminaire debris created a potential hazard to traffic in the outside lane. However, since *NCHRP Report 230* does not clearly define what is meant by passenger compartment intrusion or what constitutes undue hazard to other traffic, it was judged that in all seven tests no significant damage to the passengers or to nearby traffic was likely to occur. Rear window shattering may occur over a range of low impact speeds (somewhere between 20 and 40 mph), no matter how effective the breakaway device, because of the pole mass and low trajectory.

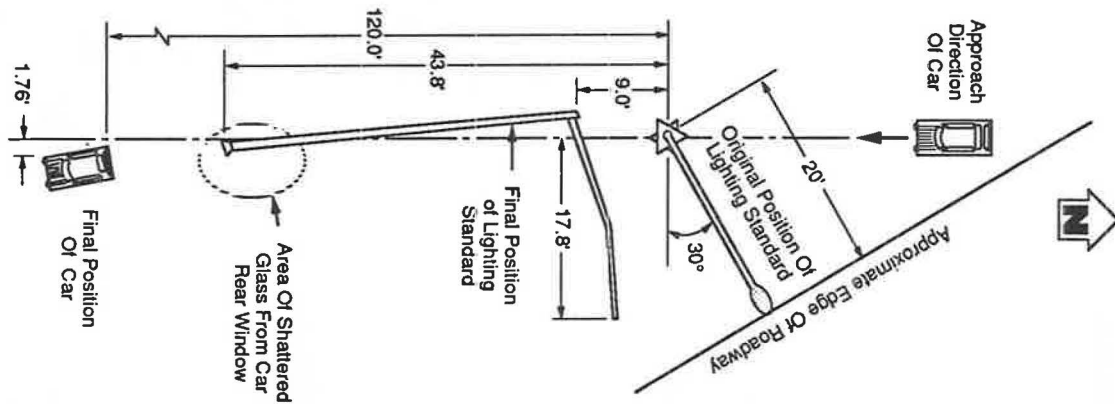
TEST NO. 407
 DATE June 23, 1987
 TYPE OF LIGHT STD. Modified Type 31
 POLE MATERIAL Galvanized Steel
 POLE DIMENSIONS 33'-0" x 10" O.D. x 5-3/8" O.D.
 THICKENED POLE BASE 2'-0" x 10" O.D. x 0.25"
 MOUNTING HEIGHT 39'-3"
 PROJECTED LENGTH OF MAST ARM 20'-0"
 TOTAL WEIGHT 639.4 Lb.
 BREAKAWAY DEVICE Type 31 Triangular Slip base
