TRANSPORTATION RESEARCH RECORD

Geosynthetics, Geomembranes, and Silt Curtains in Transportation Facilities

TRANSPORTATION RESEARCH BOARD
NATIONAL RESEARCH COUNCIL
WASHINGTON, D.C. 1989

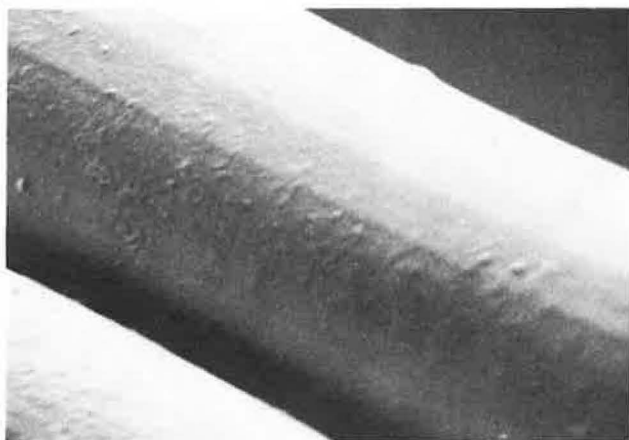
FIGURE 6 Surface of reference geotextile fiber ($\times 975$).

The original as-manufactured geotextile (the 1975 reference sample) and the individual fiber surfaces (from sample 13) are shown in Figure 6. The individual fibers (occasionally a few are bonded together in a parallel fashion) are distributed more or less randomly to produce a planar isotropic structure. The surfaces of the individual fibers are generally very smooth,

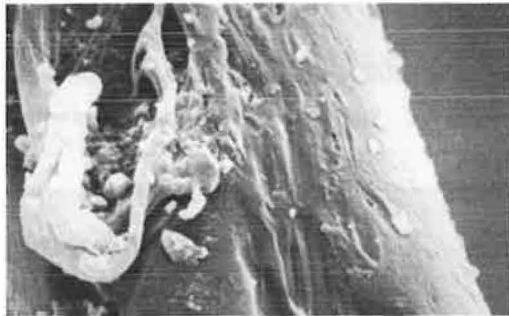
FIGURE 10 Surfaces of fibers from (a,b) sample 12 and (c) sample 13 ($\times 975$).

In comparison, Figure 10 shows the surfaces of fibers removed from samples 12 and 13. In general, the fibers from sample 12 are more severely damaged than those from either the sample 13 fibers or the reference sample. The damage appears to be more of a ductile "smearing" than a brittle chipping. In other words, the fiber material is not lost but is just redistributed, probably as a result of spreading of the limestone aggregate over the geotextile during installation.

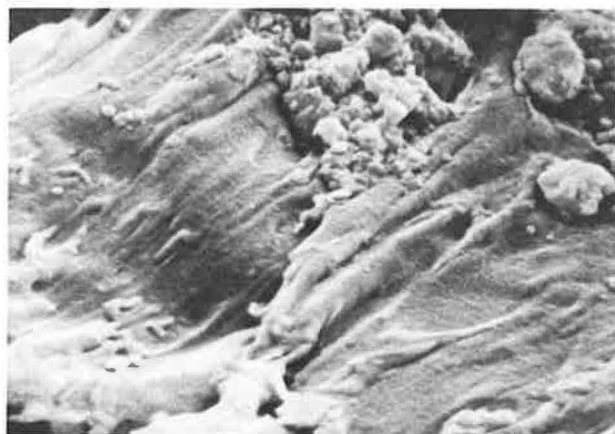
FIGURE 14 Fracture characteristics of fibers in area circled in Figure 13 ($\times 1950$).

The fiber fracture in sample 13, shown in Figures 13 and 14, is essentially a replicate of the fiber fracture in the ref-

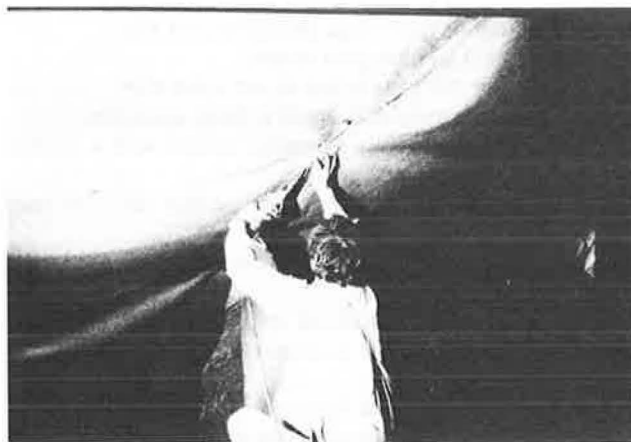
FIGURE 5 Heat seaming the geotextile.

damage to the geomembrane system. Once the geotextile strips have been nailed in place and overlapped a minimum of 100 mm, the geotextile is then heat-bonded at the seams as shown in Figure 5.

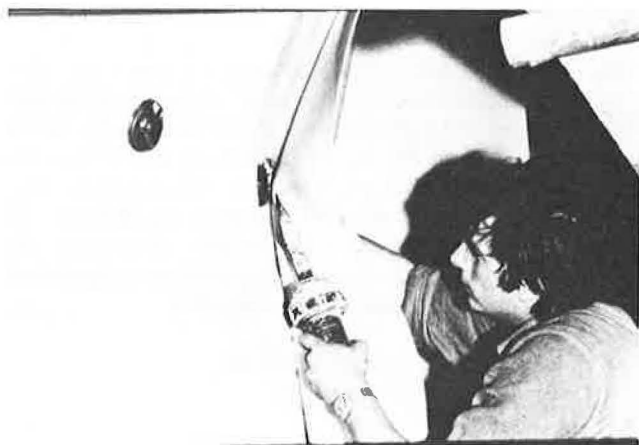
FIGURE 6 Welding the PVC geomembrane to fixing disks.

The geomembrane is unrolled and positioned from the mobile scaffold, also in a radial manner. As it is supported below the crown, it is manually hot-air-welded to the fixing disks, thus providing the required support for each strip, as shown in Figure 6. As the geomembrane strips are supported in place, they are positioned with a minimum 70-mm-wide overlap to facilitate thermal welding. Placement of the geomembrane strips is such that seam lengths are always radial within the tunnel.

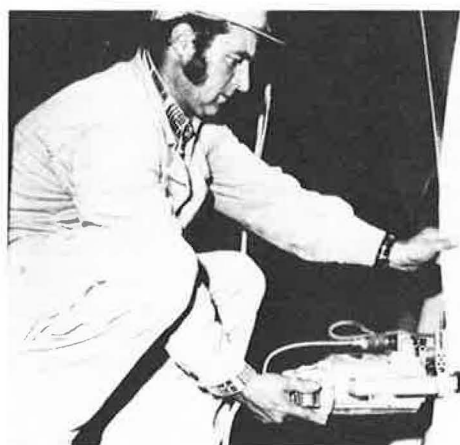
FIGURE 8 Welding a PVC geomembrane panel.

PVC seams are welded using an automatic, double-wedge, thermal self-tracking welder, as shown in Figure 8. The double-wedge weld produces a seam that contains a con-

tinuous channel between welded tracks. The channel is then used to test the continuity of the seam with air pressurization as a quality control procedure. The channel is generally subjected to a pressure of 2 Pa for approximately 10 min with a requirement for not more than 10 percent pressure loss (6). HDPE sheet material is generally welded by the extrusion welding process, as shown in Figure 9. This type of weld allows joining of the geomembrane panels in limited access areas. The seams can be inspected using the vacuum-box technique similar to steel weld testing.

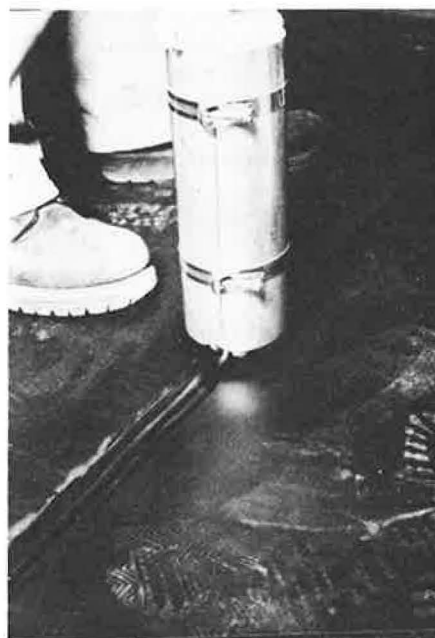
FIGURE 9 Extrusion welding of HDPE sheets.

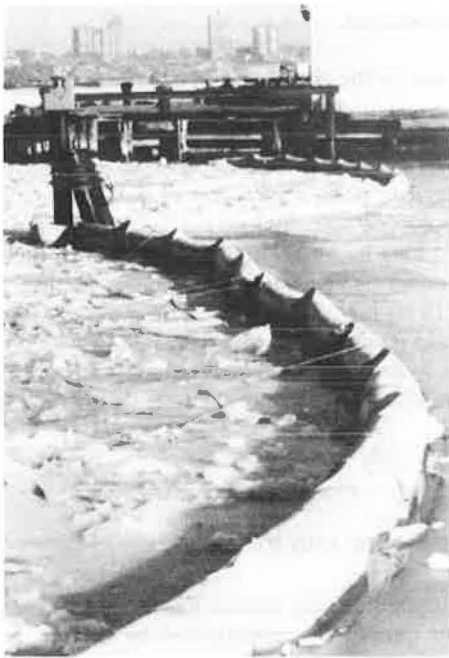
FIGURE 4 Curtain in place.

The prototype turbidity curtain consisted of four panels 34 m (110 ft) long by 11 m (35 ft) high, including the 3.7-m (12-ft) high impermeable barrier; one panel 34 m (111 ft) long by 5 m (16 ft) high; and two closure panels 5 m (15 ft) long by 11 m (35 ft) high. The closure panels provided a means of access in and out of the area within the curtain. Figure 3 shows the fabricated curtain, and Figure 4 shows the curtain in place.
