# Performance Level 2 Bridge Railings

C. E. BUTH, T. J. HIRSCH, AND C. F. McDEVITT

This paper presents the results of work performed to develop and test four railing designs to meet PL 2 requirements.

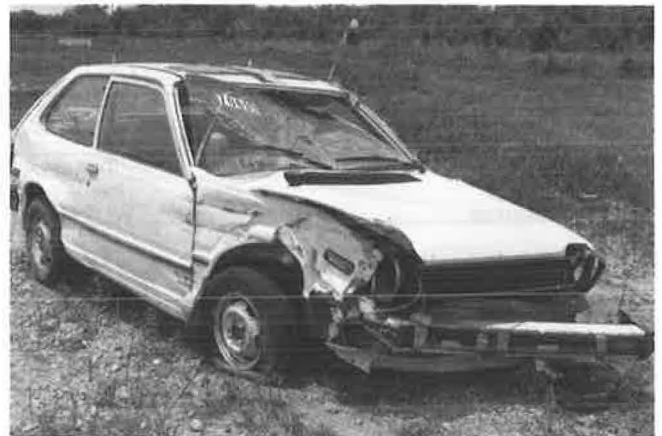
FIGURE 3 Vehicle after Test 7069-1 (1,795 lb, 58.7 mph, 20.0 degrees).

Damage to the vehicle is shown in Figure 3. Maximum crush of the right front corner at bumper height was 8 in. There was no measurable movement or deformation of the railing.

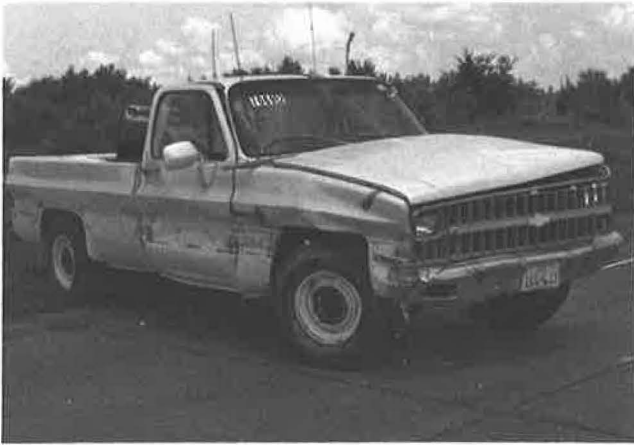
FIGURE 5 Damage to vehicle in Test 7069-2 (5,450 lb, 63.6 mph, 19.2 degrees).

Exterior damage to the vehicle is shown in Figure 5. Both right side wheels and the front suspension were damaged. Also, the cab was twisted and the frame was permanently deformed.

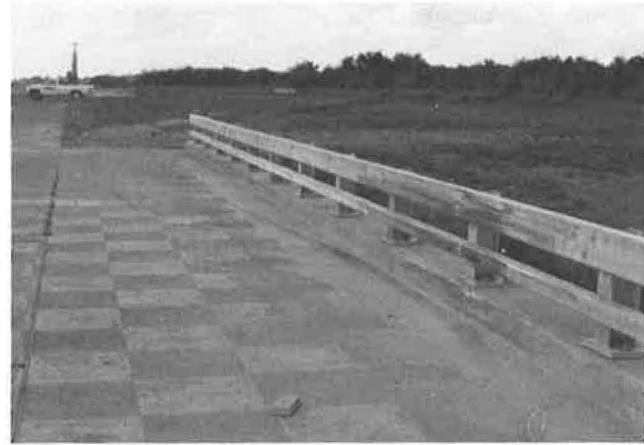
FIGURE 6 After-test photograph at railing in Test 7069-2.

Damage to the railing is shown in Figure 6. Maximum dynamic deflection of the railing was 2.4 in. and maximum permanent deflection was 0.5 in. The front of the baseplate

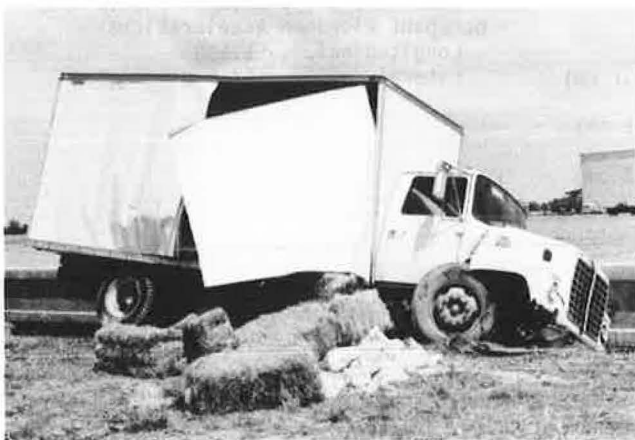
**FIGURE 8** Photograph of vehicle after Test 7069-15 (18,000 lb, 50.8 mph, 15.1 degrees).

Damage to the vehicle is shown in Figure 8. The frame of the truck was permanently deformed. The cargo box was torn during the test; as the vehicle left the rail, the load shifted and tore open the right side of the cargo box.

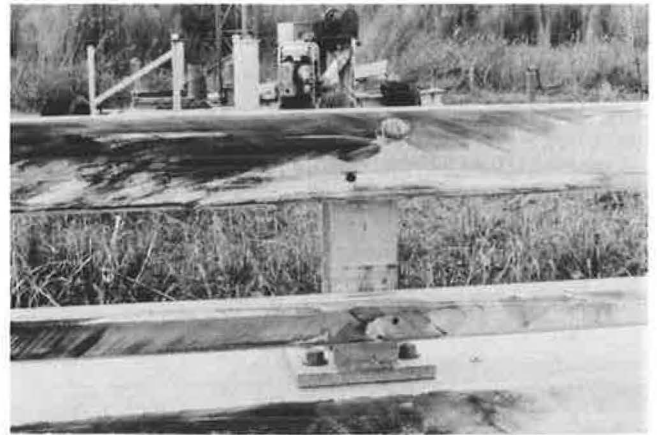
**FIGURE 9** Damage to railing at Post 6.

Damage to the railing in the vicinity of Post 6 is shown in Figure 9. The bolts connecting the lower rail element to the post were sheared on Posts 3 through 7, apparently because of vertical downward load. At Post 5, the bolt on the upper rail element was sheared and the face of the rail element itself was gouged. The flange on Post 6 was bent and the concrete curb was cracked at Posts 6 through 9. The top of Post 8 was deformed by the edge of the cargo box on the truck.

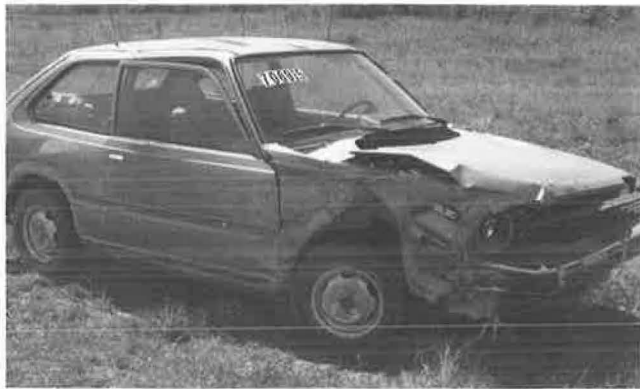
**FIGURE 12** Vehicle after Test 7069-5 (1,800 lb, 60.5 mph, 21.0 degrees).

Damage to the vehicle is shown in Figure 12. Maximum crush of the right front corner at bumper height was 5 in. Damage to the railing was cosmetic only and is shown in Figure 13.

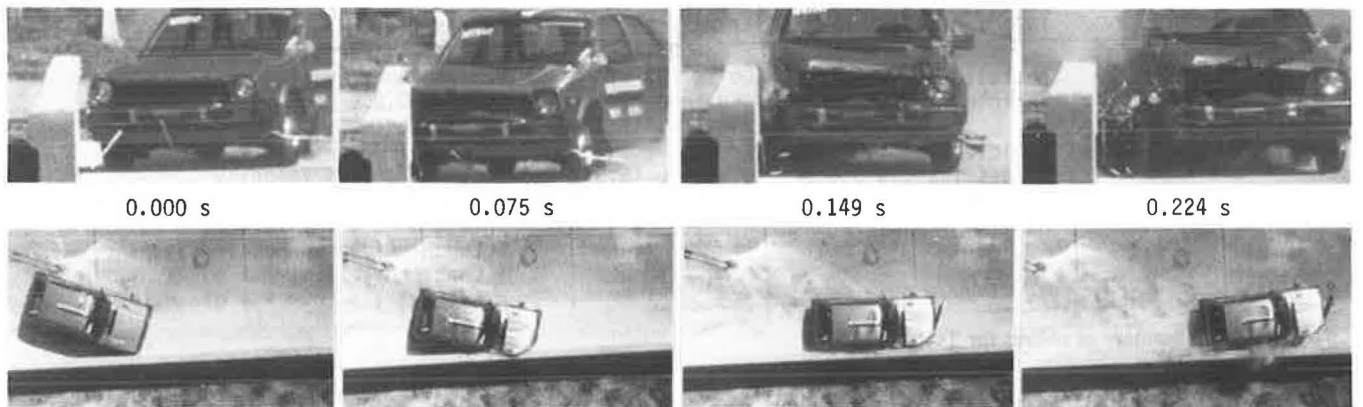
**FIGURE 14** Summary of results for Test 7069-5.

Test No. . . . .	7069-5	Impact Speed. . .	60.5 mi/h (97.3 km/h)
Date . . . . .	9/24/87	Impact Angle. . .	21.0 deg
Test Installation . .	32 in Vertical Wall	Exit Speed. . . .	48.6 mi/h (78.2 km/h)
Installation Length .	100 ft (30 m)	Exit Trajectory .	6.2 deg
Vehicle . . . . .	1981 Honda Civic	Vehicle Accelerations (Max. 0.050-sec Avg)	
Vehicle Weight		Longitudinal. . .	-8.0 g
Test Inertia . . . . .	1,800 lb (817 kg)	Lateral . . . . .	14.0 g
Gross Static . . . . .	1,965 lb (892 kg)	Occupant Impact Velocity	
Vehicle Damage Classification		Longitudinal. . .	20.1 ft/s (6.1 m/s)
TAD . . . . .	01RFQ4	Lateral . . . . .	26.0 ft/s (7.9 m/s)
CDC . . . . .		Occupant Ridedown Accelerations	
Maximum Vehicle Crush	5.0 in (12.7 cm)	Longitudinal. . .	-1.6 g
		Lateral . . . . .	9.4 g

and other pertinent information from the test are summarized in Figure 14.

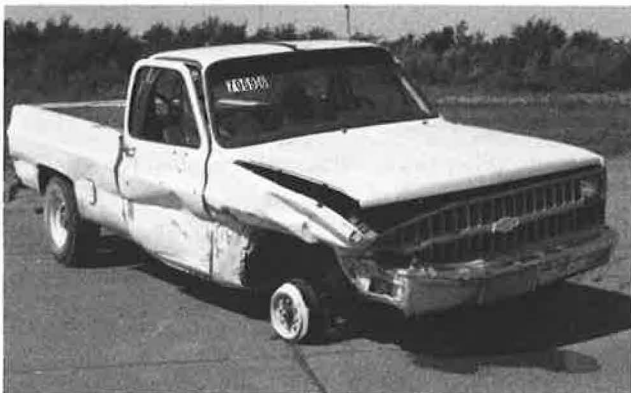
**FIGURE 15** Vehicle after Test 7069-6 (5,400 lb, 59.7 mph, 20.2 degrees).

Damage to the vehicle is shown in Figure 15. Note that the right front wheel was separated at the welds connecting the outer and inner portion, allowing the outer portion of the wheel and tire to separate from the vehicle. The front suspension was damaged. The cab was twisted and the frame was permanently deformed. No structural distress was noted in the parapet (Figure 16).

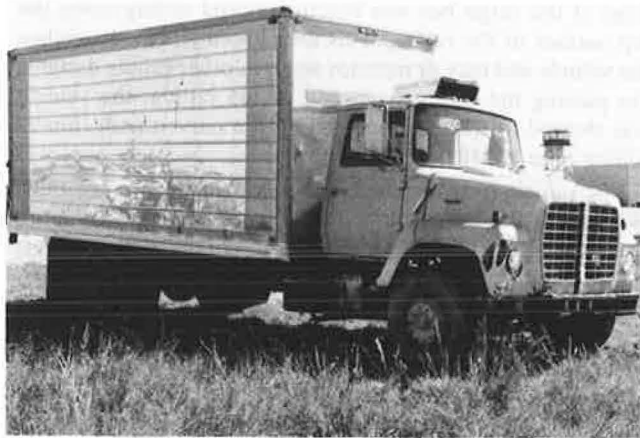
FIGURE 18 Damage to vehicle in Test 7069-16 (18,000 lb, 50 mph, 14 degrees) after being uprighted.

The vehicle sustained damage to its right side during interaction with the railing, as indicated in Figure 18. Maximum crush at the right front corner at bumper height was 10.0 in.

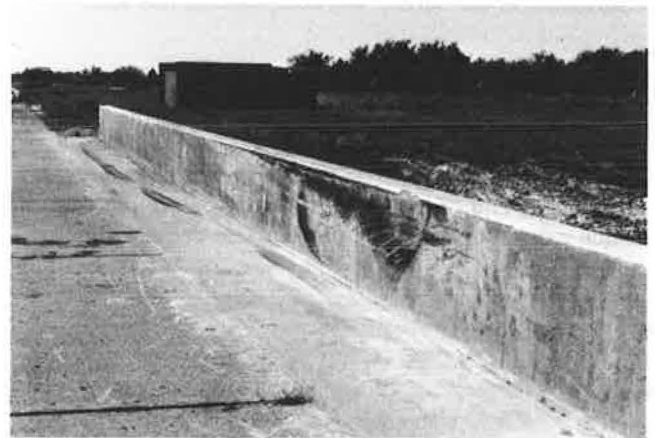
FIGURE 19 Thirty-two-in. vertical parapet after Test 7069-16.

As can be seen in Figure 19, the bridge rail sustained cosmetic damage. Tire marks on the face extended to the top edge for about 30 ft. The box of the vehicle scraped the top of the bridge rail for another 15 ft. The vehicle was in contact with the bridge rail for about 45 ft.

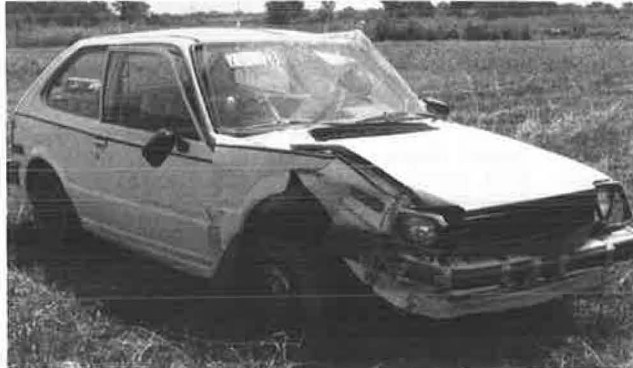
**FIGURE 22** Damage to vehicle in Test 7069-3 (1,800 lb, 60.1 mph, 21.4 degrees).

Damage to the vehicle is shown in Figure 22. Damage to the railing was cosmetic only and is shown in Figure 23.

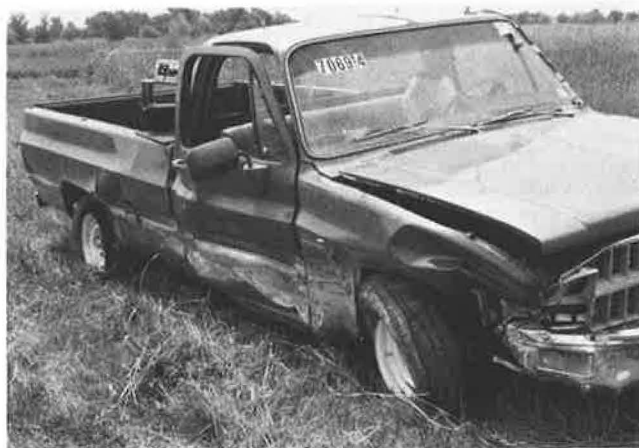
**FIGURE 25** Damage to vehicle in Test 7069-4 (5,440 lb, 65.4 mph, 20.4 degrees).

After-test photographs of the vehicle and barrier are shown in Figures 25 and 26, respectively.

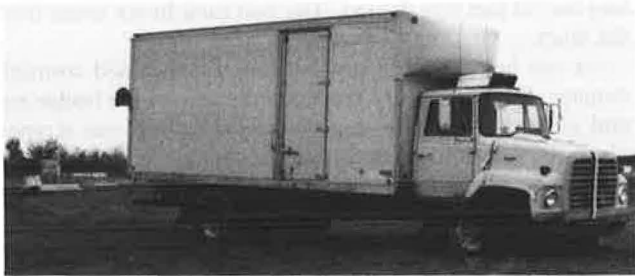
FIGURE 28 Vehicle after Test 7069-11 (18,000 lb, 52.1 mph, 14.8 degrees).

The vehicle sustained extensive damage to the right side, as shown in Figure 28. Maximum crush at the right front corner at bumper height was 20.0 in. The front axle was torn loose, which caused damage to the springs, shackles, U-bolts, and tie rods. The steering arm and cylinder were damaged and the oil pan was dented. The fuel tank broke loose from the truck.

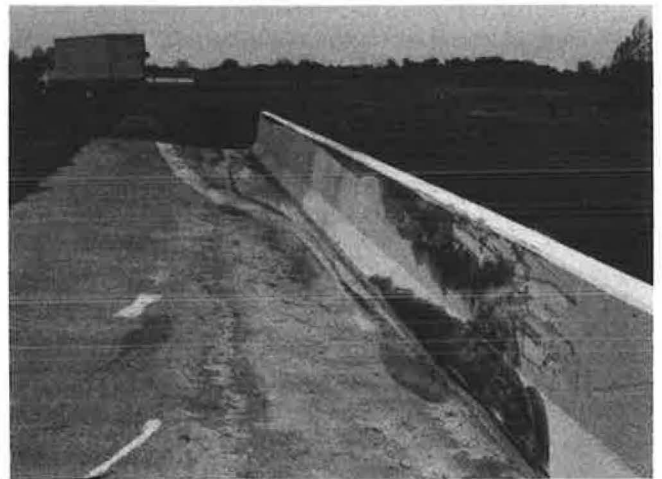
FIGURE 29 Thirty-two-in. F-shape after Test 7069-11.

As can be seen in Figure 29, the rail sustained cosmetic damage. There were tire marks on the face of the bridge rail and along the top. The top of the bridge rail was scraped along the remaining length from the lower edge of the cargo box of the truck. The vehicle was in contact with the bridge railing for 39 ft.

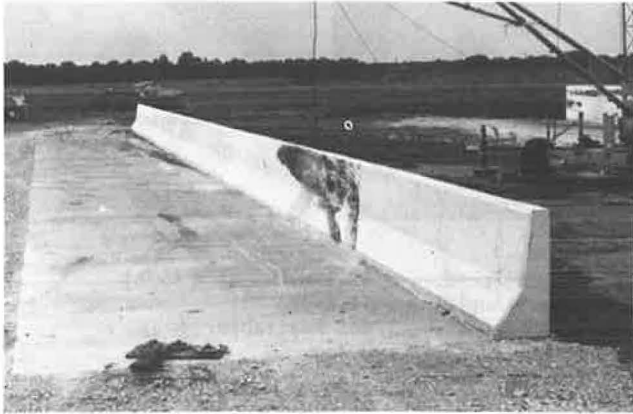
FIGURE 32 Thirty-two-in. safety shape railing after Test 7069-14.

and traveling at 35.8 mph with a heading of 0.9 degree and a trajectory of 0.9 degrees, the vehicle lost contact with the railing. The vehicle rose approximately 23 in. above the pavement. Approximately 15 ft of railing was in contact with the vehicle (Figure 32).

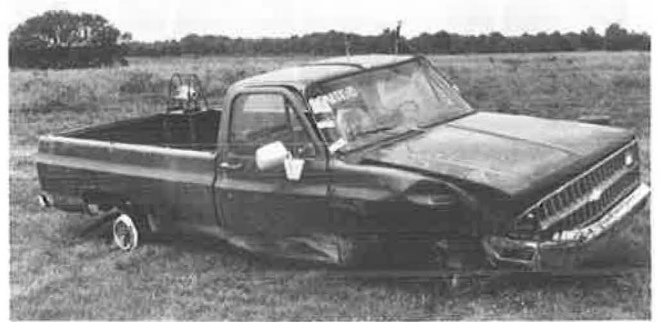
FIGURE 33 Damage to vehicle in Test 7069-14 (5,390 lb, 57.7 mph, 20.6 degrees).

Damage to the vehicle is shown in Figure 33. Maximum crush at the right front corner at bumper height was 12 in.

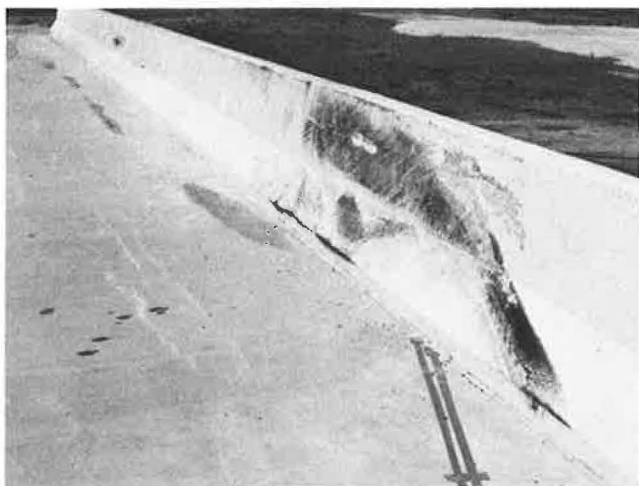
**FIGURE 35** Thirty-two-in. New Jersey safety shape railing after Test 7069-12.

As can be seen in Figure 35, the rail sustained cosmetic damage. There were tire marks on the face of the bridge rail and along the top. The top of the bridge rail was scraped along the remaining length from the undercarriage of the truck. The vehicle was in contact with the bridge rail for 77 ft.

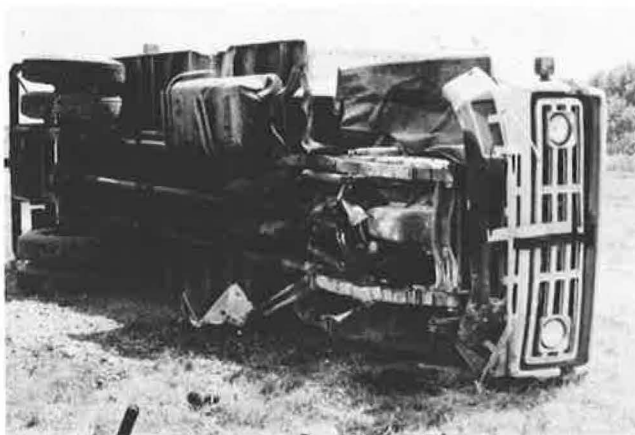
**FIGURE 36** Damage to vehicle in Test 7069-12 (18,000 lb, 51.6 mph, 15.5 degrees).

The vehicle sustained damage, as shown in Figure 36. Maximum crush at the right front corner at bumper height was 8.0 in. The front axle was torn off the vehicle and the undercarriage was damaged. There was damage to the U-bolts, Pittman arm rod, steering arm, brake lines, and leaf spring bolts. The outer right rear wheel rim was bent and the tire was damaged. The fuel tank was also damaged.
