Development of an IBC MK-7 Barrier Capable of Restraining and Redirecting an 80,000-lb Tractor Van-Trailer

T. J. HIRSCH AND KING K. MAK

This paper summarizes the results of an effort to develop an International Barrier Corporation (IBC) MK-7 barrier that can contain and redirect an 80,000-lb tractor van-trailer. After evaluation of various options, the approach of using portland cement-stabilized sand as the fill material was selected. The developmental effort included laboratory testing to determine the appropriate mix for the stabilized sand fill material, computer simulation to investigate the bending moments and shear strength required for the barrier to contain and redirect various vehicle types and weights, and full-scale crash testing of the smaller IBC MK-9 barrier with automobiles to obtain baseline data for use in developing the MK-7 truck barrier. A mix of 100 lb sand, 10 lb portland cement, and 10 lb water was selected for use as the fill material for the IBC MK-7 truck barrier. The barrier was struck by an 80,000-lb tractor van-trailer at 50.9 mph and 15.0 degrees. The tractor-trailer was contained and smoothly redirected by the barrier. The tractor-trailer rolled co

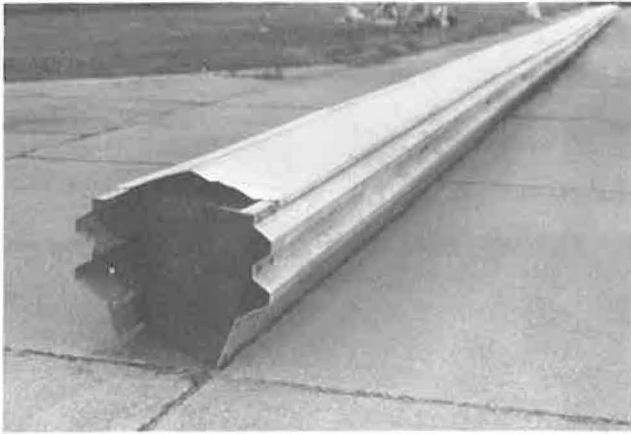
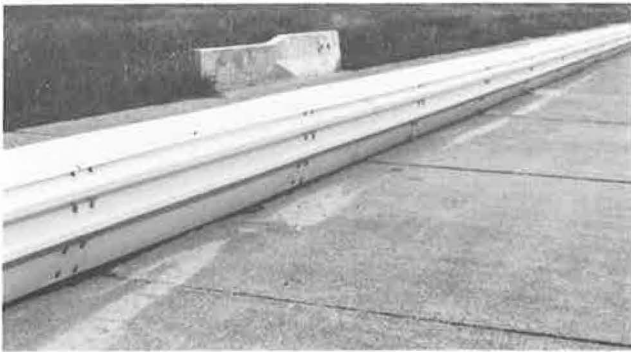
FIGURE 3 MK-9 barrier test installation.

was 189 ft. The first installation was filled with untreated sand and the second installation was filled with portland cement-stabilized sand, except for the bottom 2 to 3 in., which consisted of untreated sand to prevent the stabilized fill material from bonding with the pavement surface. The dimensions and details of the IBC MK-9 barrier are shown in Figure 2. Photographs of the test installation are shown in Figure 3.

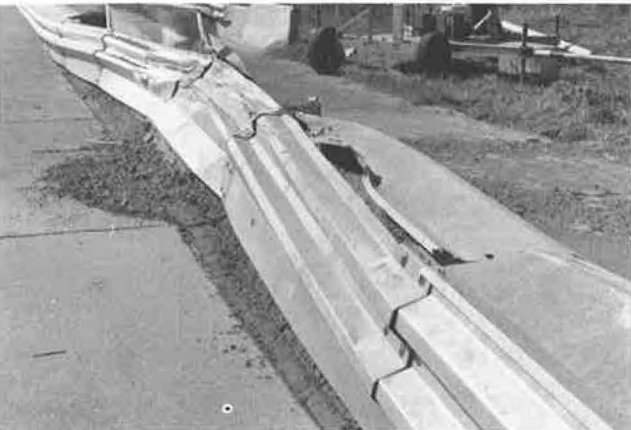
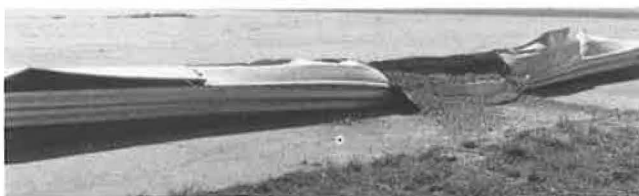
FIGURE 4 MK-9 barrier after Test 7091-2.

The barrier sustained severe damage, as shown in Figure 4. The permanent residual deformation was 29.0 in. laterally, located approximately 5 ft from the point of initial impact. The vehicle was in contact with the rail for 22.5 ft.

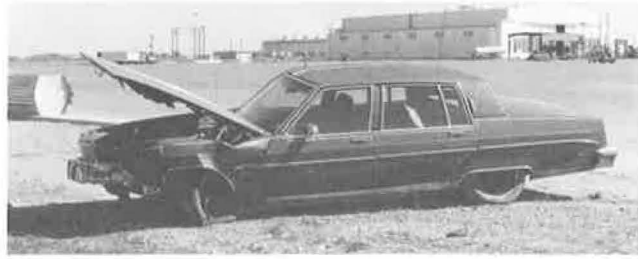
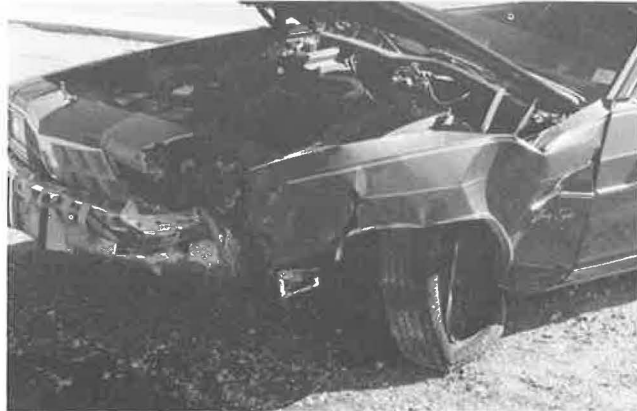
FIGURE 5 Vehicle after Test 7091-2.

The vehicle sustained severe damage, as shown in Figure 5. Maximum crush was 13.0 in. at the left front corner of the vehicle. The left front wheel and control arm were severely bent and pushed rearward 9.0 in., causing damage to the floor pan under the driver's feet. The entire left side of the vehicle was dented and scraped. There was also considerable damage to the hood, bumper, grill, and radiator.

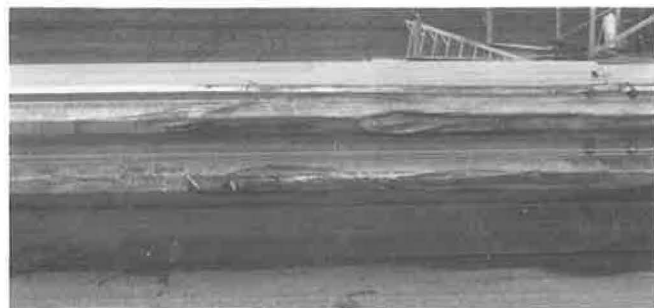
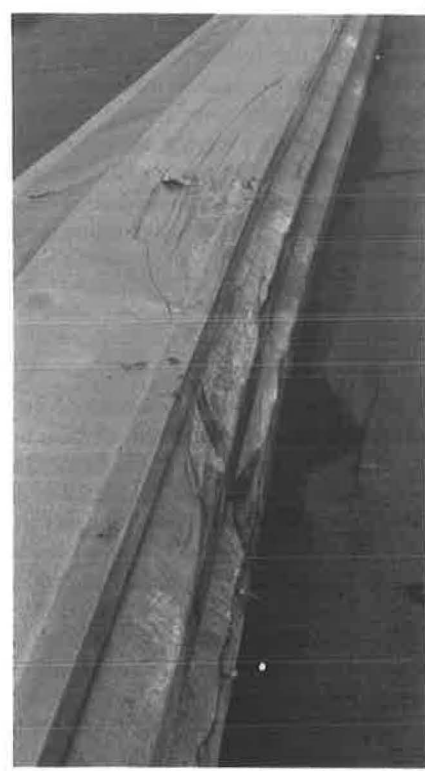
FIGURE 7 MK-9 barrier after Test 7091-10.

The barrier sustained minor damage as shown in Figure 7. The maximum permanent residual deformation to the barrier was 1.0 in. laterally. The barrier moved laterally 4.5 in. on impact. The vehicle was in contact with the barrier for 14.0 ft.

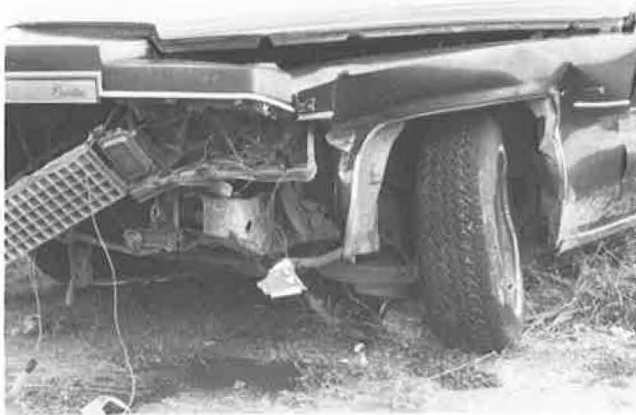
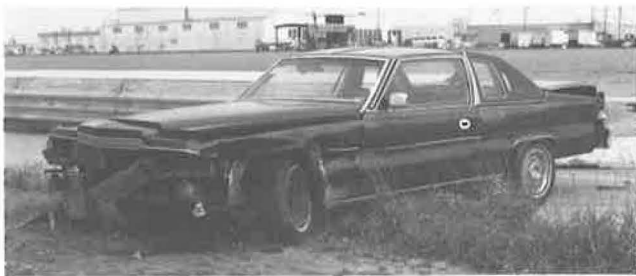
FIGURE 8 Vehicle after Test 7091-10.

The vehicle sustained severe damage, as shown in Figure 8. Maximum crush was 16.0 in. at the left front corner of the

vehicle. The left front wheel was severely bent and pushed rearward 4.3 in. In addition, the subframe was bent. The entire left side of the vehicle, including the front and rear fenders and the door, was dented and scraped. The entire front end of the vehicle sustained considerable damage.

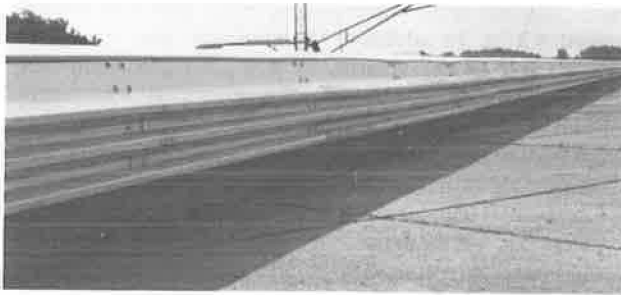
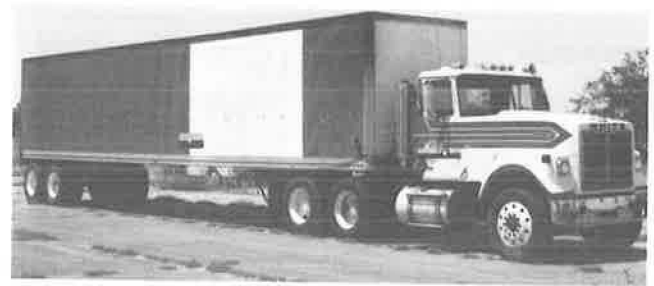
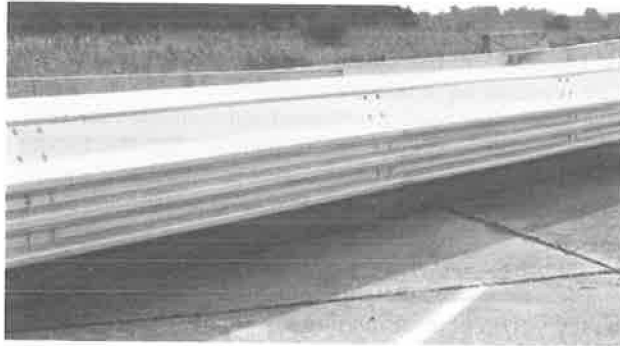
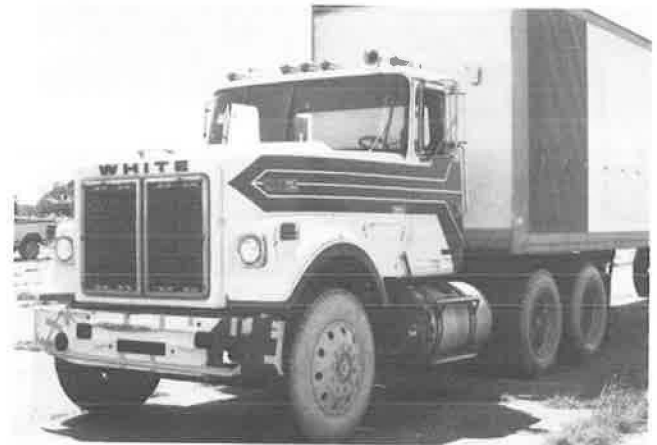
FIGURE 10 IBC MK-7 barrier test installation.

FIGURE 11 Tractor-trailer before Test 7132-1.

346.5 ft. The barrier modules were filled with portland cement-stabilized sand and the sand was mechanically compacted. The stabilized sand consisted of pit run sand mixed with 10 percent portland cement with a 10 percent moisture content (i.e., 100 lb sand mixed with 10 lb portland cement and 10 lb water). The test installation was placed directly on a concrete pavement surface with no anchorage to the pavement. A layer of untreated sand 2 to 3 in. high was placed at the bottom of the test barrier installation. The purpose of using a layer of untreated sand was to prevent the stabilized sand from bonding with the pavement surface. Photographs of the test installation are shown in Figure 10.

The crash test procedures were generally in accordance with guidelines presented in *NCHRP Report 230*. The test tractor was a 1979 White Road Boss with an empty weight of 16,240 lb. The trailer was a Theurer enclosed van-trailer with an empty weight of 13,060 lb. The combined tractor-trailer empty weight was 29,480 lb. Photographs of the tractor-trailer are shown in Figure 11.

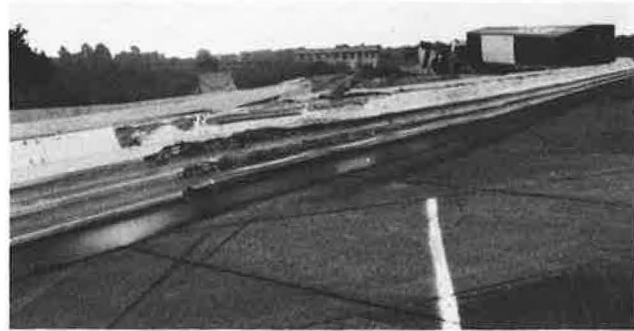
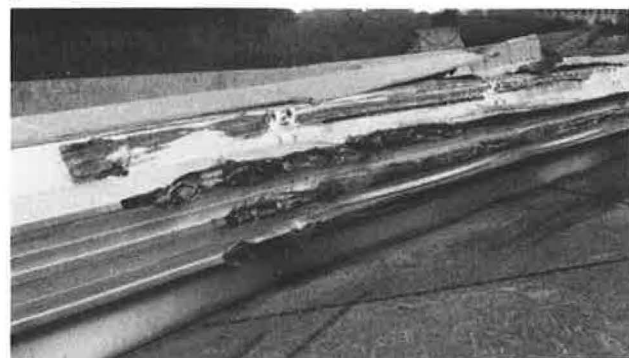
FIGURE 13 IBC MK-7 barrier after Test 7132-1.

The barrier sustained minor damage as shown in Figure 13. The maximum permanent residual deformation to the barrier was 4.0 in. and the maximum permanent lateral movement was 7.0 in. The stabilized sand fill material remained basically intact after the impact with only localized areas of crushing. Although the vehicle was in contact with the barrier for 239.0 ft, the major damage to the barrier was confined to the first three modules (or roughly 30 ft) downstream from the point of initial impact. Damage to the other modules was limited to scrapes and tears of the side panels as the tractor-trailer slid along the barrier to its final rest position.

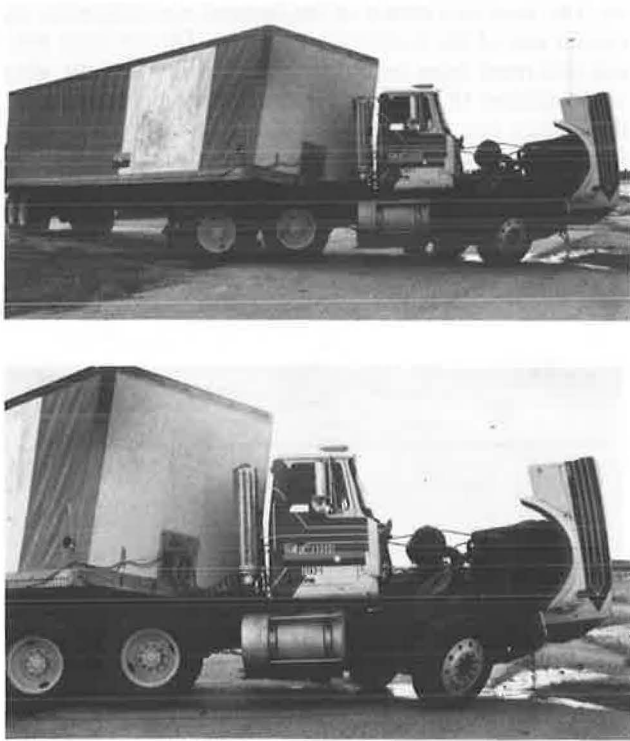
FIGURE 14 Tractor-trailer after Test 7132-1.

The vehicle sustained severe damage, as shown in Figure 14. The front left corner of the bumper was deformed, and the left side of the tractor was damaged. The left front wheel was deformed from impact with the barrier, and the wheel was displaced 18 in. rearward from its normal position into the battery box. The rearward displacement was a result of the fracturing of one right-side and both left-side U-bolts, which mount the front axle to the front leaf springs. The lower left front and upper right front shock absorber mounts were

separated from the axle assembly, and the pitman arm separated from the steering assembly as the axle was displaced rearward. The battery box was deformed and displaced rearward into the front surface of the left fuel tank, but the fuel tank remained intact with only minor deformations.

The trailer sustained direct contact damage along the entire lower left side. The left rear suspension mounting rail was fractured, allowing the floor to drop down approximately 22.8 in., forming a V-shaped left side surface. The left wall of the trailer shifted to the left approximately 40 in. (when viewed from the rear) and separated from the roof structure at the top joint. The right wall was deformed slightly due to induced damage. Both left outer tires on the trailer axles were deflated and the rims were damaged extensively. The trailer landing gear also sustained minor damage.
