TRANSPORTATION RESEARCH

No. 1258

Highway and Facility Design

Roadside Safety 1990

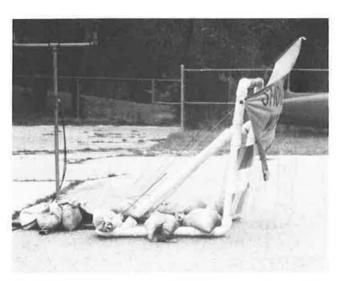
FIGURE 3 Phase 2 wind test with 1-ft-clearance vinyl sign at 69 mph.

As Table 2 shows, the 1-ft-clearance vinyl sign passed this wind test as well (Figure 3). Whereas the 5-ft-clearance vinyl sign endured the test (Figure 4), the aluminum sign failed when the frame separated with the wind into the sign. The 7-ft-clearance aluminum sign frame failed when the top Y fitting fractured (Figure 5).

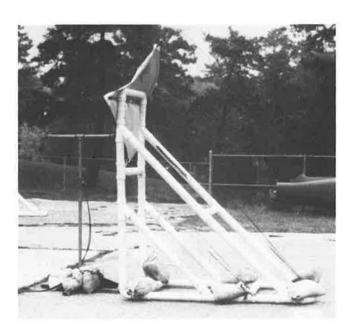
FIGURE 4 Phase 2 wind test with 5-ft-clearance vinyl sign at 63 mph.

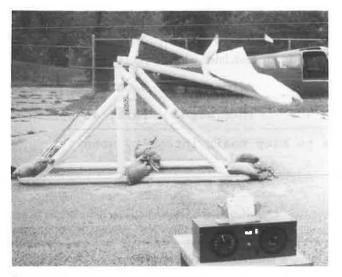
FIGURE 5 Phase 2 wind test with 7-ft-clearance aluminum sign at 46 mph.

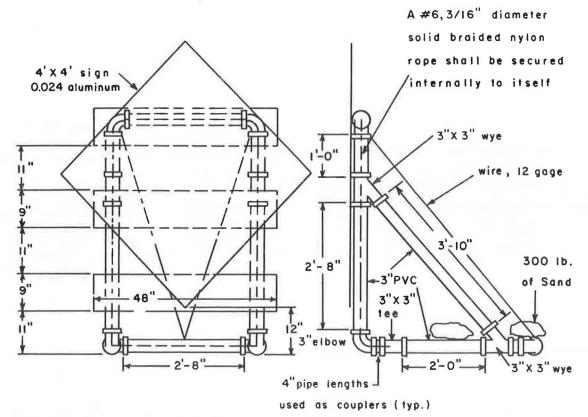
FIGURE 6 Aluminum sign on barricade with 12 in. of clearance.

Based on the results of the wind tunnel tests, additional changes were made to make the sign frames more durable. The springs that provided tension for the wires used on the standard barricade were removed because they allowed too much flexing under wind loads. The springs were also judged to be hazardous because they tended to come loose and become projectiles when adjusted by workers. The wires were pulled tight to provide tension. The aluminum sign clearances were reduced to 12, 29, and 41 in., and the vinyl sign clearances were reduced to 21, 38, and 50 in. The 29- and 38-in.-clearance signs were attached to barricades extended up 1 ft, and the 41- and 50-in.-clearance signs were attached to barricades extended up 2 ft. The vinyl signs were 9 in. higher than the aluminum signs because the vinyl signs had their own support systems. See Figures 6 through 11 for details.

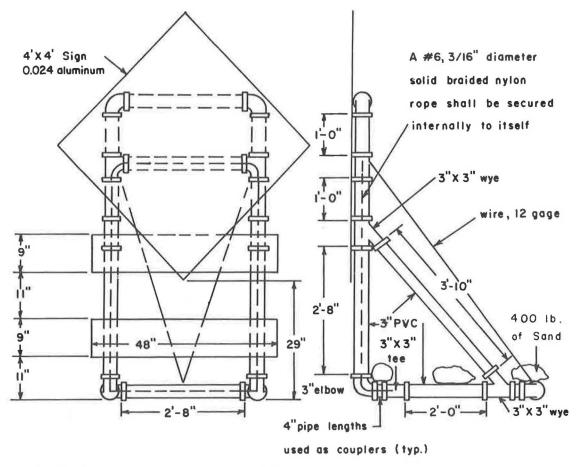
All dimensions on full pipe length Socket depth of fittings I $\frac{1}{2}$

FIGURE 7 Aluminum sign on barricade with 29 in. of clearance.

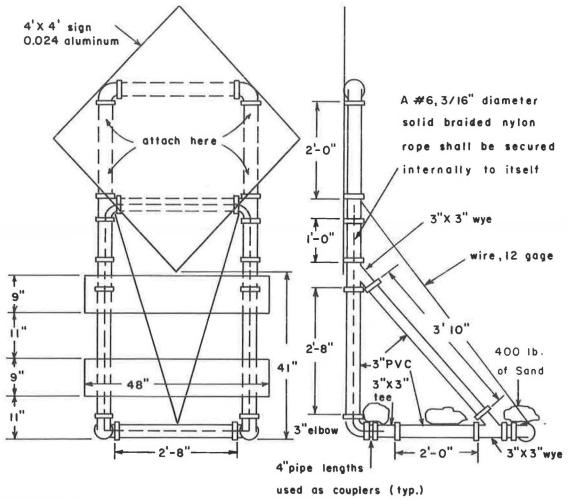
All dimensions on full pipe length. Socket depth of fittings is $1\frac{1}{2}$ ".

FIGURE 8 Aluminum sign on barricade with 41 in. of clearance.

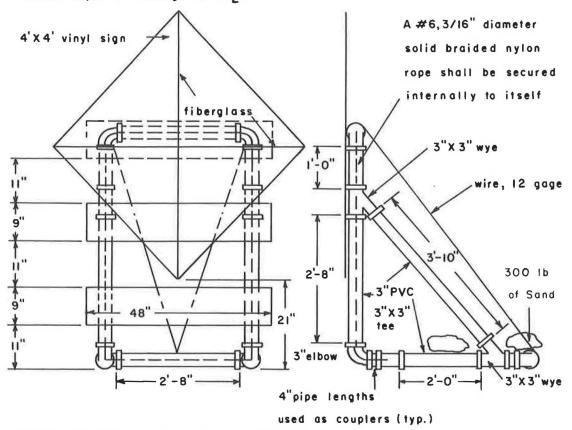
All dimensions on full pipe length. Socket depth of fittings is $1 \frac{1}{2}$ ".

FIGURE 9 Vinyl sign on barricade with 21 in. of clearance.

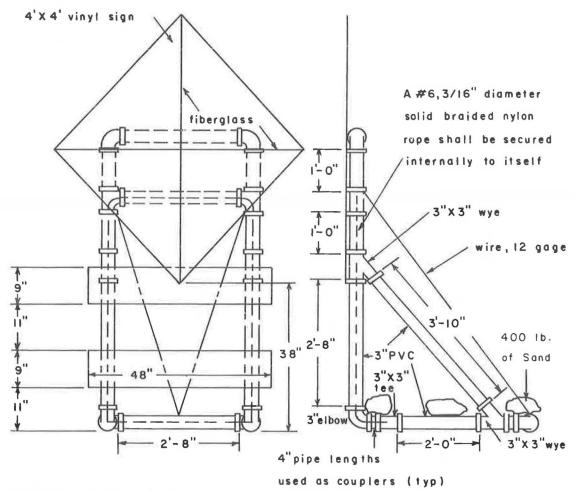
All dimensions on full pipe length Socket depth of fittings is $1\frac{1}{2}$ "

FIGURE 10 Vinyl sign on barricade with 38 in. of clearance.

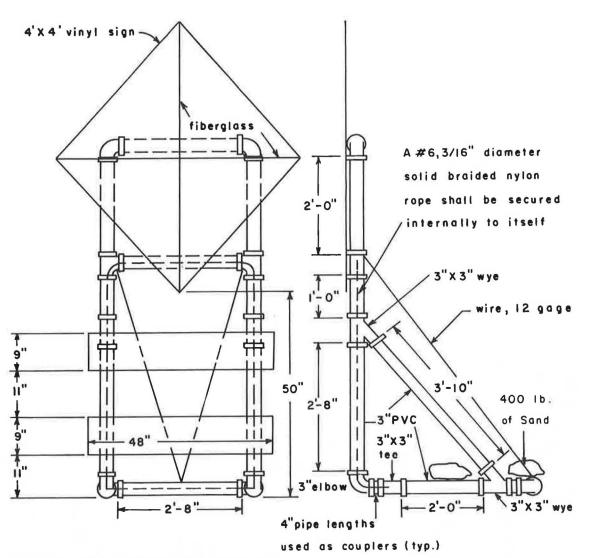
All dimensions on full pipe length. Socket depth of fittings is $1\frac{1}{2}$ ".

FIGURE 11 Vinyl sign on barricade with 50 in. of clearance.

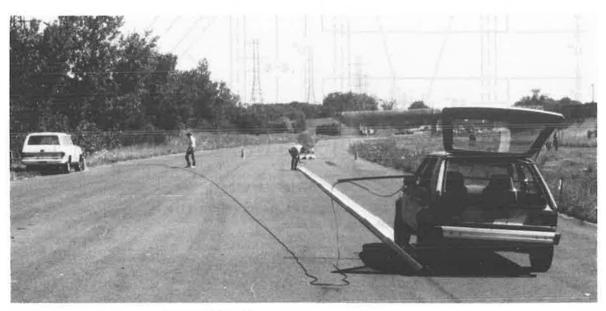
FIGURE 12 Preliminary crash test vehicle guidance system.

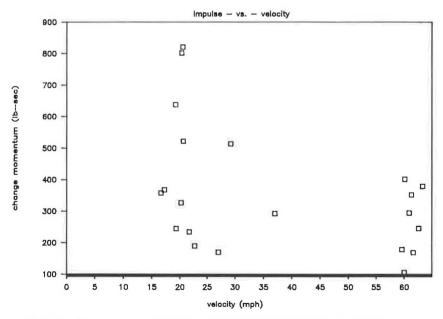
FIGURE 1 Breakaway connections—change in momentum versus velocity.

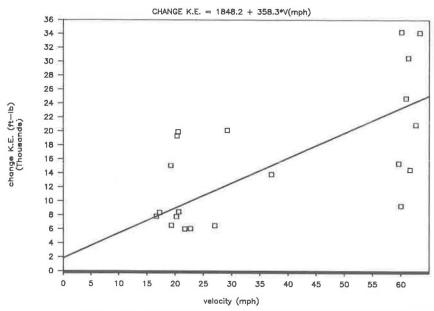
FIGURE 2 Breakaway connections—change in kinetic energy versus velocity.

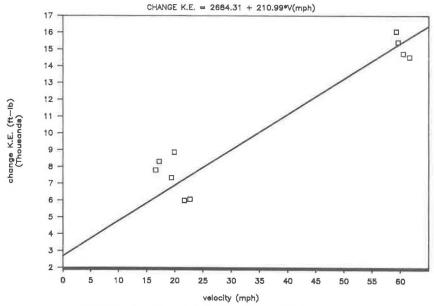
FIGURE 3 Breakaway steel U-post (3 lb/ft)—change in kinetic energy versus velocity.

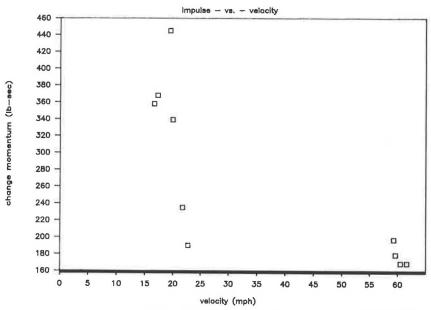
FIGURE 4 Breakaway steel U-post (3 lb/ft)—change in momentum versus velocity.

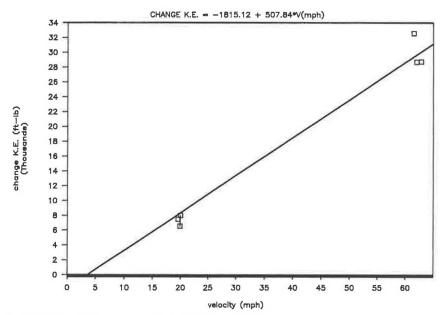
FIGURE 5 Nonbreakaway steel U-post (3 lb/ft)—change in kinetic energy versus velocity.

The 3-lb/ft nonbreakaway U-posts (Figure 5) and the sets of 4-lb/ft U-posts (Figures 6 and 7) exhibit similar linear behavior. It was noted that the line for the nonbreakaway systems was generally steeper than for the breakaway systems. The greater slope corresponded to the greater stiffness of the nonbreakaway systems.

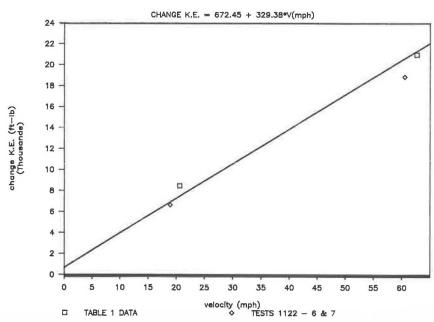
FIGURE 6 Breakaway steel U-post (4 lb/ft)—change in kinetic energy versus velocity.

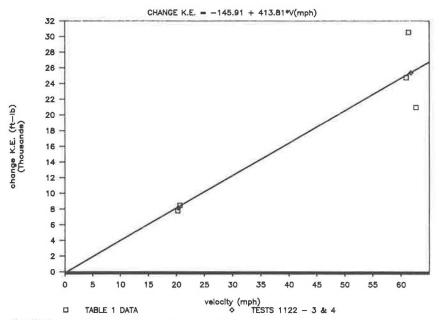
FIGURE 7 Nonbreakaway steel U-post (4 lb/ft)—change in kinetic energy versus velocity.

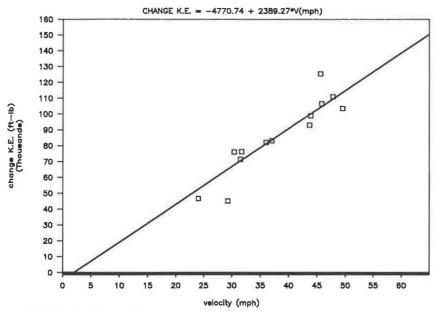
FIGURE 8 Steel U-post (8 lb/ft)—change in kinetic energy versus velocity.

During the data search, many data points were found for 8-lb/ft U-post systems. The data were plotted in Figure 8 because of the number of data points and the variety of impact speeds even though this system is no longer used. Figure 8 clearly illustrates the linear relationship between impact velocity and change in kinetic energy. Two additional graphs are included with linear relationships. The $2\frac{1}{2}$ -in. pipe with frangible connectors, Figure 9, and the 2-in. \times 2-in. square perforated steel tube, Figure 10, exhibit good approximations to linear relationships.

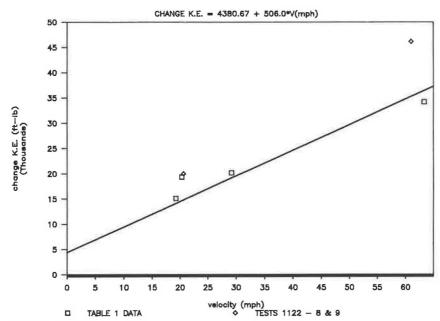
FIGURE 9 Breakaway $2\frac{1}{2}$ -in. standard steel pipe—change in kinetic energy versus velocity.

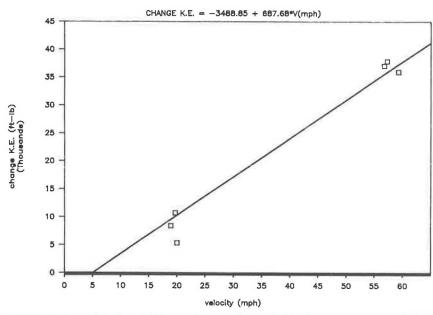
FIGURE 10 Unistrut post (2 in. × 2 in.)—change in kinetic energy versus velocity.

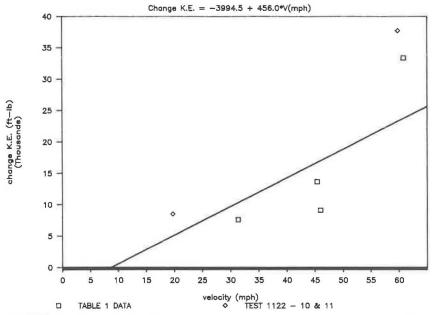
FIGURE 11 Change in kinetic energy versus velocity for 3-in. pipe on triangular slip base—linear relationship.

One other system, a 3-in. pipe on a triangular slip base, is shown in Figure 11. This is certainly a breakaway system, but

The final set of tests, 10 and 11, involved a 3-in. pipe tree mounted on a triangular slip base. The changes in velocity were calculated using the linear and the cubic fits from Figures 11 and 12, respectively. As originally thought, the linear fit

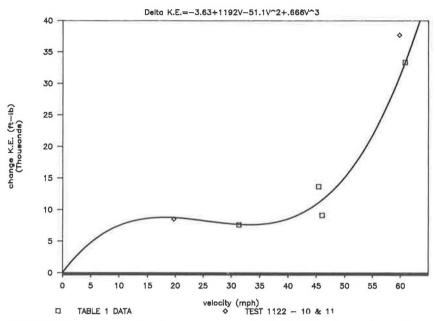
FIGURE 12 Change in kinetic energy versus velocity for 3-in. pipe on triangular slip base—cubic relationship.

it differs from all the others considered in its failure mechanism. This system uses friction to facilitate breakaway. Such a difference could mean that the relationship between velocity and change in kinetic energy is not linear but perhaps cubic, as indicated in Figure 12. Considering the limited number of data points available, it would be inappropriate to use any "recommended" best-fit curve for this system.

The one notable exception to the linear fit was the triangular slip base. This system, because of its unique failure mechanism, is more appropriately modeled by a cubic equation of best fit. Including the new test data would certainly improve the predictions; however, use of the current cubic equation is not recommended.

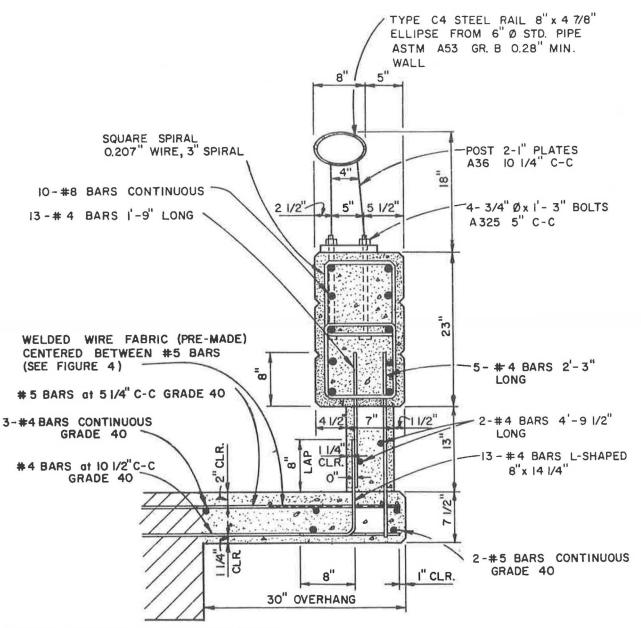
FIGURE 1 Cross section of modified C202 bridge rail.

The rail was a modification of the concrete parapet, Texas traffic rail type C202. The modified C202 rail consisted of a concrete beam element 13 in. (33 cm) wide and 23 in. (58 cm) deep, mounted 36 in. (91 cm) high on concrete posts located at 10-ft (3-m) center-to-center spacing. The posts were concrete walls 7 in. (19 cm) thick \times 5 ft (1.5 m) long with 5-ft (1.5-m) openings. The beam element contained considerable reinforcing steel and provides flexibility, thus minimizing cracking of the concrete when struck by heavy vehicles. The modified C202 concrete parapet can be placed in lengths that give good structural continuity and strength.

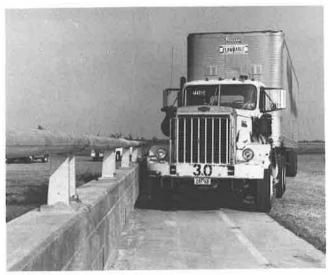
FIGURE 3 Comparison of 80,000-lb truck with modified combination rail.

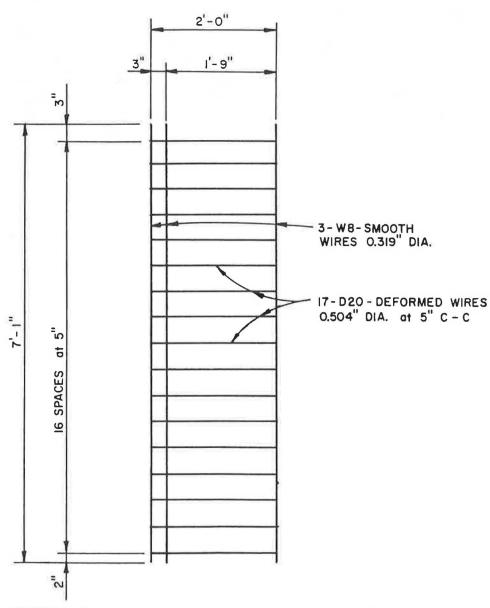
$FIGURE\ 4\quad Detail\ of\ special\ slab\ reinforcement\ used\ under\ each\ concrete\ post.$

To increase the effective height of this bridge rail, another standard Texas steel rail, designated C4, was mounted on top of the concrete rail. The bridge deck strength was also increased to minimize cracking or damage when the bridge rail is struck by a heavy vehicle.

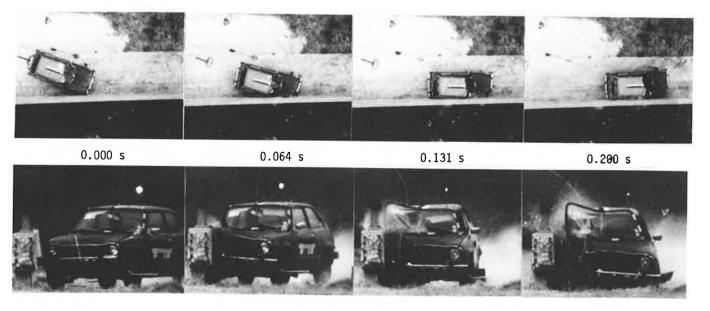
Test No	11/24/87	Impact Speed 61.3 mi/h (98.6 km/h) Impact Angle 21.0 deg
Test Installation	C202 Bridge Rail with C4 Steel Rail	Exit Speed
Length of Installation Vehicle	101 ft (31 m)	Vehicle Accelerations at C.G. (Max. 0.050-sec Avg)
Vehicle Weight		Longitudinal10.2 g
Test Inertia	1,750 lb (795 kg) 1,918 lb (871 kg)	Lateral +14.0 g Occupant Impact Velocity
Vehicle Damage Classification TAD	01RF05	Longitudinal 23.3 ft/s (7.1 m/s) Lateral 25.7 ft/s (7.8 m/s)
CDC		Occupant Ridedown Accelerations
		Longitudinal 2.0 g Lateral

FIGURE 7 Summary of results for Test 1179-1.

The Honda struck the rail at 61.3 mph (98.6 km/hr) at a 21-degree angle. The impact occurred 7.0 ft upstream of Post 11 and was smoothly redirected. The exit angle of the Honda was only 0.6 degrees, and the car would have remained on the right-hand shoulder and not reentered the traffic lanes. Figure 6 shows the bridge rail and test site immediately after Test 1179-1. The Honda sustained damage to the right front and right side. The right front tire came in contact with Post 11, which can be seen in Figure 6. This contact caused some damage to the front right wheel and suspension; however, the wheel was still rolling after impact. An anthropomorphic dummy was placed in the driver's seat for this test. A summary of the crash test data is shown in Figure 7.

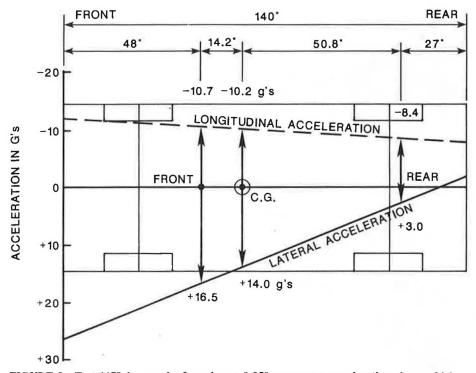
FIGURE 8 Test 1179-1—graph of maximum 0.050-sec average acceleration along vehicle length at 0.050 sec after impact.

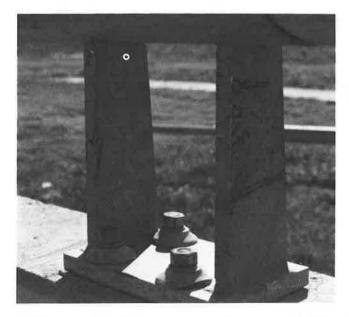
FIGURE 12 Damage to upper and lower Post 11 after Test 1179-2.

The Cadillac struck 5 ft upstream of the leading edge of the concrete post and 7 ft upstream of the leading edge of the steel post. The Cadillac wheel did not contact the concrete post, and the damage to the wheel and suspension was moderate. The wheel was still rolling after impact, and the vehicle trajectory was good with a departure angle of only 2.0 degrees. The hood contacted the steel post and was severely damaged. The hood pushed the right front windshield inward several inches but it did not intrude into the passenger compartment. Consequently, the Cadillac test was judged successful.

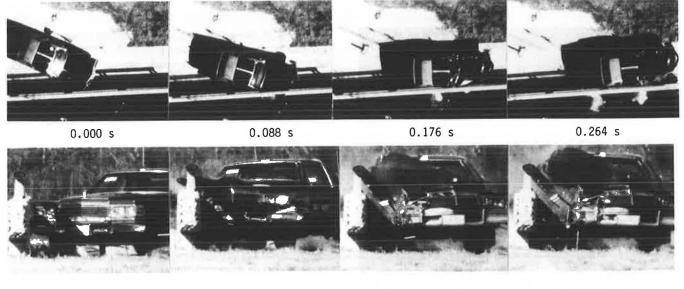
FIGURE 13 Summary of results for Test 1179-2.

Test No		Impact Speed 59.4 mi/h (95.6 km/h)
Date	12/01/87	Impact Angle 25.9 deg
Test Installation	C202 Bridge Rail	Exit Speed
	with C4 Steel Rail	Exit Angle 2.0 deg
Length of Installation	101 ft (31 m)	Vehicle Accelerations at C.G.
Vehicle	1979 Cadillac	(Max. 0.050-sec Avg)
Vehicle Weight		Longitudinal9.7 g
Test Inertia	4,400 lb (1,998 kg)	Lateral +14.3 g
Vehicle Damage Classification		Occupant Impact Velocity
TAD	01RFQ6	Longitudinal 23.9 ft/s (7.3 m/s)
CDC	01RYAS4	Lateral 27.3 ft/s (8.3 m/s)
		Occupant Ridedown Accelerations
		Longitudinal4.9 g
		lateral = 16.7 g

The Cadillac struck the rail at 59.4 mph (95.6 km/hr) and at a 25.9-degree angle. Impact occurred 7.5 ft upstream of Post 11 and was smoothly redirected. Figure 11 shows the bridge rail and test site immediately after Test 1179-2. The Cadillac sustained damage to the right front and right side. The right front tire made light contact with concrete Post 11 and the hood came in contact with the metal post directly above concrete Post 11, as shown in Figure 12. This contact caused slight damage to the front right tire and suspension; however, the wheel was still rolling after contact. Severe damage to the hood resulted when it struck the steel post. The impact cracked the right front windshield, which is shown in Figure 10. The hood pushed the windshield inward several inches but did not penetrate the passenger compartment. A summary of the crash data is shown in Figure 13.

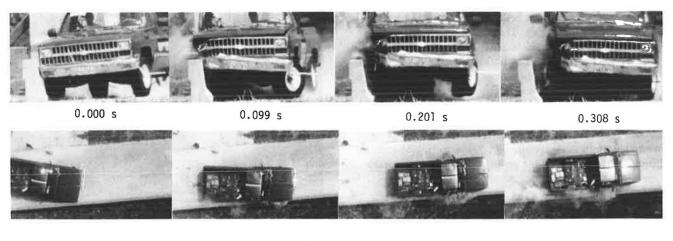
Test No. 7069-4 Date . 7/30/87 Test Installation . . 32 in F-Shape Bridge Rail Installation Length 100 ft (30 m) Vehicle 1981 Chevrolet Pickup Vehicle Weight Test Inertia . . . 5,440 lb (2,470 kg) Gross Static . . . 5,780 lb (2,624 kg) Vehicle Damage Classification TAD 01RD4 Maximum Vehicle Crush 5.0 in (12.7 cm)

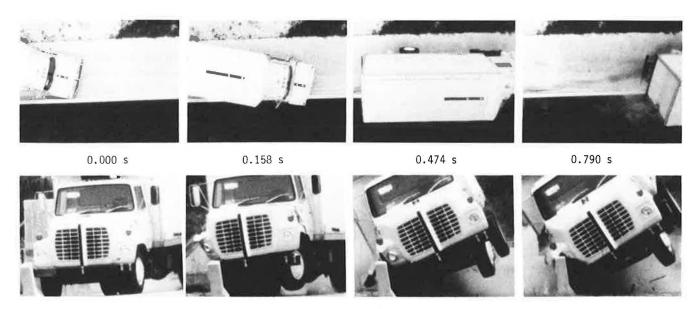
FIGURE 30 Summary of results for Test 7069-11.

Test No. 7069-11 Date 3/30/88 Test Installation . . 32 in F-Shape Bridge Rail Installation Length. . 100 ft (30 m) Vehicle 1982 Ford 7000 Single-Unit Truck

Impact Speed. . . 52.1 mi/h (83.8 km/h)
Impact Angle. . . 14.8 deg
Exit Speed. . . Not Available
Exit Trajectory . 0 deg Vehicle Accelerations (Max. 0.050-sec Avg) Longitudinal. . -1.4 g Lateral 3.9 g Occupant Impact Velocity
Longitudinal. 5.7 ft/s (1.7 m/s)
Lateral . . . 8.2 ft/s (2.5 m/s) Occupant Ridedown Accelerations Longitudinal. . 1.3 g Lateral 5.4 g

The exit speed was not available. Exit angle was about 0 degree. The effective coefficient of friction was calculated to be 0.12. Occupant impact velocity was 5.7 ft/sec in the longitudinal direction and 8.2 ft/sec in the lateral direction. The highest 0.010-sec occupant ridedown accelerations were 1.3 g (longitudinal) and 5.4 g (lateral). These data and other pertinent information from the test are summarized in Figure 30.

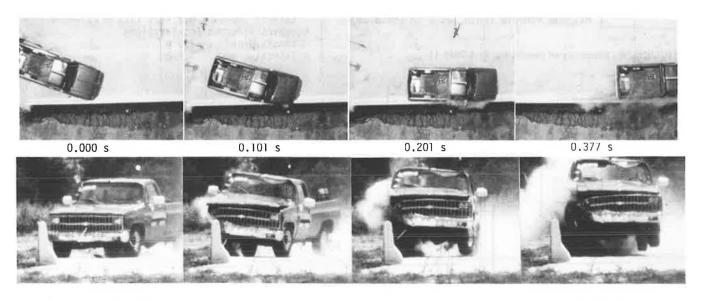
```
Impact Speed. . . 57.7 mi/h (92.8 km/h)
Impact Angle. . . 20.6 deg
Exit Speed. . . . 35.8 mi/h (57.6 km/h)
Exit Trajectory . 0.9 deg
Vehicle Accelerations
(Max. 0.050-sec Avg)
Longitudinal. . -6.6 g
Lateral . . . 7.3 g
Occupant Impact Velocity
Longitudinal. . 17.8 ft/s (5.4 m/s)
Lateral . . . 18.7 ft/s (5.7 m/s)
Occupant Ridedown Accelerations
Longitudinal . -5.1 g
Lateral . . . 9.2 g
```

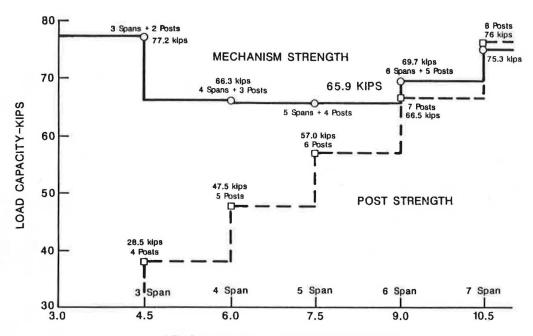
FIGURE 4 Failure mechanism analysis for Texas Type T411 bridge rail.

LENGTH OF FAILURE MECHANISM-FEET

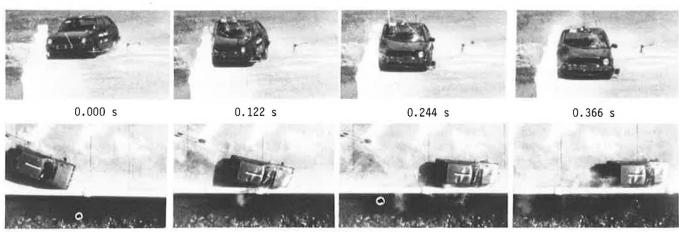
FIGURE 10 Summary of results for Test 1185-1.

Impact Speed . . . 60.2 mi/h
Impact Angle . . . 21.2 degrees
Speed at Parallel . 39.3 mi/h
Exit Speed . . . 30.2 mi/h
Exit Trajectory . . 0 degrees
Vehicle Accelerations
(Max. 0.050-sec Avg)
Longitudinal . . -13.5 g
Lateral 11.3 g
Occupant Impact Velocity
Longitudinal . . 28.6 ft/s
Lateral 16.6 ft/s
Occupant Ridedown Accelerations
Longitudinal . . -2.0 g
Lateral . . . 3.6 g

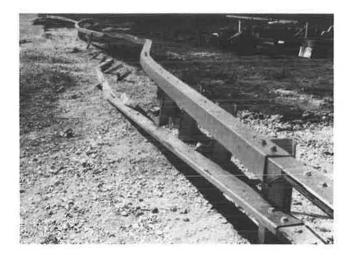
FIGURE 9 Barrier and vehicle damage after Test 0382-2.

The box-beam guardrail and transition treatment sustained only minor damage, as shown in Figure 9. The first seven posts downstream from the point of impact (Posts 5 through 9 of the transition treatment and Posts 10 and 11 of the box-beam guardrail) were bent over and separated from the upper and lower rails. The next four posts (Posts 1 through 4 of the

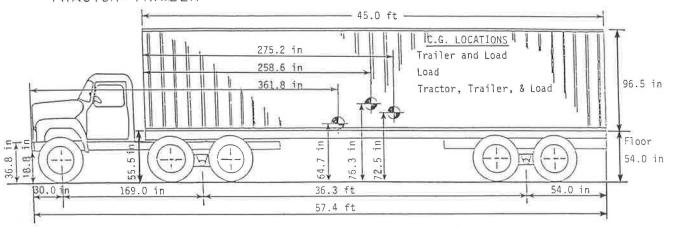
1979 Road Boss Theurer Enclosed Van-Trailer

TRACTOR - TRAILER

Weight on front axle	8,720
Weight on center axles	11,920
Weight on rear axles	8.840
Total Empty Weight	29,480

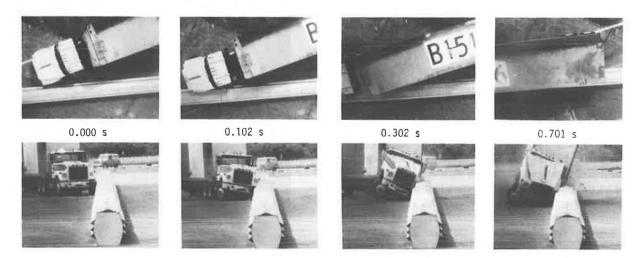
FIGURE 15 Summary of results for Test 7132-1.

Test No			7132-1
Date			05/31/89
Test Installation		e.	IBC MK-7 Median
			Barrier w/stabilized
			fill material
Installation Length			346.5 ft (105.6 m)
Vehicle			1979 White Road Boss
			Tractor w/van-trailer
Vehicle Weight			
Test Inertia			80,000 lb (36,287 kg)

Sequential photographs, a summary of the test results, and other information pertinent to this test are given in Figure 15. The maximum 0.050-sec average accelerations experienced by the tractor-trailer at the various accelerometer locations along the tractor-trailer are summarized in Table 1. For instance, the maximum 0.050-sec average acceleration experienced by the tractor near the fifth wheel was $-5.4 \, g$ in the

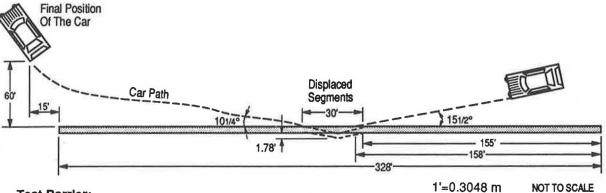
FIGURE 9 Summary of data for Test 444.

Minor scratches at the area of contact with test car Barrier Damage:
