# Underwater Inspection of Bridges— Overview of a Statewide Program

R. RICHARD AVENT AND MARSHALL D. WHITMER III

A comprehensive statewide underwater bridge inspection program was conducted for the state of Mississippi. A total of 229 bridges on the federal-aid system were inspected. An overview of the inspection program is presented. The average number of bents or piers inspected per bridge was four, excluding four long bridges that averaged 235 bents or piers each. The type of inspection equipment, inspection methodology, and evaluation process used are described. The inspections were conducted by two three-man commercial diving teams under the on-site direction of a professional engineer. Before the project, the divers were required to take a 1-week course on bridge inspections that included a field dive. The overall condition of the underwater portions of the bridges on the federal-aid system was good. Less than 10 bents or piers out of nearly 1,900 inspected needed immediate attention. Only 6 percent were found to require remedial action over the next several years. Although a few scour problems were found, none were serious enough to immediately threaten the integrity of a

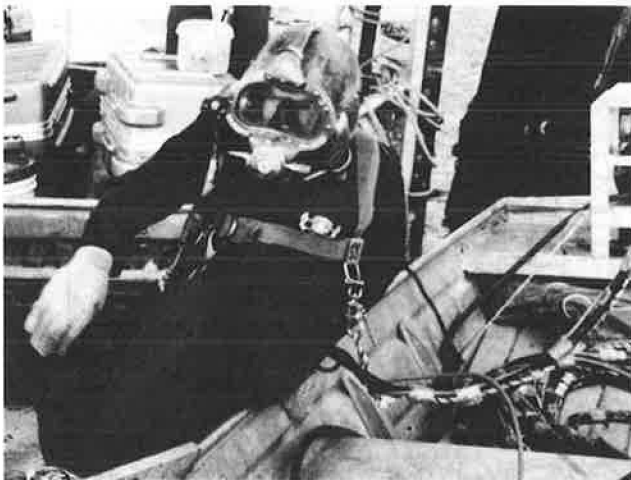
FIGURE 2 Outfitted diver entering water.

The dive teams used commercial diving equipment. A compressor provided surface air to the diving hats. Two-way communication was maintained at all times through a communication line. A volume tank provided a reservoir of air and was connected with a pneumo tube that enabled the diver to measure water depths. The diver was equipped with various hand tools for inspection including a light, scraper, knife, calipers, incremental borer used for timber piles, and rule. In general, access to the bents or piers was from a motor launch. For some of the small streams, the access was from the shore. An outfitted diver and the launch equipment are shown in Figures 2 and 3.
