Using Strip Films To Record Pavement Distress in the Strategic Highway Research Program: Long-Term Pavement Performance Study

HERNÁN DE SOLMINIHAC AND HARVEY ROPER

The system recommended by the researchers to the Long-Term Pavement Performance (LTPP) studies of the Strategic Highway Research Program for the collection and storage of surface distress data is described. Specifically, the distress acquisition system, film interpretation system, quality assurance plan, certification procedure for Pavement Distress Analysis System operators, and, finally, how the system benefits the LTPP study are described. There are several advantages to using this system: it is semiautomatic and provides a permanent record of the pavement surface; in addition, work is performed exclusively at night, ensuring that there will be a minimum of traffic interference. Films provide additional information for the LTPP studies; that is, a complete picture of each site is available at the office. Such a capability allows the engineers not only to analyze pavement distress, but to perform quality control of the test sites as well (e.g., inspecting the locations of the weigh-in-motion and automatic vehicle cou

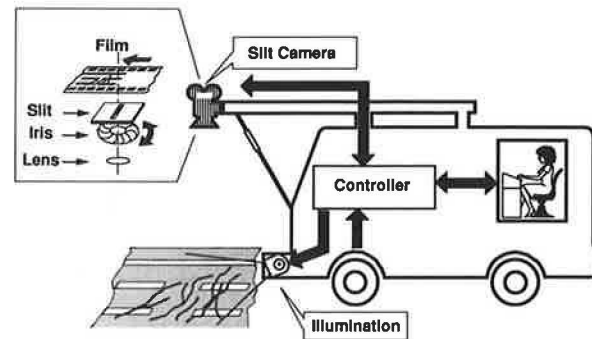
FIGURE 2 ROADRECON-70 for condition survey (3).

Designed exclusively for night operation, the RR-70 system consists of a 35-mm slit camera, lighting equipment, a power source, and a remote control device—all mounted on a bus-sized cargo van (see Figure 2). The camera is installed at a height of 10 ft perpendicularly facing the road surface. The lighting equipment is mounted in a position in geometric relation to the camera. The photographing scale is 1:200.

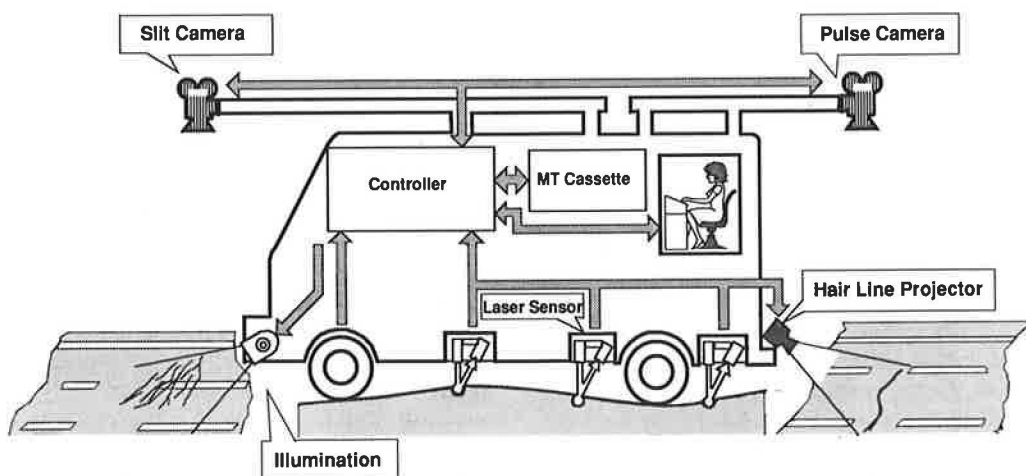
FIGURE 1 ROADRECON vehicle (3).

The distress acquisition system vehicle—properly termed the Roadrecon pavement photographing system vehicle—was developed by PASCO Corporation of Japan in 1970 (see Figure 1). While traveling at speeds of 5 to 55 mph, this van (weighing nearly 5 tons and running on diesel fuel) takes continuous photographs for distress information, and pulsed photographs for rut depth surveys. Two components of the system—the RR-70 and RR-75 subsystems—perform these photographic functions.

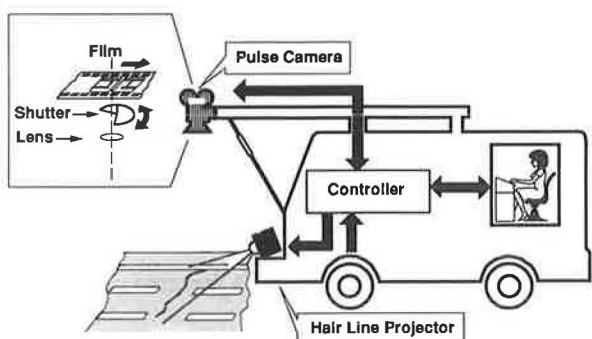
FIGURE 3 ROADRECON-75 for rutting survey (3).

a 35-mm pulse camera, a hairline projector, lighting equipment, a power source, and a remote control device (Figure 3). The hairline projector is installed over the bumper of the vehicle at an angle of 26 degrees 33 min to the road surface; the camera is mounted at a height of 10 ft from the ground perpendicular to the road surface. The lighting equipment is mounted in a position in geometric relation to the camera. The photographic scale is 1:200.

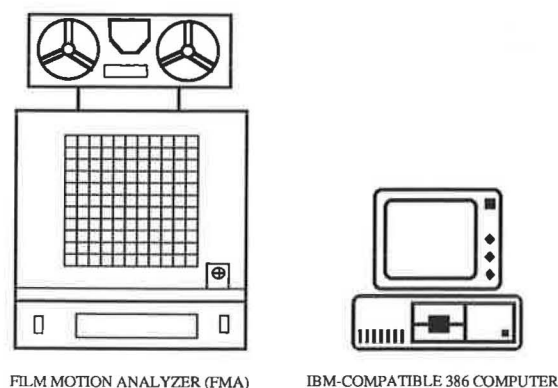
FIGURE 4 Main components of PADIAS (4).

(PADIAS). The PADIAS, shown in Figure 4, is a set of applications designed to control the interpretation of pavement distresses from a 35-mm strip of film. The hardware consists of an IBM-compatible 386 computer, a film motion analyzer (FMA) for interpretation of 35-mm films, and a printer for preparing the reports.
