# Mitigation of Traffic Mortality of Endangered Brown Pelicans on Coastal Bridges

L. KAROLEE OWENS AND RAY W. JAMES

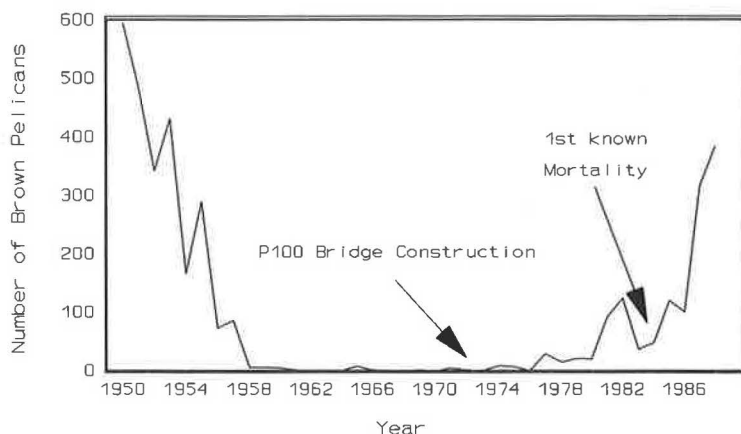
**FIGURE 2** Decline and recovery of Texas brown pelican population—Audubon Christmas bird counts, 1950–1988.

Figure 2 shows the decline and recovery of the brown pelican breeding population, the date of completion of the P100 bridge, and the time of the first recorded brown pelican mortality on the span. The breeding population had risen from nonexistence in 1964 to 230 in summer 1984 just before the first recorded mortality in September 1984. In the 1989 breeding season, six colony sites were used and the population increased markedly as a result of successful nests on five of these sites. Pelican Island in Corpus Christi Bay had 565 nesting pairs that produced about 900 young. This is an increase from the summer 1988 nesting season which had 350 nesting pairs producing 575 young. Other sites included Sundown Island (50 adults and 25 young), Second Chain (10 adults, 10 young), Steamboat Island (12 adults, 6 young), and Dressing Point (25 adults, 22 young). Flooding caused by a hurricane aborted nesting attempts by 14 adults at Cedar Lakes. This new nest site was the result of an attempt to establish a nest colony of brown pelicans at San Bernard National Wildlife Refuge. Thus, a total of 676 nesting pairs produced about 963 young in Texas during the 1989 breeding season.

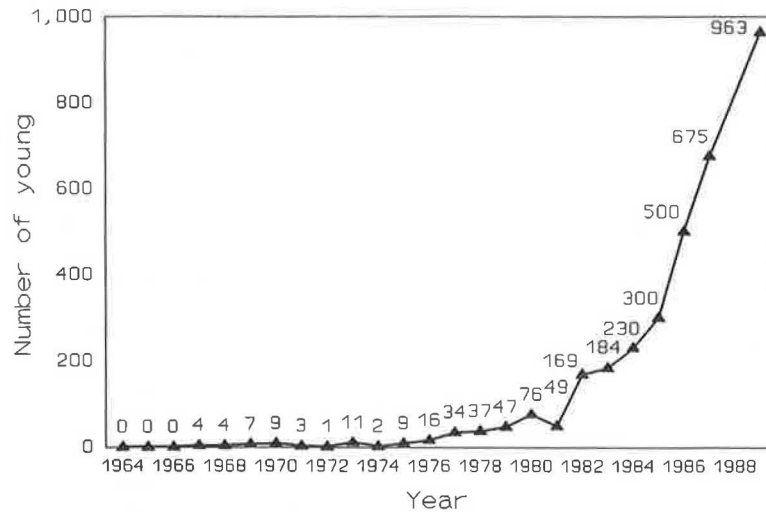
**FIGURE 3** Recent historical data for Texas brown pelican wintering population—numbers of young produced, 1964–1989.

Figure 3 shows the recovery of the brown pelican wintering population along the Texas coast as indicated by the Audubon Christmas bird counts (CBC) from 1950 to 1988 (11). The results of all of the Audubon Christmas bird counts for Texas for Christmas 1989 (90th CBC) will not be accumulated until April or May. However, there was an early report of 104 brown pelicans counted in the coastal tip of Texas count, which includes the area around the study site in a 15-mi-diameter count circle centered (26 deg 02 min N, 97 deg 14 min W) on the Brownsville ship channel. The coastal tip of Texas count was initiated during the Christmas 1986 (87th CBC) count and a total of 12 brown pelicans were seen. Subsequent count totals were 55 in 1987 (88th CBC) and 88 in 1988 (89th CBC), indicating a continuing trend of an increasing winter population.
