Aesthetically Pleasing Steel Pipe Bridge Rail

T. J. HIRSCH, C. E. BUTH, AND DARRELL KADERKA

DESCRIPTION OF TEXAS TYPE T421 BRIDGE RAIL

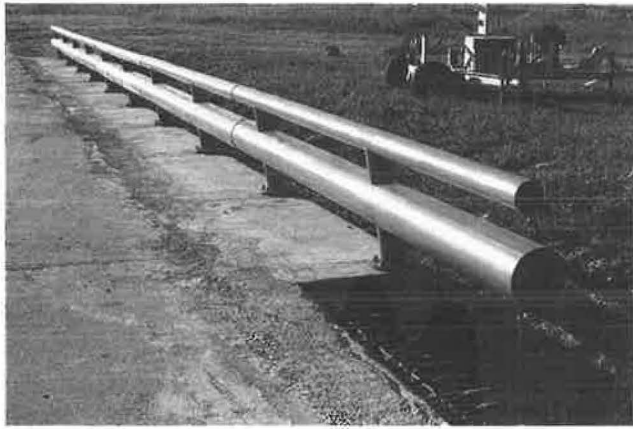
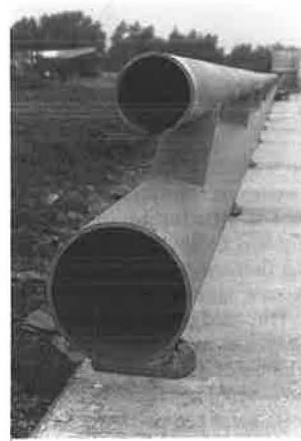
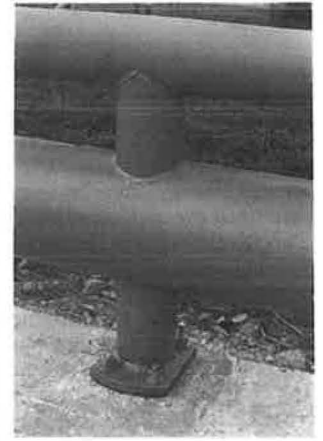
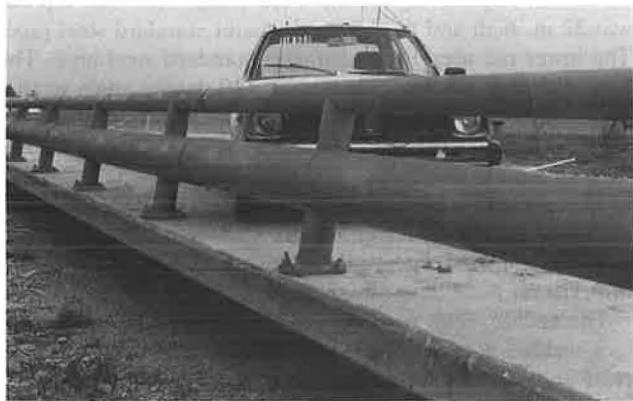
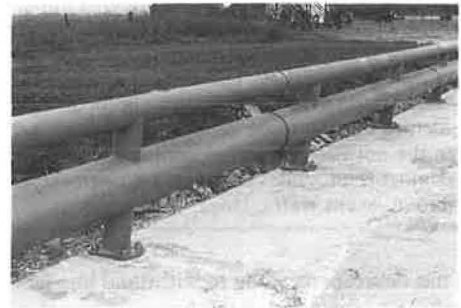
FIGURE 1 T421 bridge rail installation.

This bridge rail is constructed of standard steel pipe 5 or 10 in. in diameter. Figure 1 shows photographs of the steel pipe bridge rail installed on a typical simulated 8-in.-thick concrete bridge deck. Figures 2 and 3a show a cross section and side elevation, respectively, of the T421 bridge rail. The top rail was 32 in. high and used 5-in.-diameter standard steel pipe. The lower rail uses 10-in.-diameter standard steel pipe. The 5-in.-diameter posts are sloping at a 10-degree angle so that the traffic side or face of the two rails is a vertical plane.

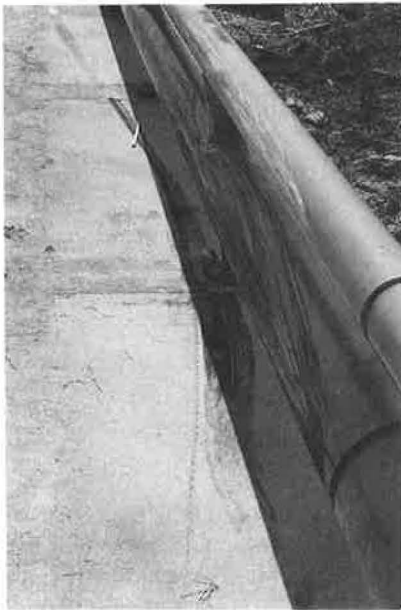
FIGURE 6 T421 bridge rail after Honda impact.

As can be seen in Figure 6, the rail received minimal cosmetic damage. Tire marks appeared 3 in. (7.6 cm) behind the traffic edge of the baseplate of Post 7 before impacting the lower part of the post and riding over the baseplate. The vehicle was in contact with the rail for 9.25 ft (2.8 m).

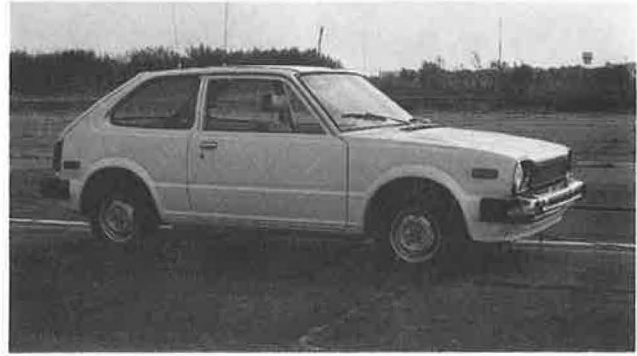
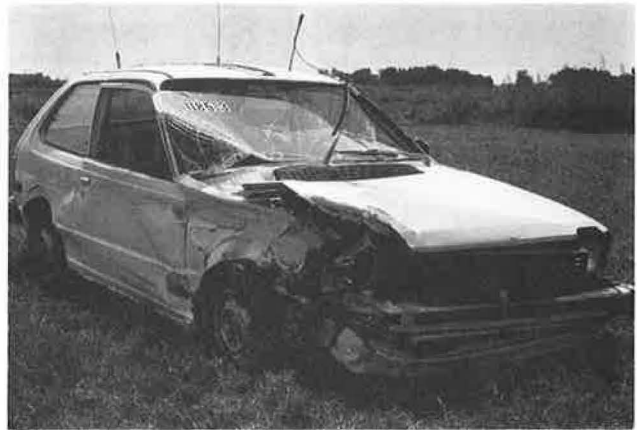
FIGURE 7 Honda before and after impact with T421 bridge rail.

The vehicle sustained severe damage to the right side, as shown in Figure 7. Maximum crush at the right front bumper heights was 10.0 in. (25.4 cm). The constant velocity joint and right strut were damaged. The right front rim was bent and the tire damaged. The roof was bent and the windshield was broken. There was damage to the hood, grill, bumper, right front quarter-panel, the right door and glass, the right rear quarter-panel, and the rear bumper.

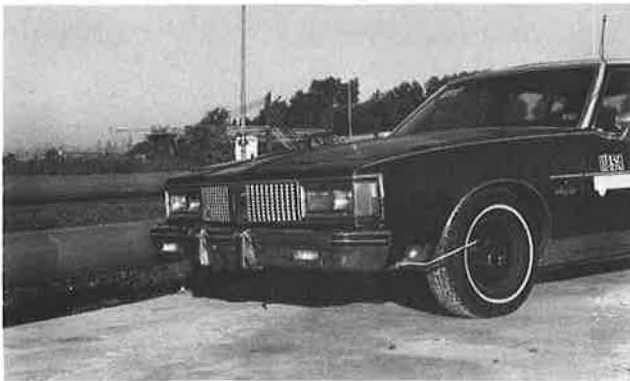
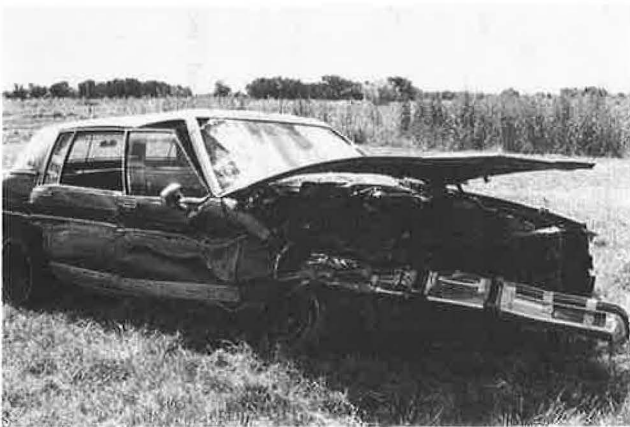
FIGURE 9 Oldsmobile before and after impact with T421 bridge rail.

The vehicle sustained severe damage to the right side, as shown in Figure 9. Maximum crush at the right front corner at bumper height was 18.0 in. (45.7 cm). The right front axle was pushed back 15.0 in. (38.1 cm). The right A-arm, sway bar, tie rod, and upper and lower ball joints were damaged and the subframe was bent. The instrument panel in the passenger compartment as well as the floor pan and roof was bent, and the windshield was broken. The right front and rear rims were bent and the tires were damaged. There was damage to the hood, grill, front bumper, right front quarter-panel, right front and rear doors, right rear quarter-panel, and rear bumper.

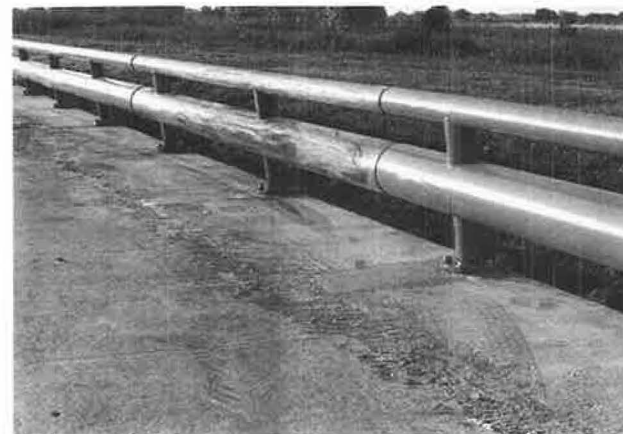
FIGURE 11 T421 bridge rail after Oldsmobile impact.

As shown in Figures 11-13, the rail received minor damage and the slab received moderate damage. The vehicle impacted the rail between Posts 4 and 5. The bases on both Posts 4 and 5 were pushed back approximately 0.25 in. (0.6 cm). The bridge deck behind Post 4 was cracked. Tire marks appeared 5 in. (12.7 cm) behind the traffic edge of the baseplate of Post 5 before the tire impacted the lower part of the post. The bridge deck around Post 5 was broken, as shown in Figure 12. There were tire marks on the base of Post 6 and, shortly thereafter, the vehicle left the rail. The vehicle was in contact with the bridge rail for 15.5 ft (4.7 m).

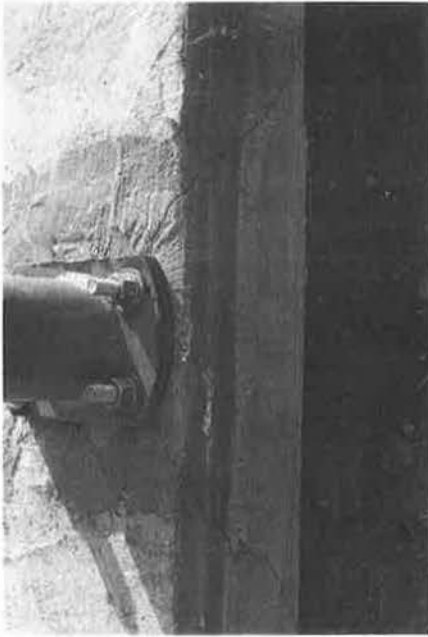
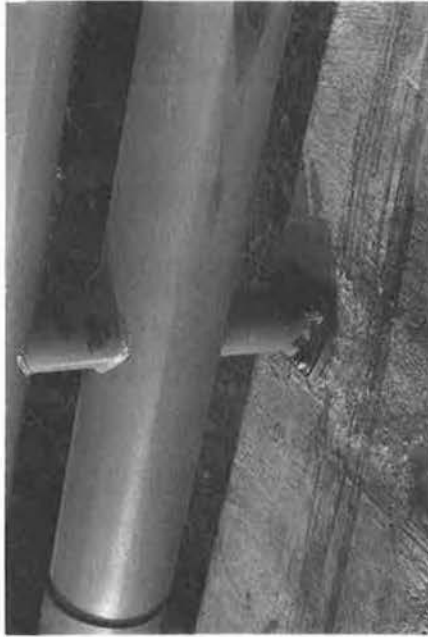
FIGURE 13 Posts 4 and 6 after Oldsmobile impact.

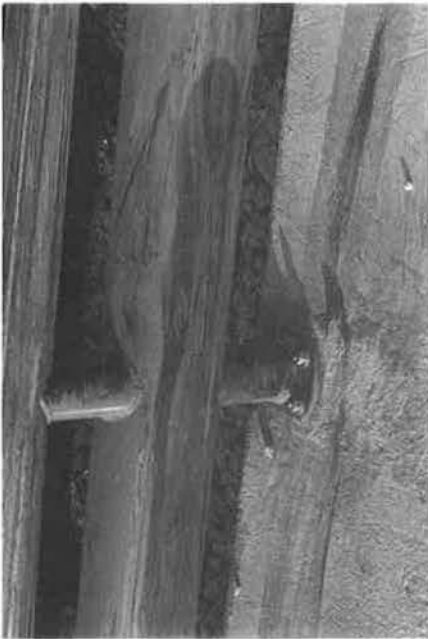
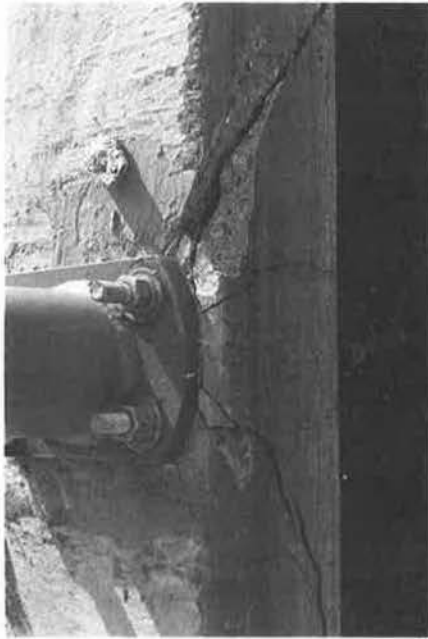
FIGURE 12 Damage at Post 5.
