# Proposed Correction of Landslide for Relocation of Kentucky Highway 9 Using Deep Drainage Gallery

DARYL J. GREER AND HENRY A. MATHIS

The proposed relocation of Kentucky Highway 9 places the new alignment in a known landslide area. The geotechnical investigation for the proposed alignment required correction of the landslide problems. Deep drainage galleries were proposed to lower the groundwater tables in the landslide area. The deep drainage gallery consists of a series of interconnected vertical wells with intersecting horizontal drains. A 100-ft-long test section was built to confirm the practicability of constructing such a system, to test the effectiveness of the system in lowering groundwater levels, to see the effects of lowering groundwater on landslide movement, and to evaluate the costs of constructing such a system. Extensive monitoring of the test section was performed using observation wells and slope inclinometers. Groundwater tables were effectively lowered, and landslide movements were significantly reduced. The cost to construct the deep drainage gallery is expected to be 40 percent less than its alternative, a tied-back retaining wall. Results of the test sect

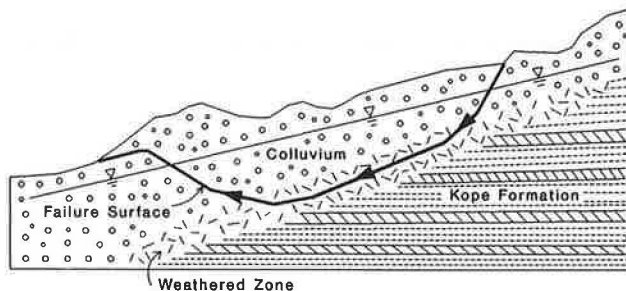
FIGURE 2 Sketch of typical landslide on Kope Formation—modified from Fleming (2).

Subsurface investigation along the proposed alignment reveals alluvium, colluvium, and terrace deposits as well as bedrock from the Ordovician Age formations. The alluvium, colluvium, and terrace deposits consist of silty clays with minor sands and gravels. The Ordovician Age bedrock consists of the Kope formation with minor outcrops of the Point Pleasant formation. Figure 2 shows a cross section of a typical natural landslide on the Kope formation.

The Kope formation consists of shale (75 to 80 percent) and limestone. It ranges from medium gray to light bluish gray, and when weathered it becomes greenish gray to dark yellowish orange. The shale of this formation slumps readily when wet, and extreme care must be taken to provide adequate drainage for structures placed on the Kope formation (1). A weathered rock zone typically occurs between the shales of the Kope and the overburdened soils.

The shale of the Kope formation shows a very low permeability (2). Small fractures in the interbedded limestone can transmit additional water into the slopes in addition to the natural groundwater that is already seeping downhill in the weathered rock zone. The weathered rock zone is typically more permeable than either the underlying shale or the overlying soils, and landslides in the Kope typically occur in this zone.

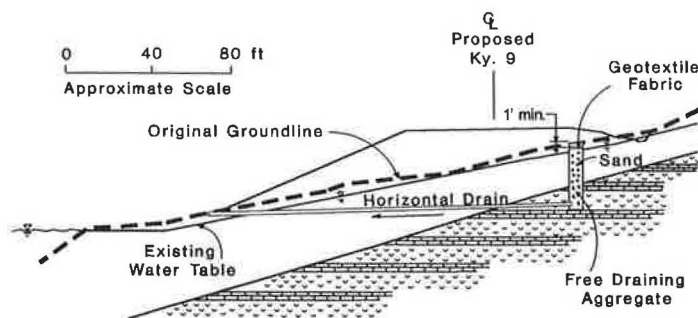
FIGURE 3 Deep drainage gallery system—Cross-section view.

The deep drainage gallery system is similar to that used by the California Division of Transportation on a landslide on I-80 near Pinhole, California (4). The proposed deep drainage gallery system is shown in Figure 3. The system proposed for this project consists of a line of drilled vertical wells placed on the uphill side of the new embankment. Each vertical well would have a diameter of 3 ft, be placed on 6-ft centers, and

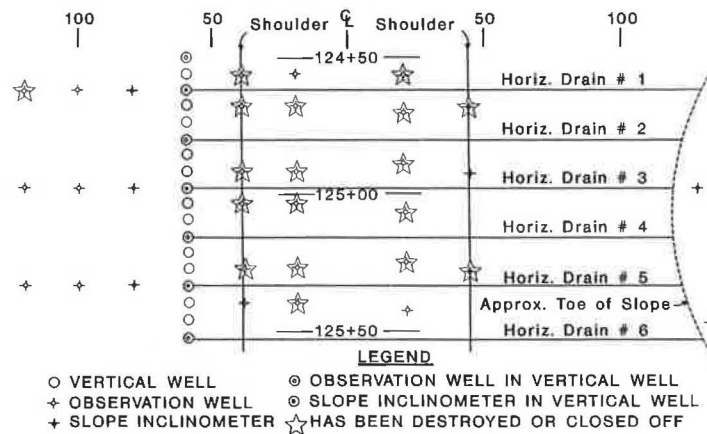
FIGURE 4 Instrumentation plan view.

The area chosen for the test section construction was located near the center of the landslide area between Stations 124+50 and 125+50. Before construction, extensive drilling was performed in the test section area between Stations 124+00 and 126+00. A total of 30 borings were performed in this area, and either observation wells or slope inclinometers were installed in all but three of the boreholes. Monitoring of the instrumentation at the site began in October 1985. Figure 4 shows a plan view of the instrumentation locations.

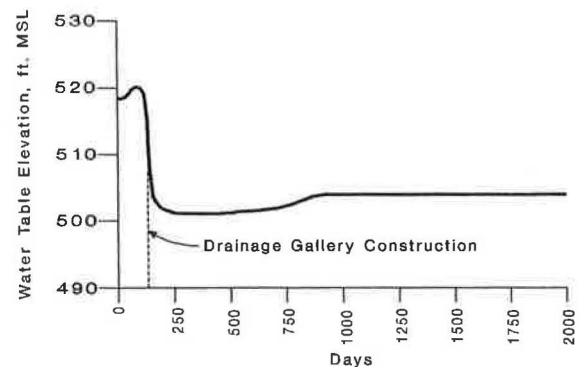
FIGURE 6 Typical water table elevation-versus-days plot.

Drought conditions were common from the end of construction of the test section until spring 1989. From spring 1989 to present, rainfall amounts have been at or above normal levels. However, only minor fluctuations in the water table have been observed since the test section was completed. A typical plot showing the water table elevation versus days is shown in Figure 6; this plot shows Observation Well 24, Station 125+40 at ground surface elevation of 532.0 ft mean sea level (MSL). The initial reading was taken November 15, 1985.

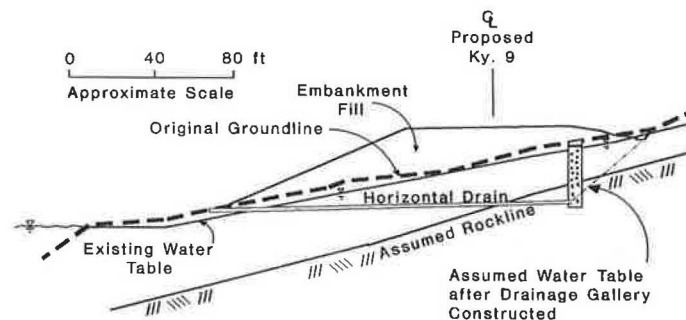
FIGURE 5 Anticipated water tables before and after drainage gallery construction.

vation wells that remained open showed an approximate drop in the water table in the drainage gallery area of 10 to 20 ft after construction. This drop corresponded with the water table being at or near the elevation of the horizontal drains. Figure 5 shows a typical cross section of the drainage gallery with anticipated water tables both before and after construction.

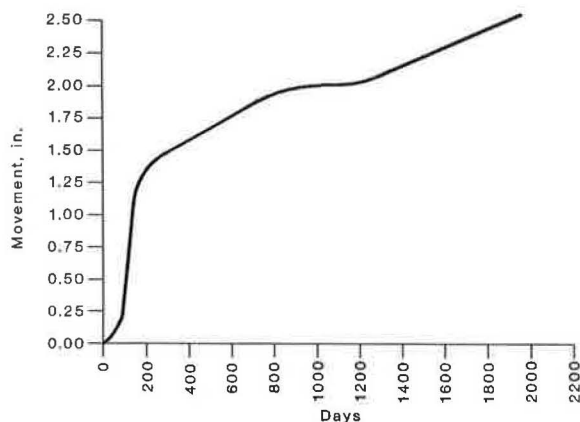
plot for the test section area; it shows Inclinometer 4 in Campbell County. Depth was 6 ft, and initial reading date was December 3, 1985.

FIGURE 7 Typical movement-versus-days plot for drainage gallery test section.

Monitoring of the slope inclinometers in the test section area indicated a rate of movement of about 1 in./year before construction. Movement during construction was relatively large and was mainly due to dewatering, lateral squeeze from embankment construction, and consolidation of the foundation soils. From the end of construction to April 1991, the average rate of movement was about 0.35 in./year. No significant fluctuations in the rate of movement were noted as a result of precipitation amounts or pool elevations of the Licking River. Figure 7 shows a typical movement versus days

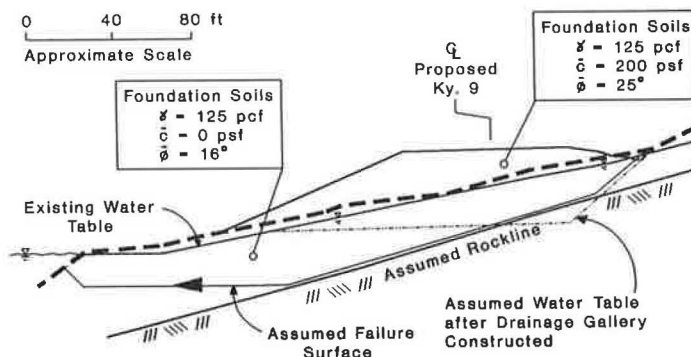
FIGURE 8 Typical embankment stability section (effective stress analysis: using existing water table,  $FS = 1.0$ ; using lowered water table,  $FS = 1.2$ ).

Stability analyses were performed on the assumption that the groundwater table would drop to the elevation of the horizontal drains. These analyses were conducted using the backed-in parameters and the failure planes determined from slope inclinometer movements (wedge analysis). These analyses indicated that marginal factors of safety ( $FS = 1.2$  to  $1.3$ ) exist for constructed embankments in the drainage gallery area. KYDOH's typical target factors of safety for roadway embankments are 1.4 to 1.8. Figure 8 shows a typical embankment stability analysis for the test section area. Stability analyses (rotational) using the strength data obtained from triaxial tests were also run to further check the stability of the embankments.
