TRANSPORTATION RESEARCH
RECORD

No. 1343

**Rockfall Prediction and
Control and Landslide
Case Histories**

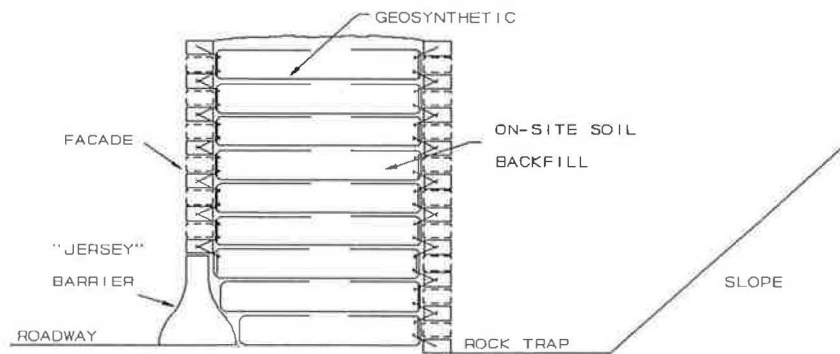
FIGURE 3 Geosynthetic rockfall barrier.

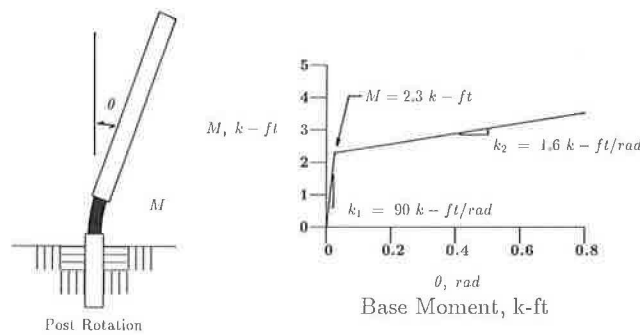
FIGURE 2 Flexpost static tests.

Flexpost rotational stiffness was determined in 16 static tests of six posts. Flexposts were loaded at the top by a cable attached to a hydraulic ram. Cable tension was calculated from hydraulic pressure readings and ram calibration. Hori-

zontal and vertical deflections of the tops of the posts were recorded along with ram hydraulic pressure readings, and the data were used to compute base moment M and post rotation θ . Flexposts exhibit bilinear M versus θ behavior with an initial tangent stiffness of 90,000 ft-lb/rad for moments up to 2,300 ft-lb, and a second tangent stiffness of 1,600 ft-lb/rad for higher moments. The average M versus θ curve obtained from static tests is shown in Figure 2.

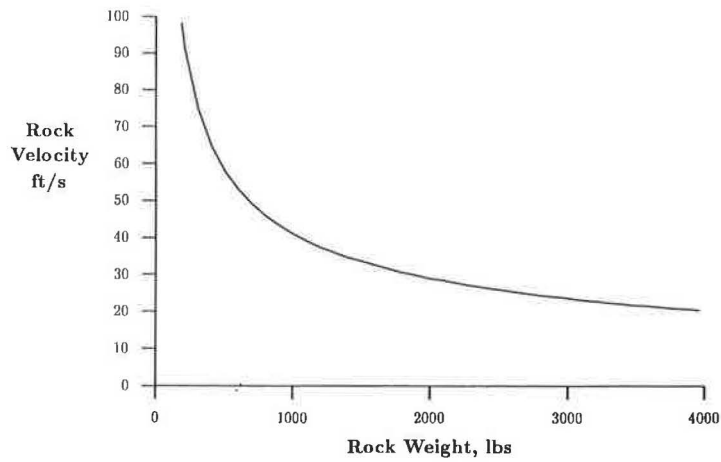
FIGURE 9 Flexpost rockfall fence: limiting rock velocity versus rock weight.

interior stay cables are shown in Figure 8. Despite some scatter, a linear dependence is apparent for all components (correlation coefficients exceed 0.9). Maximum member forces only have a weak dependence on impact location. This result can be understood from an examination of deflected shapes of the fence. Most rockfalls are ultimately stopped near the top of the mesh, even when the initial impact occurs near the bottom. Rock impact near the bottom of the mesh will deflect the fence, and the fence will in turn exert forces tending to lift the rock. As a result, the pocket in the mesh that arrests the rock usually forms somewhere from the midheight to the top of the mesh. The Flexpost fence ushers rockfalls to its more compliant region, so the influence of initial impact height is minimized. It is therefore possible to state the rockfall capacity of the Flexpost fence in terms of limiting rock mass and velocity, without additional limits related to impact location within the fence. The curve of limiting rock velocity versus weight is presented in Figure 9 and indicates a limiting velocity of 41 ft/sec for a 1,000-lb rock and a limiting velocity

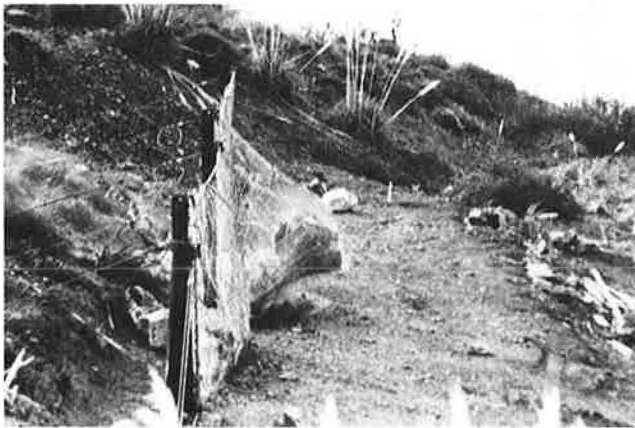
FIGURE 1 Brugg flexible rockfall net in action (rock weighs 3 tons) (Courtesy of John Walkinshaw, FHWA).

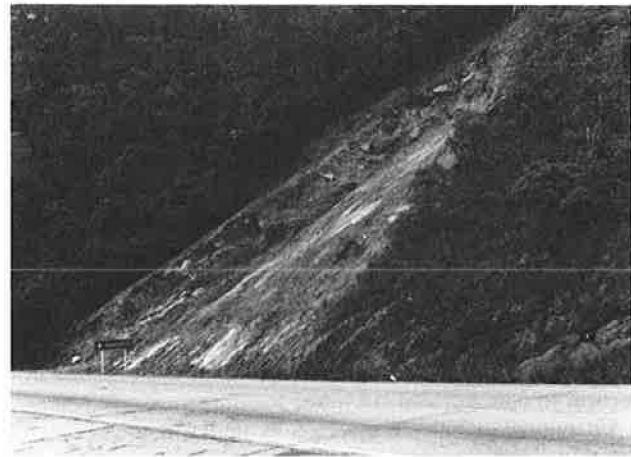
FIGURE 4 Scar of planar slide that partially closed BR 116.

Planar or translational slides, involving masses of residual soils moving along a rock surface dipping downslope, are the dominant form of slope failure along the roadway. The common cause is a cut that extends into rock, exposing a face of overlying soils (see Figure 3). Failure is sudden, occurring during or immediately after heavy rains. Sufficient material is usually displaced to either partially or completely close the roadway. Additional failure will not occur if the slide reaches the crest of the hill, because it is self-corrected. The scar of a planar slide is shown in Figure 4.

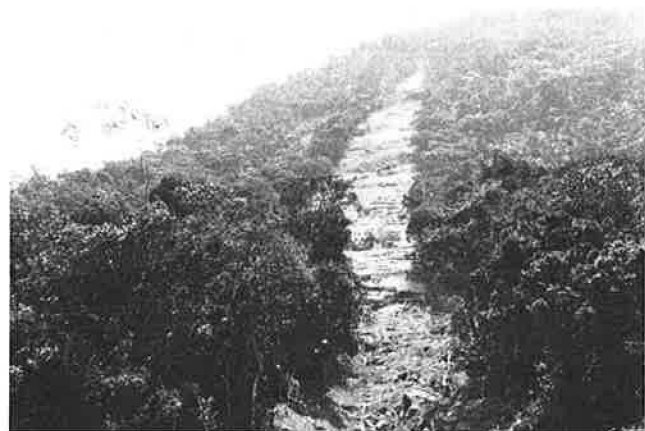
FIGURE 5 Scar of debris avalanche that partially closed BR 116 near Km 89.

Debris avalanches can completely or partially close the roadway. Occurring during heavy rains, they develop along the hillsides at the higher elevations where residual soils are not thick and overlie a rock surface dipping downslope. Large quantities of runoff move masses of soil and rock fragments downslope at high velocities. Figure 5 shows the scar of a

debris avalanche that occurred along the upper reaches of the roadway.

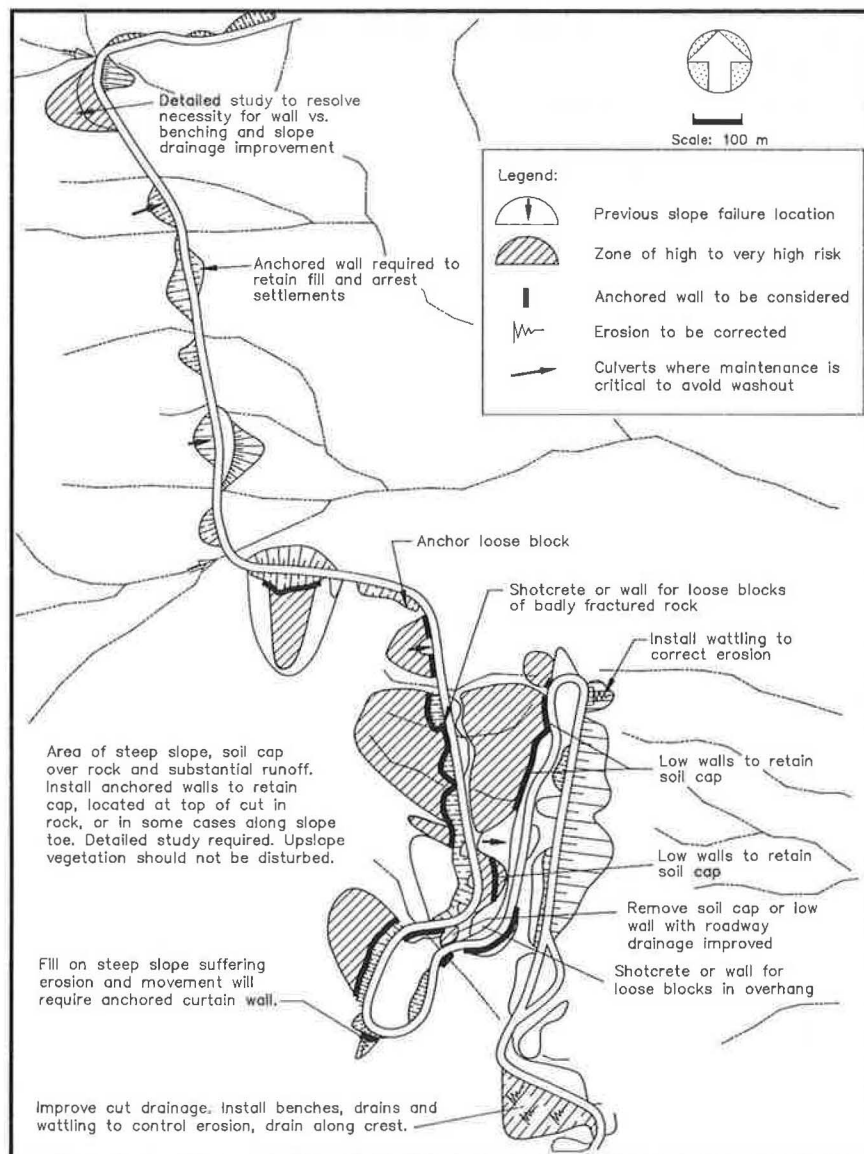
FIGURE 7 Preliminary consideration of slope stabilization schemes for high-risk areas along BR 116, Km 91-95.

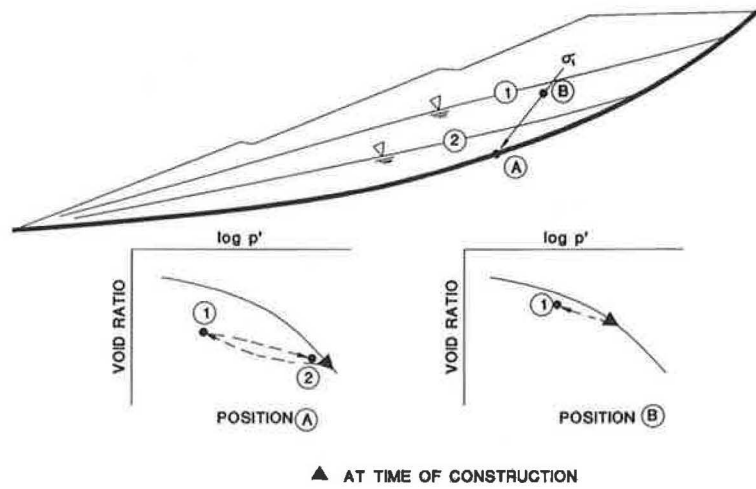
FIGURE 7 Effective stresses in valley-side fill during periods of high and low groundwater accumulation.

Figure 7 is a schematic section through a nonkeyed embankment composed of clayey fill subjected to varying groundwater levels. Shallow groundwater commonly accumulates in fills because of perching along less-permeable strata or older native soils buried beneath the embankment. In Figure 7 the relative change in effective stress (defined as the total stress minus the pore pressure) at two different positions in the

embankment is represented on conventional pressure-void ratio consolidation plots. Position *A* represents the approximate position of maximum effective stress at the time of construction. Note that this location lies on the virgin compression curve. If groundwater accumulates to a Level 1 (approximately five-eighths saturation of the embankment), the soil at Position *A*, through buoyance, swells along the rebound curve to Point 1, a reduction of two-thirds of the effective stress it originally felt. The amount of shear strength that could be mobilized at Position *A* is thereby greatly diminished through buoyance.

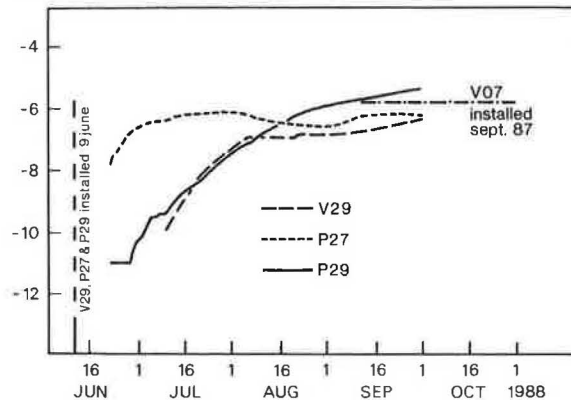
FIGURE 4 Typical piezometer equalization curves.

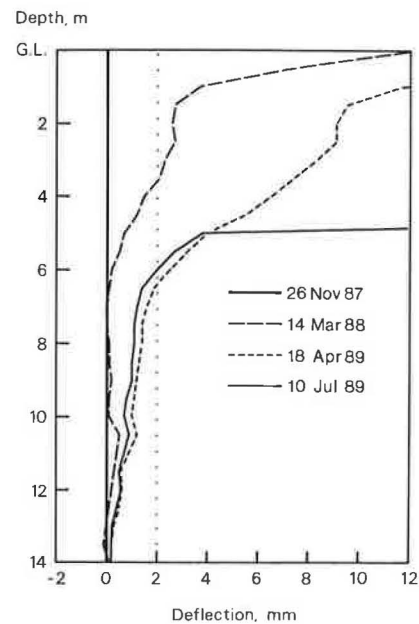
FIGURE 8 Typical inclinometer fixed-length behavior (Inclinometer 06).

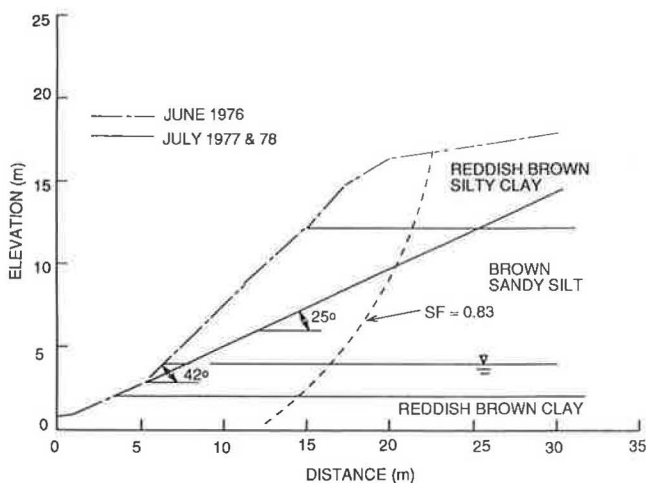
FIGURE 4 Bluff profiles in Cross-section 5.

Another cross section, Cross-section 5, was also analyzed; it was found to have potential for slumping as shown by the failure surface in Figure 4. The bluff segment in this area was chosen for a slope stabilization demonstration. After considering several alternatives—including terracing, berms, and various combinations of these—it was decided to regrade the bluff to a uniform slope of about 25 degrees. On the basis of a similar analysis, this inclination was determined to be safe. The bluff stabilization demonstration included surface water diversion in the upland and seeding of the bluff face to prevent surface erosion. The project was completed in the fall of 1977. The toe of the bluff was protected with a longard tube that was placed parallel to the toe and another longard tube placed perpendicular to the shoreline (see Figure 3), which effectively built up the beach in front of the longard tube acting as a seawall. The six longard tubes that were placed as groins perpendicular to the shoreline were all destroyed by spring 1980. The other tubes that were put as seawalls, for the most

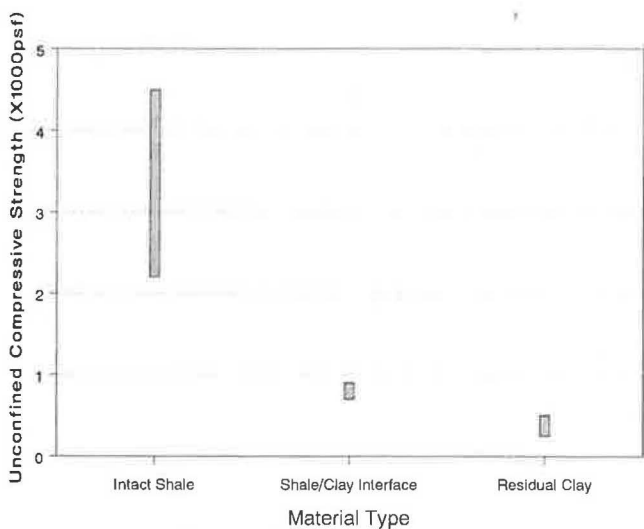
FIGURE 1 Comparison of undrained strength of various materials under saturated conditions.

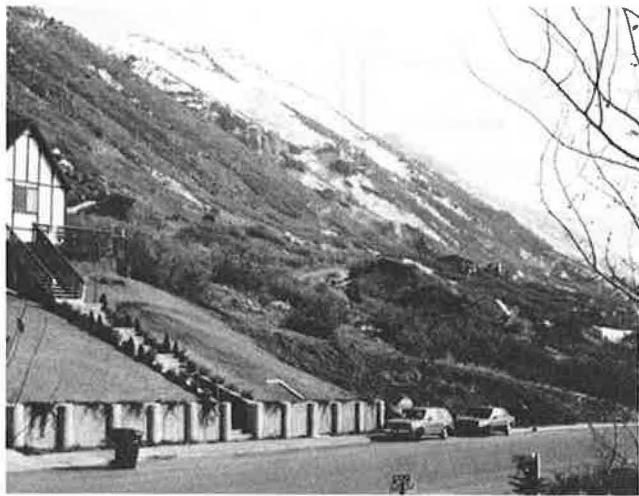
FIGURE 4 View of completed drilled-shaft wall with landslide developing immediately adjacent to it.

intended to prevent surface erosion that might not be controlled by soil arching. In addition to the shaft wall, a 10-ft-deep interceptor drain was constructed across the back side of the house as shown in Figure 2. A perforated 4-in. PVC drainpipe was placed at the bottom of the trench and extended to the roadway at the base of the slope. A photograph of the completed wall is shown in Figure 4.

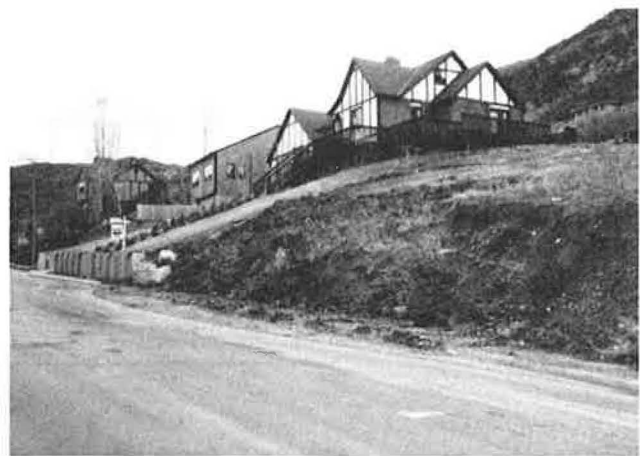
FIGURE 5 View of slide mass with drilled-shaft wall in background.

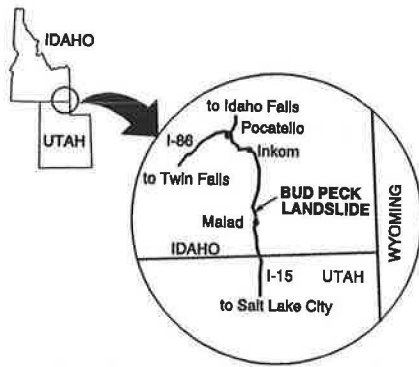
FIGURE 1 Site plan for Bud Peck slide, I-15, near Malad, Idaho.

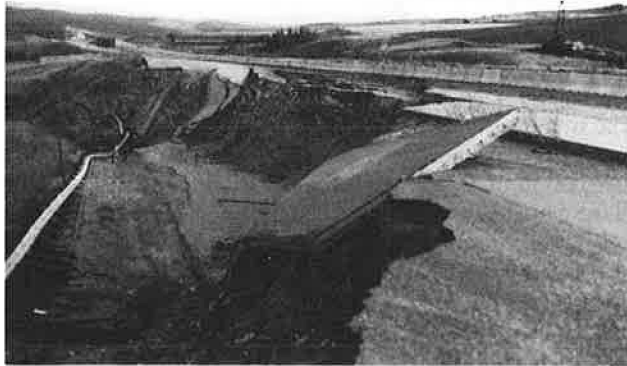
FIGURE 2 View of failed embankment, near Station 297+00, May 1983.

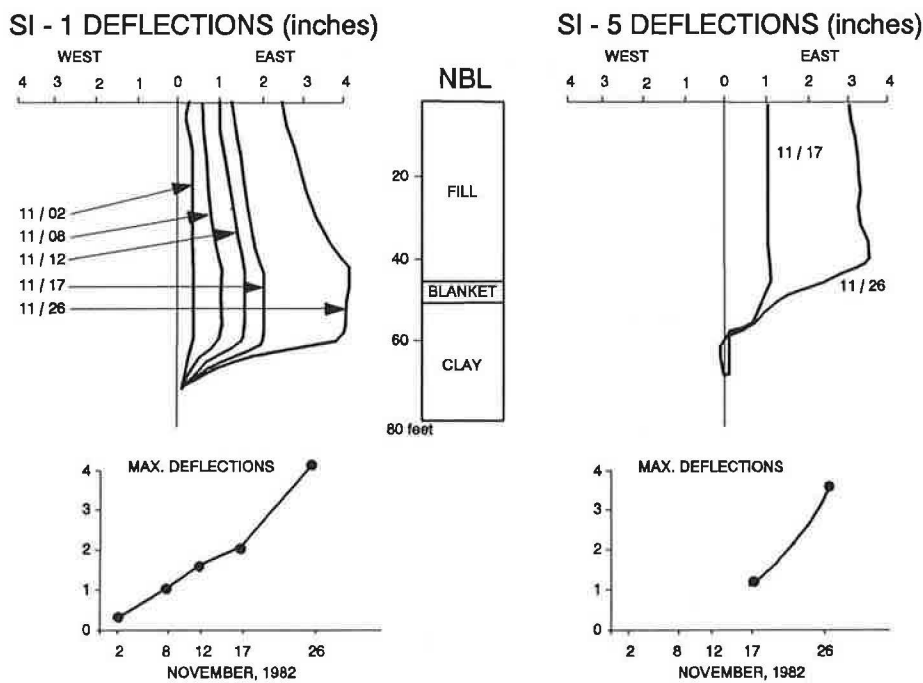
FIGURE 6 Slope indicator data for SI-1 and SI-5 at crest of embankment.

For the locations shown in Figure 4, the slope indicator data for readings obtained during November 1982 are shown in Figures 6 and 7. The data for locations SI-1 and SI-5 at the crest of the slide (Figure 6) indicate the existence of a potential failure plane below the sand-fill blanket. It appears that there is considerable movement 50 to 60 ft below the surface, or 5 to 10 feet below the sand blanket. At location SI-1 and SI-5 movements of up to 2 in. were measured between November 17 and 26, 1982. The increasing rate of movement for SI-1 and SI-5, as shown in Figure 6, suggests that the slope mass was unstable and appeared to be moving rapidly. Supporting evidence regarding the location of the failure plane was also provided by the slope indicator data for SI-2 and SI-3, located near the toe of the embankment, as shown in Figure 7. Unfortunately, the observations made at slope indicator sites, SI-2 and SI-3, were small and generally inconsistent as the base of the slope indicator does not appear to have been anchored into a stable zone.
