# Strategic Highway Research Program Pothole Repair Materials and Procedures

As funding for rehabilitation of pavements becomes more scarce, the ability of maintenance agencies to extend pavement service life with patching and other maintenance techniques becomes more critical. The Strategic Highway Research Program has conducted a study of the effectiveness of several pothole patching materials and methods. Eight test sites were installed throughout the United States and Canada, and the performance of the patches was monitored at those sites. The ability to identify good-quality patching materials for use by highway agencies will benefit many agencies, from state departments of transportation to county, city, and municipal streets and roads departments. If agencies can reduce the amount of patch material purchased, as well as the manpower required by increasing the life expectancy of patches, the potential exists to save millions of dollars each year on patching operations. The "patchability" of an area is determined by a number of factors beyond the control of the average maintenance crew—traffic, underlying support, drainage, climate and so on. However, the quality of patching

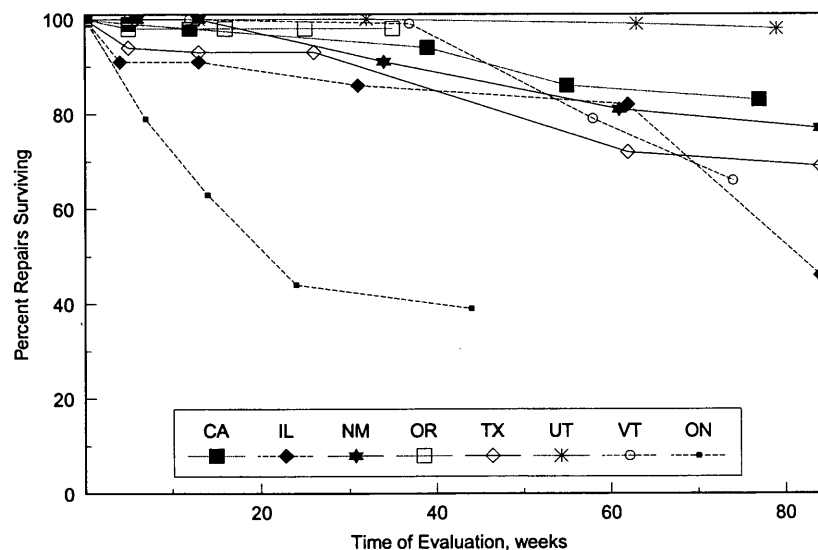
FIGURE 1 Patch survival over time for all sites.

As of the latest performance evaluations, 355 of the original 1,250 patches (28 percent) have failed at the test sites, as is shown by Table 6. Another 49 repairs have been lost to overlay (4 percent), leaving 866 patches surviving (69 percent). As can be seen from this table, the highest failure rate is at the test site in Ontario, where the patches were placed in an older asphalt-concrete pavement in freezing weather, subjected to snow and subsequent deicing salts 2 days after installation was completed and then hit with rain and freezing rain for most of the first 3 months after installation. The climatic conditions experienced at the other sites did not provide nearly that amount of stress to the patches, and as Figure 1 shows, the percentage of patches still performing at the Ontario site is decreasing much more rapidly than at any of the other sites.
