# Vehicle Crash Tests of Concrete Median Barrier Retrofitted with Slipformed Concrete Glare Screen

PAYAM ROWHANI, DORAN GLAUZ, AND ROGER L. STOUGHTON

Two vehicle crash tests were performed on a retrofit concrete glare screen (CGS) slipformed on top of an existing concrete safety shape barrier 0.81 m (32 in.) high. The CGS is intended as a replacement for the current standard expanded metal mesh glare screen. This CGS is 0.51 m (20 in.) high, 0.15 m (6 in.) thick at the base, and tapers slightly to 0.13 m (5 in.) thick at the top. Reinforcing consists of two longitudinal #4 bars tied to vertical #5 hoops (inverted U-shaped stirrups). At the base of the glare screen is a 19-mm (3/4-in.) chamfer to match that at the top of the concrete barrier. The two test vehicles included a pickup truck ballasted to 2447 kg (5,390 lb) traveling 89 km/hr (55.3 mph) and impacting at 20 degrees; and a station wagon ballasted to 1979 kg (4,360 lb), traveling 90 km/hr (56.2 mph) and impacting at 25 degrees. Both tests showed that a CGS can successfully withstand the impact of both a pickup truck and a heavy passenger car, and satisfy the requirements for structural adequacy, occupant risk and vehicle

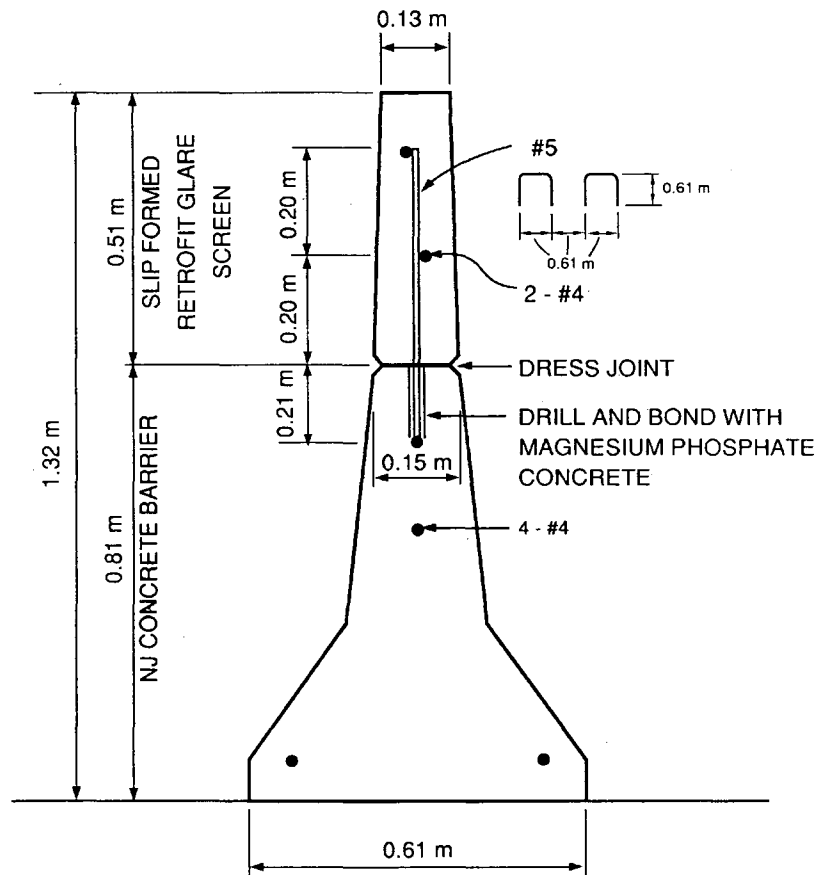
FIGURE 1 Type 50R typical cross section.

The type 50R barrier that was crash-tested was a standard Caltrans slipformed CMB (Concrete Barrier Type 50) retrofitted with a slipformed CGS on top. The barrier design is shown in Figure 1. The barrier design was a joint effort by the researchers and personnel from the Caltrans Division of Structures. A California barrier contractor with considerable slipforming experience advised the researchers that it would probably be feasible to slipform a CGS on top of a CMB.

The CGS was 0.15 m (6 in.) wide where it sat on top of the CMB, the same as the 0.15-m (6 in.) stem width of the CMB. The CGS tapered slightly to a 0.13-m (5-in.) top width. Minimum taper was used to get as thick a CGS as possible for added strength and ease of slipforming, but it was also thought that a slight taper was required to slipform the CGS properly. The minimum concrete strength for the test barrier was specified to be 2.11 MPa (3,000 psi). It was intended that the strength not be too high so the test conditions would be conservative. Test cylinders made during construction showed a 7-day strength of 2.42 MPa (3,440 psi), and a 14-day strength of 2.72 MPa (3,870 psi). It was necessary to control the slump of the concrete during the slipforming operation in order for the concrete to hold its shape.

The height selected for the Type 50R barrier was 1.32 m (52 in.): a 0.81-m (32-in.) CMB plus a 0.51-m (20-in.) CGS. This is 51 mm (2 in.) higher than the minimum height recommended in the NCHRP Synthesis on glare screens (3). It is also higher than the vertical center of gravity height for

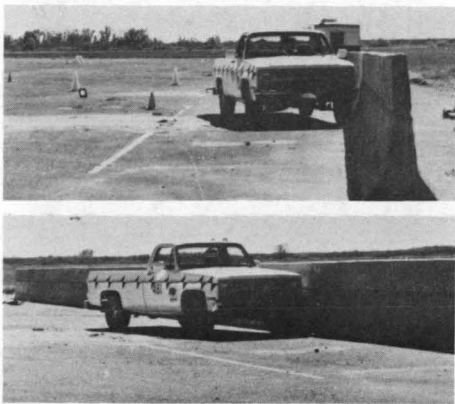
**FIGURE 2** Test 481, preimpact photographs.

The planned test conditions for Test 481 were 2450 kg (5,400 lb) at 97 km/hr (60 mph) and 20 degrees (Figure 2).

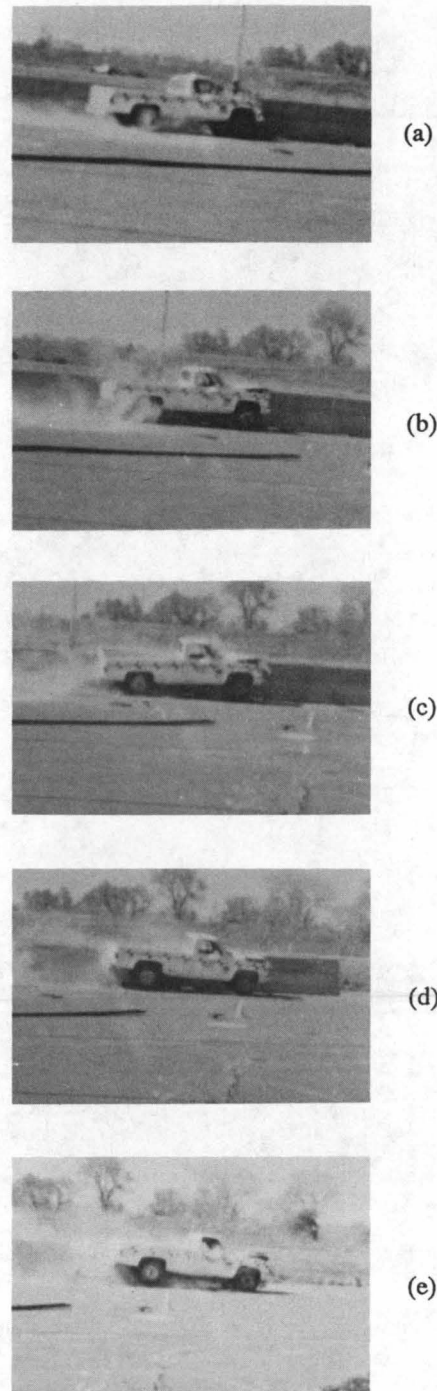
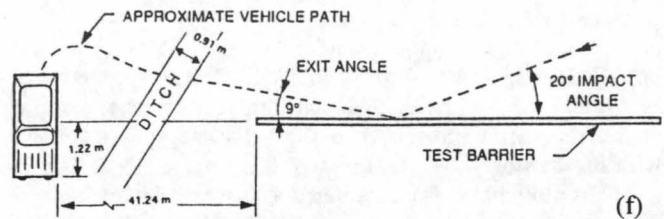
**FIGURE 3** Test 481, vehicle trajectory and sequential test: (a)  $t = 0.00$  sec; (b)  $t = 0.05$  sec; (c)  $t = 0.10$  sec; (d)  $t = 0.15$  sec; (e)  $t = 0.20$  sec; (f) vehicle trajectory.

The left front tire of the vehicle made first contact with the face of the barrier 32.9 m (108 ft) from the upstream end of the barrier (see Figures 3 and 4). The vehicle impact speed was 89 km/hr (55.3 mph) and the impact angle was 20 degrees. The vehicle rose about 0.8 m (2.75 ft) above the ground as evidenced by the marks on the barrier. The left front corner of the vehicle remained in contact with the barrier for a distance of about 5.2 m (17.2 ft).

The left rear tire touched the lower part of the barrier 34.0 m (111.5 ft) from the upstream end of the barrier. The highest mark of the left rear tire on the barrier was 0.94 m (37 in.). The length of vehicle contact with the barrier was about 5.6 m (18.3 ft). The body contact of the vehicle with the concrete glare screen began 24.5 m (107 ft) from the upstream end of the barrier and ran for a length of about 3.3 m (11 ft). The

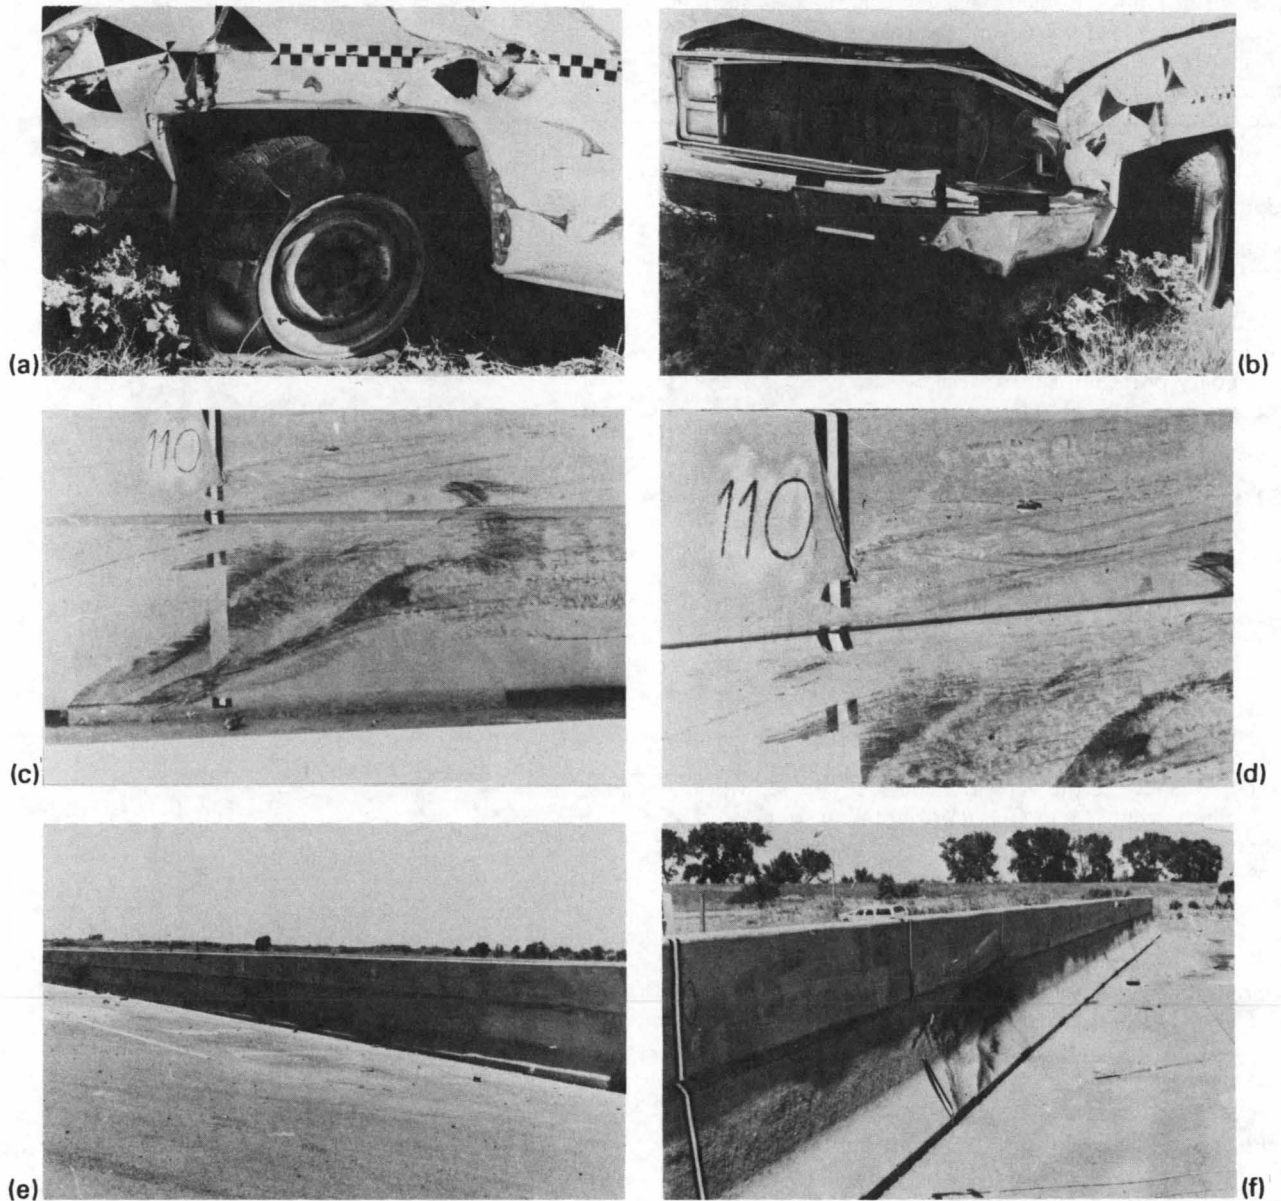
FIGURE 4 Test 481, postimpact photographs: (a) left front tire of vehicle, (b) left front corner of vehicle, (c–f) barrier.

There was no evidence of any structural distress of the CGS or CMB (see Figure 4). A few hair-like cracks were observed but were indistinguishable from cracks due to shrinkage. They may have existed before the crash. Lateral movement of the CGS was measured during the test; dynamic deflection was up to 10 mm (0.39 in.) at the top face, but there was no permanent deflection.

The only damage to the barrier were a few scrapes and tire marks. The length of gouge marks was 3.3 m (11 ft) on the CGS and about 3.6 m (12 ft) on the CMB. The tire marks of the left front wheel scuffed a length of 1.6 m (5.2 ft) on the CMB. The left rear tire marks were 3.5 m (11.4 ft) long on the CMB and 0.76 m (2.5 ft) on the CGS.

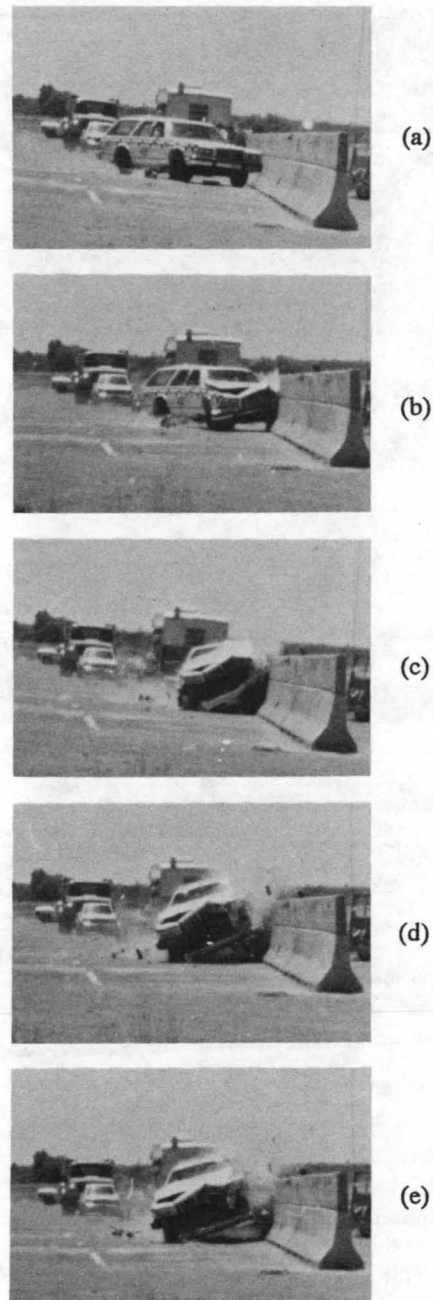
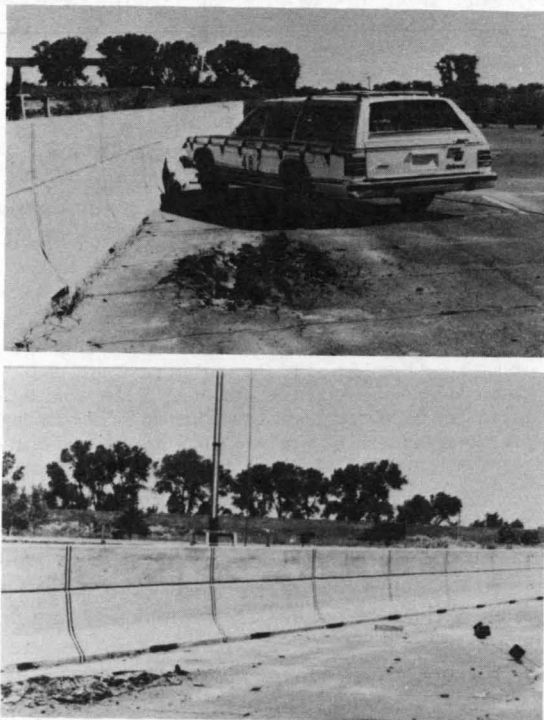
**FIGURE 5** Test 482, preimpact photographs: *top*, vehicle; *bottom*, barrier.

The planned test conditions for Test 482 were 2043 kg (4,500 lb) at 97 km/hr (60 mph) and 25 degrees (Figure 5).

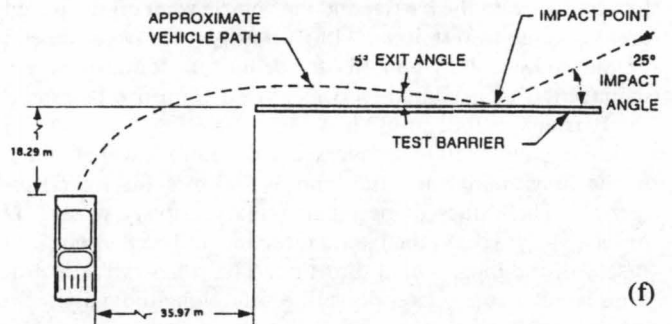
**FIGURE 6** Test 482, vehicle trajectory and sequential test: (a)  $t = 0.00$  sec; (b)  $t = 0.05$  sec; (c)  $t = 0.10$  sec; (d)  $t = 0.15$  sec; (e)  $t = 0.20$  sec; (f) vehicle trajectory.

The left front bumper of the vehicle first contacted the barrier face 15 m (49.2 ft) from the upstream end of the barrier (see Figures 6 and 7). The measured impact speed was 90.4 km/hr (56.2 mph), at an impact angle of 25 degrees. The left front tire initially contacted the lower part of the CMB 15.3 m (50.3 ft) from the upstream end. The highest mark on the barrier was 0.8 m (32 in.). The body contact with the CMB extended for a length of 3.8 m (12.5 ft) starting 15 m (49.3 ft) from the upstream end of the barrier. The length of the body contact with the CGS began 15.5 m (50.8 ft) from the upstream end of the barrier.

The test vehicle was redirected smoothly without exhibiting any tendency to snag or pocket with an exit angle of 5 degrees. It remained upright throughout and after collision. The exit velocity was 68.8 km/hr (42.6 mph). Exit velocity and angle

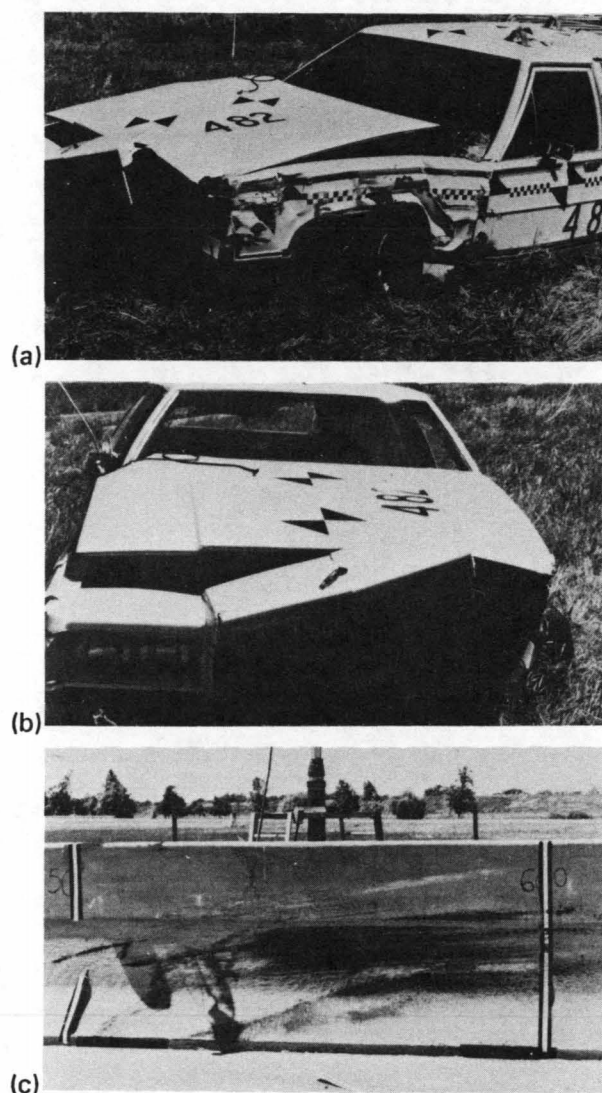
FIGURE 7 Test 482, postimpact photographs: (a,b) vehicle, (c) barrier.

There was no evidence of any structural distress of the CGS or CMB (see Figure 7). The only damage imparted to the

barrier was minor extension of a few preexistent hair line cracks. About eight hair-like cracks 25 to 114 mm (1 to 4½ in.) long developed on the top face of the CGS over a length of 1.1 m (3.5 ft) upstream from the 18.3-m (60-ft) mark. A preexisting crack root on the barrier face at about 18.3 m (60 ft) from the barrier upstream end went on for an additional 38 mm (1.5 in.). Two preexisting contraction cracks on the back of the barrier branched out into five hair-like cracks 76 to 102 mm (3 to 4 in.) long. These preexisting cracks were located at 0.12 m (0.4 ft) and 1.95 m (6.4 ft) downstream from the 18.3-m (60-ft) mark.
