Vehicle Crash Tests of Type 115 Barrier Rail Systems for Use on Secondary Highways

A total of three vehicle crash tests were performed on a California Type 115 bridge rail. The Type 115 bridge-rail test barrier consisted of two steel tube rails ($10 \times 10 \times 0.64$ cm) supported from the edge of deck by steel $W8 \times 31$ -posts at 244-cm spacing. The height of the top rail was 76 cm. There were two impact tests on a Type 115 bridge rail and one on a Type 115 bridge-rail transition. Although it was planned to test the Type 115 bridge rail to Performance Level 2 (PL2) and it was tested with a 2450- and 810-kg vehicle at 95 km/hr and 20 degrees, the snagging of wheels in Tests 471 and 472 led to the recommendation that the Type 115 be used as a PL1 bridge rail for lower-speed narrow bridges where impact angles are expected to be less. The Type 115 bridge-rail transition, when tested with a 2450-kg vehicle, produced some moderate pocketing, but could easily be stiffened to lessen the pocketing problem. Otherwise, the transition met all test criteria.

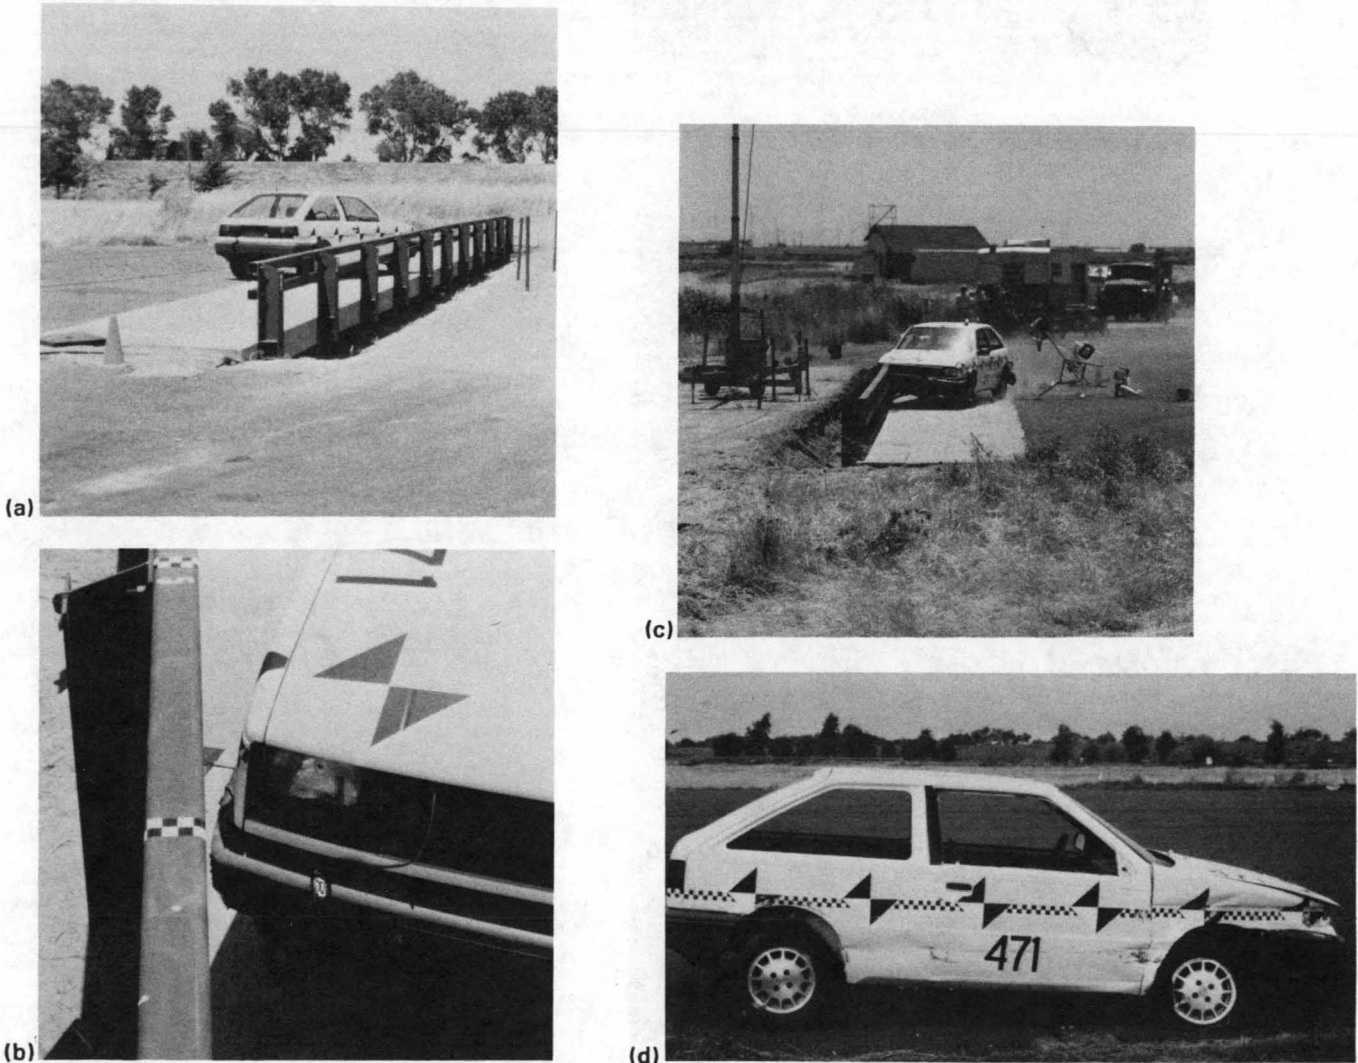
FIGURE 6 Crash sequence, Test 471.

The vehicle weighed 810 kg and measured impact speed was 94.9 km/hr. The actual impact angle was 19.0 degrees (Figures 5 and 6a). The vehicle right side contacted the barrier face 38 cm downstream from Post 6. Contact continued for a distance of about 300 cm.

The right front tire contacted the lower rail face for about 61 cm starting at 37 cm downstream from Post 6 (Figure 6b). The right rear wheel touched the lower rail face for about 160 cm and left contact 42 cm downstream from Post 7 (Figure 6c). The right front alloy wheel was damaged on Post 7.

The test car was moderately damaged, with considerable crumpling of the right side body sheet metal but little frame damage (Figure 6d). The contact pattern extended from the right front corner for about 25 cm across the right side of the vehicle. The front frame members under the engine were bent on the right side. The windshield was cracked on the lower right corner. The right front fender was severely crushed by the penetration of the upper rail for a depth of about 18 cm. The right front door was jammed. Both front wheels were broken, and the tires were flattened and wheel movement was completely restricted.

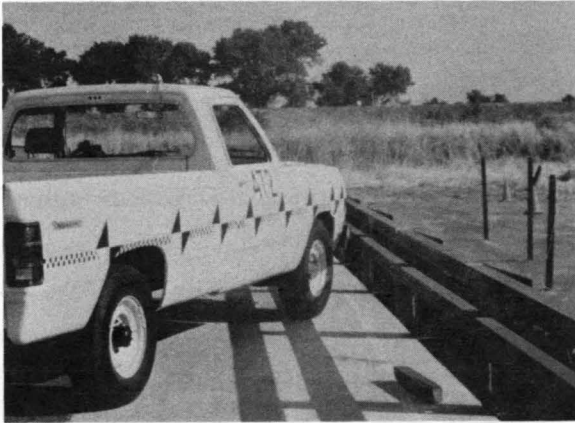
(a)

FIGURE 8 Crash sequence, Test 472.

21.0 degrees (Figure 8a). The right front corner of the truck bumper struck the lower rail face 17 cm downstream from the centerline of Post 5. The truck body's first contact with the upper rail was 37 cm upstream of the centerline of Post 5 (20 cm upstream of the bumper contact point).

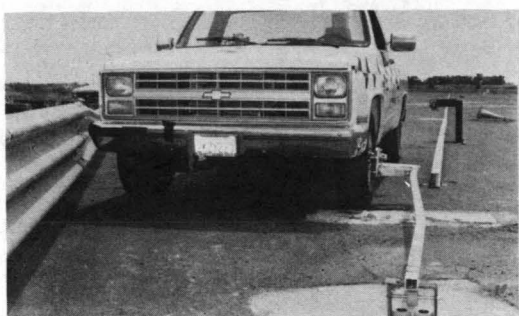
FIGURE 10 Crash sequence, Test 477.

The height to the lower edge of the truck's bumper was 44.5 cm and it was 66.8 cm to the top of the bumper. The vehicle weighed 2450 kg and was freewheeling and unrestrained just before impact. The measured impact speed was 74.8 km/hr and the angle was 19.2 degrees (Figures 9 and 10).

The vehicle bumper contacted the middle ridge of the transition face 15 cm upstream from wood Post 3. Contact continued for a distance of about 381 cm. The right front tire contacted the thrie-beam corrugation at Post 3 and ended at Post 1. The right rear tire touched the lower ridge about 40 cm upstream from Post 2 for about 84 cm. The sheet metal body contact of the vehicle with the upper ridge of the rail began 44.5 cm upstream from Post 3 and ended 15 cm downstream from metal Post 1. The body contact of the vehicle with the middle and lower ridges was noted as discontinuous scratches that ended about 15 cm past steel Post 1.
