# Known Vehicle Causes of Unintended Acceleration

»» Richard Boyd  
Acting Director  
Office of Defects Investigation

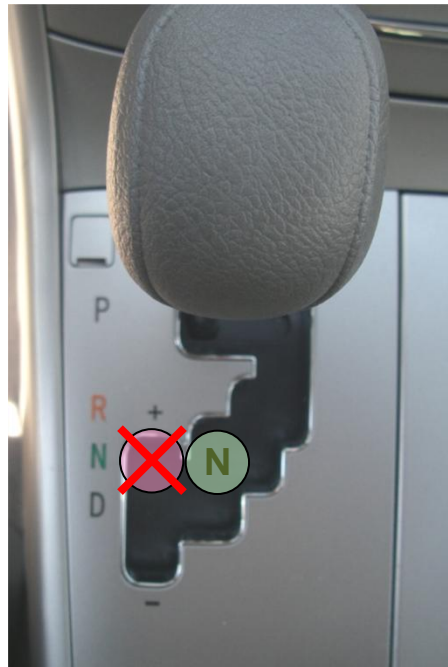
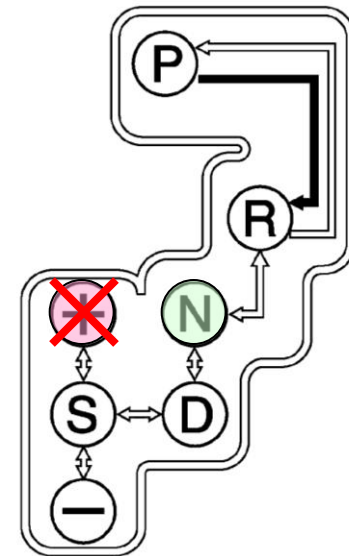
# PRNDL Gate Design

- Drivers may attempt to shift to “Neutral”
  - PRNDL gate design for Toyota Sequential Shift vehicles may not be intuitive for location of “Neutral”
  - Drivers who successfully shift to “Neutral” may misinterpret  $\uparrow$  in engine rpm and shift back to drive

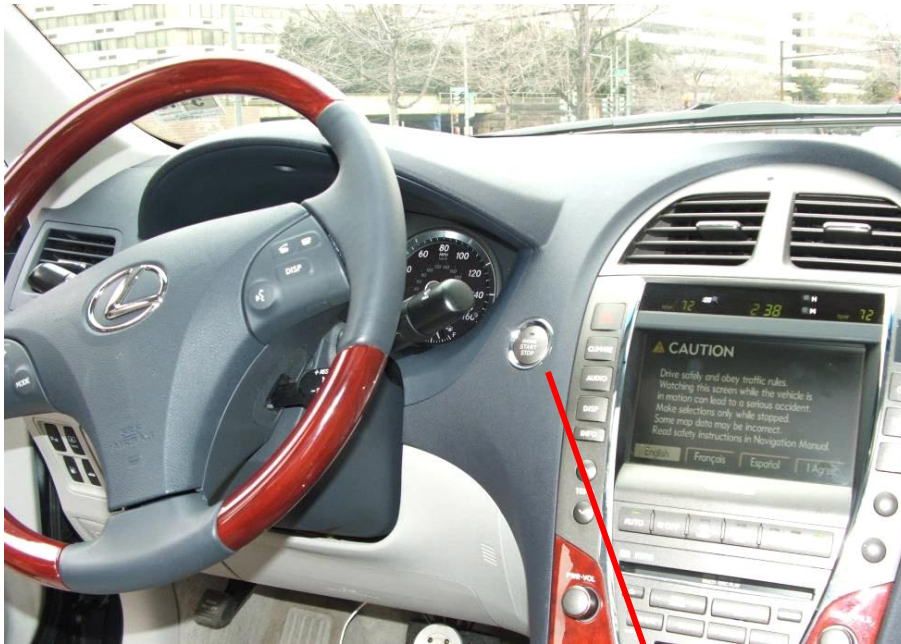
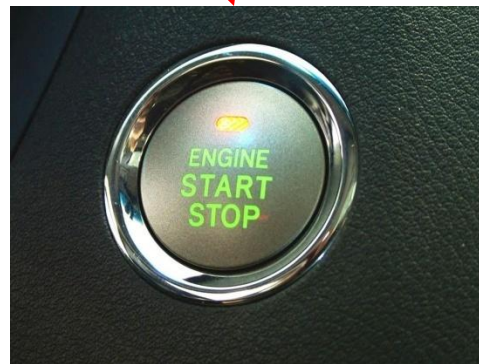
# Engine Start/Stop Switch

- Switch operation:
  - ❑ Vehicle stationary: momentary press to start and stop
  - ❑ Vehicle in-motion: must press and hold for at least 3 seconds (to avoid inadvertent shut-off)
  - ❑ Different strategies used by other manufacturers
    - Different time intervals
    - Many included shut-off with multiple press (2x or 3x)
    - Some prevent engine shutoff when moving (and not in PARK)
