Operational Evaluation of a Rail-Based Wheel Gauge Inspection System

Final Report for
Transit IDEA Project 17

Prepared by:
Zack Mian
International Electronic Machines Corporatio

August 1998

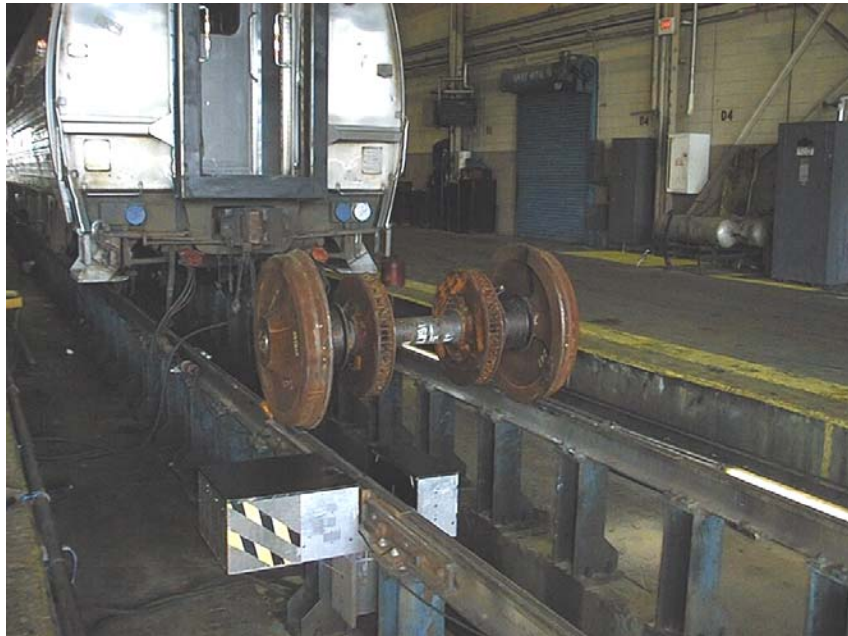
Figure 4: Profile system.

A custom rail segment was needed for the profile system. IEM designed and fabricated the segment. Stress analysis on the design was done by professional structural engineers. We installed the custom rail segment at Amtrak's Rensselaer site. Figures 3 and 4 show the profile installed at the Rensselaer site.

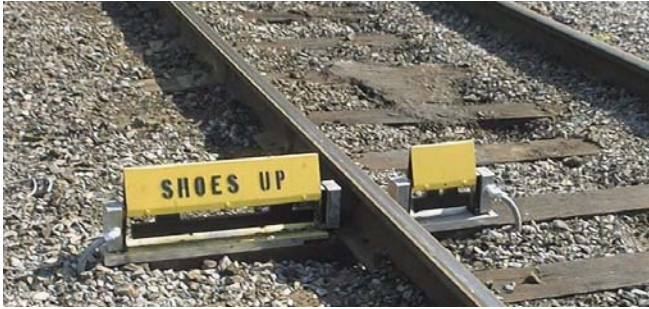
Figure 5: Rotating steel veins.

In order to guard against potential damage done by dragging equipment, we have designed a dragging equipment detector to notify the engineer when dragging equipment from the train is in danger of striking the profile system. Our detector consists of a pair of rotating steel veins attached to an optical encoder (figure 5). The encoder triggers an electronic latching circuit which turns on a red quartz caution light and an 85-decibel horn (figure 6). We mounded the detector approximately 40 yards down rail from the east entrance to the track. The light and horn are mounted at the east end of the track pit. They are within close proximity to the laborer who is responsible for guiding the train. It is the laborer's responsibility to notify

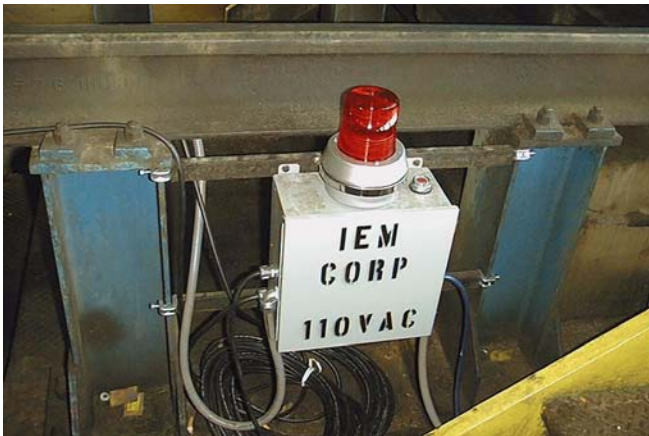
Figure 6: Caution light and 85-decibel horn.
