Wall Asset Management Implementation at Colorado Department of Transportation

Bryant Walters, Collins Engineers
Mark Vessely, Shannon & Wilson

Colorado DOT Wall Asset Management Program Development

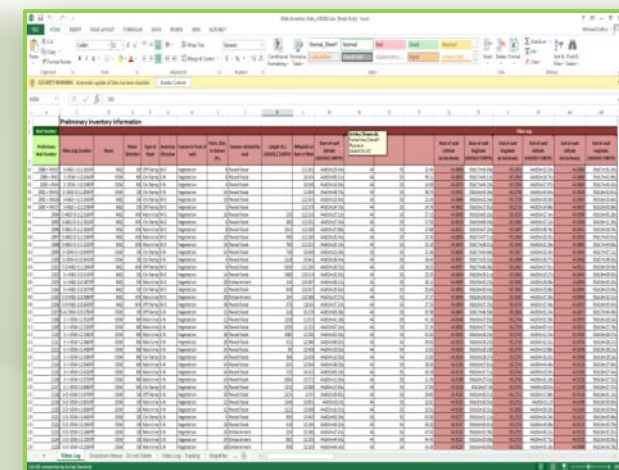
Preliminary Risk-Based Inventory

This screenshot shows a detailed spreadsheet titled 'Preliminary Risk-Based Inventory'. It contains multiple columns for item identification, location, and risk assessment. The data is organized in a grid format, with rows representing individual wall segments or structures.

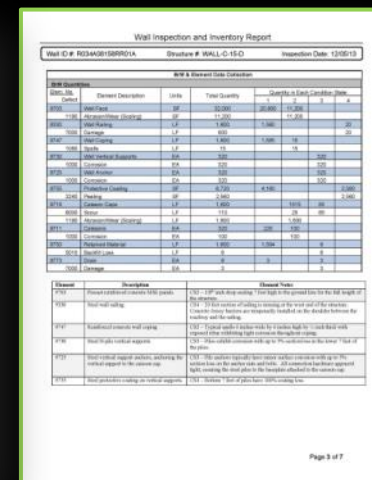
Element Report Including Maintenance Recommendations

This screenshot shows an 'Element Report' which includes a table of element data and maintenance recommendations. The table has columns for element ID, description, location, and recommended actions. The report is titled 'Wall Inspection and Inventory Report' and 'Structure # 10411-C-150'.

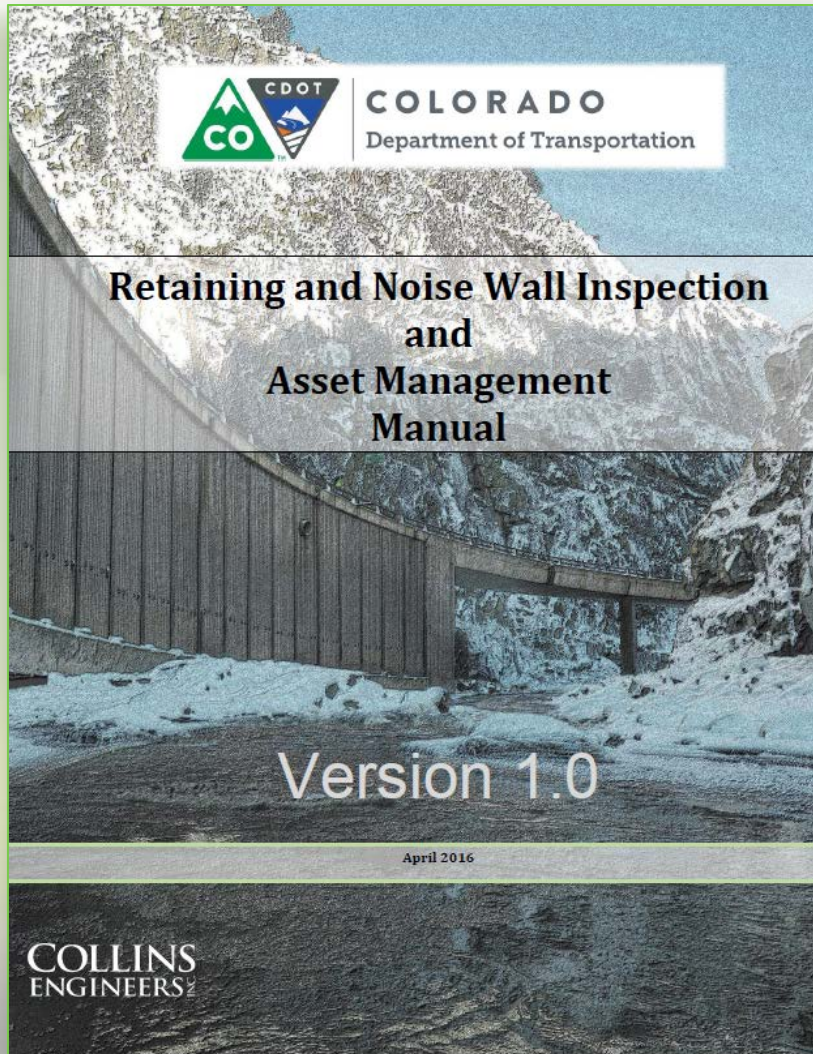
Coding Guide

- Based on bridge inspection program making it easy for current inspectors to use and maintain reporting consistency.
- Contains NBI based inspection data for locating and identifying asset inventory and appraisal information following FHWA (bridge) standards.
- Includes elements based inspection in line with FHWA BrM (bridge) standards. Includes identifying defects and association of condition ratings.
- Maintenance recommendations and priority can be assigned to element defects, providing cost takeoffs.
- Includes description of the program, definitions and examples.

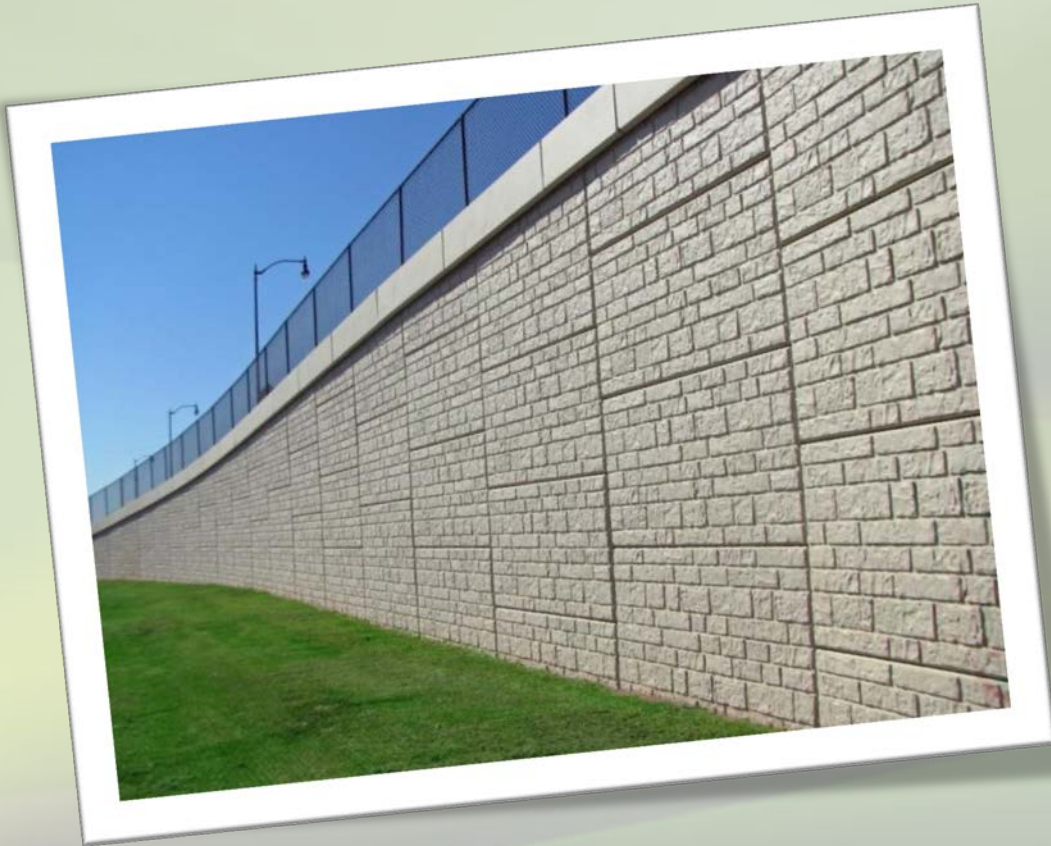
- Photos can be embedded with metadata such as lat/long
- Photos can be provided in a folder alongside a database extraction
- Photos can be associated with a database extraction
- Photos are labeled according to CDOT's file naming convention
