CHALLENGING THE PARADIGM IN BRIDGE ASSET MANAGEMENT MORE PROBLEMS REQUIRE MORE FUNDING

ROYCE GREAVES - CPENG INPE MIPENZ NDIAM

CASE STUDY ONE: AUCKLAND HARBOR BRIDGE

CASE STUDY TWO: BRIDGE STRENGTHENING PROGRAM

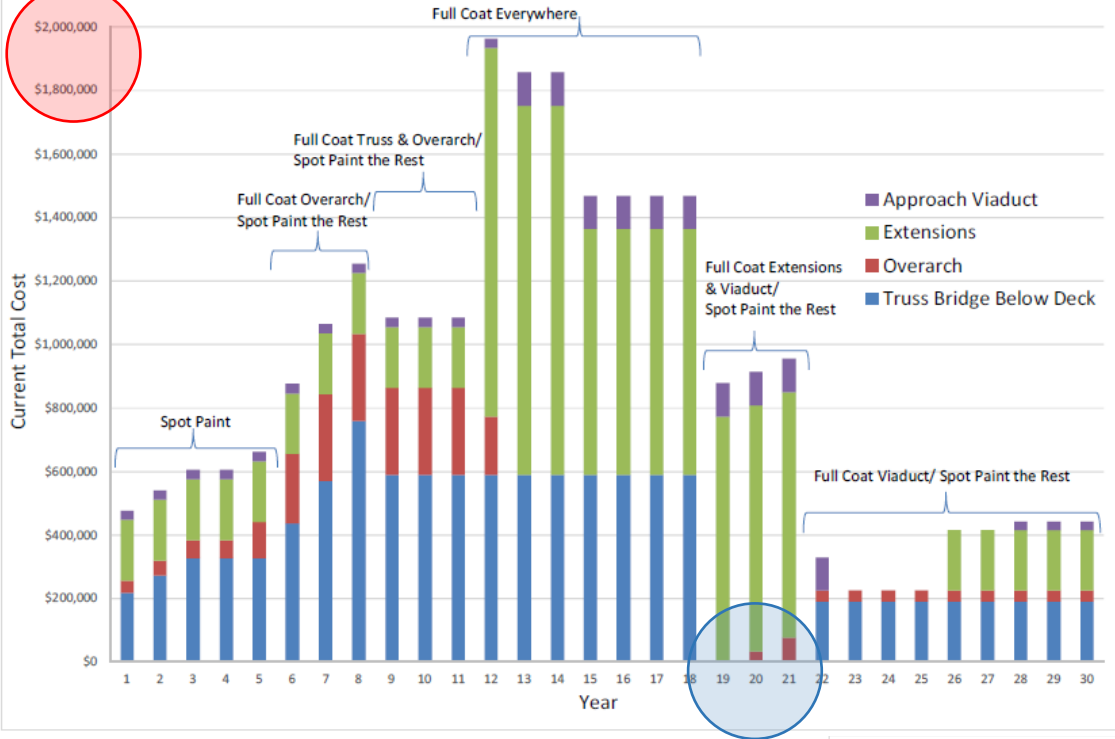
Current Maintenance Strategy NPV > \$30M over 30 years

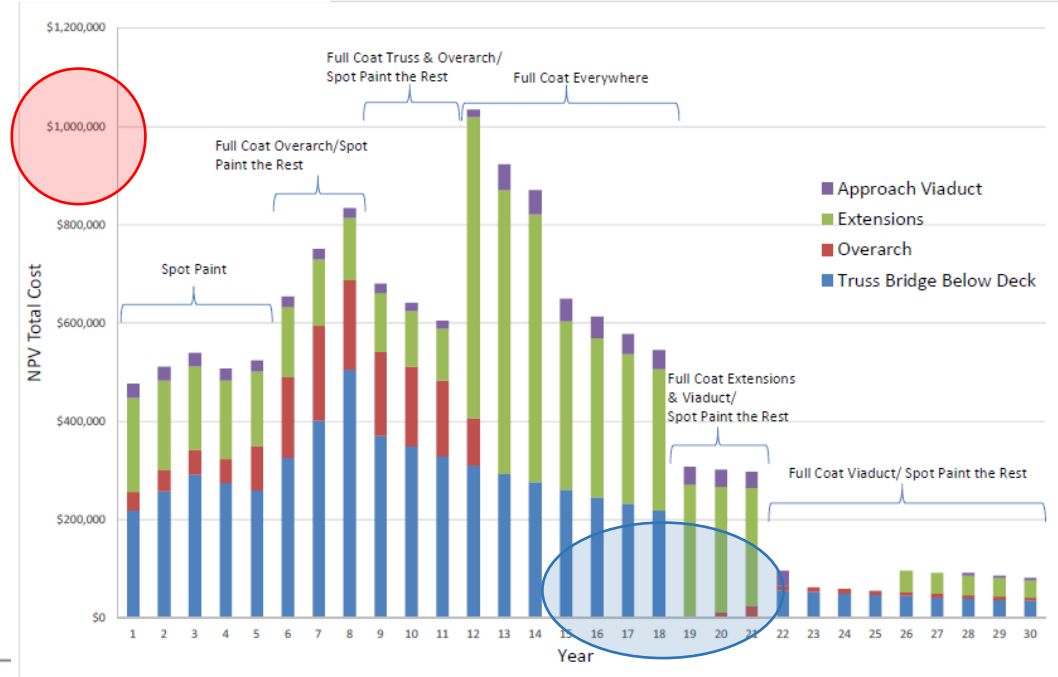
New Maintenance Strategy NPV \$13.6M over 30 years

Total NPV Cost/m ²	\$109
Total NPV for 30 years	\$13,609,672.49

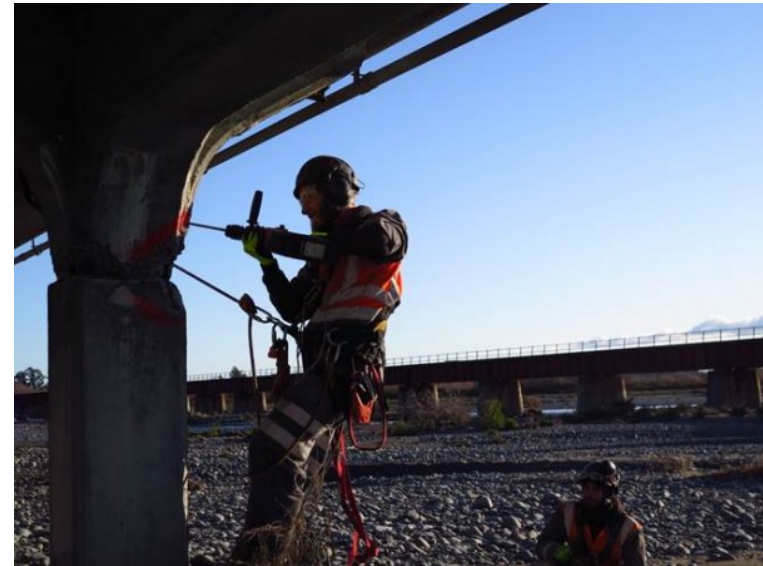
Methodology

- Understand in situ bridge performance
 - Stress gauges
 - Displacement gauges
 - Accelerometers
 - Add proof loading
 - Materials testing
- Revisit bridge strength
 - Review design vs actual
 - Identify redundancy
 - Program work accordingly
