ISAC FIELD PERFORMANCE

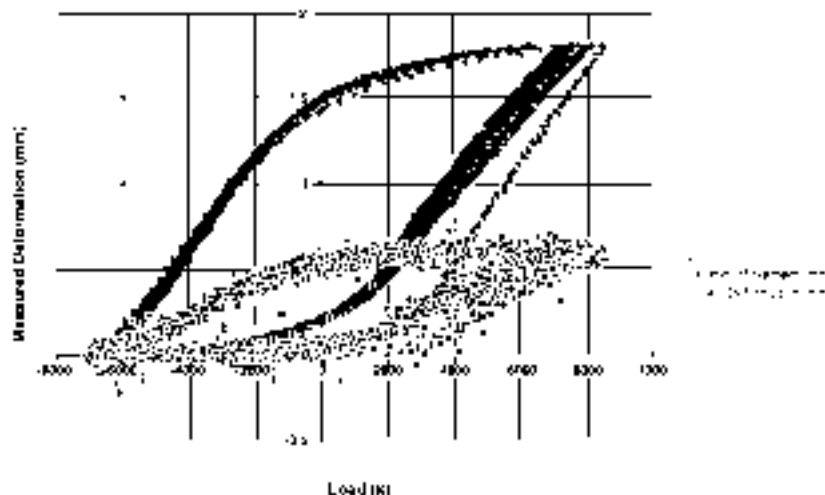
FIGURE 14 Base isolation behavior of ISAC for Cycles 28 to 43.

Performance of the ISAC system is based on the concept of isolating the overlay from movement in the underlying pavement. Figure 14 shows a continuous graphical output for measured deformation at the pavement joint and in an AC overlay during Cycles 28 to 43 in an ISAC test section. The maximum pavement joint expansion is about 1.83 mm as shown in Figure 14. The AC overlay only experiences about 0.6 mm of total deformation in a gauge length of 12.7 cm (strain of about 0.005). The ISAC material performs as a base isolation layer in the pavement overlay system.
