ISAC FIELD PERFORMANCE

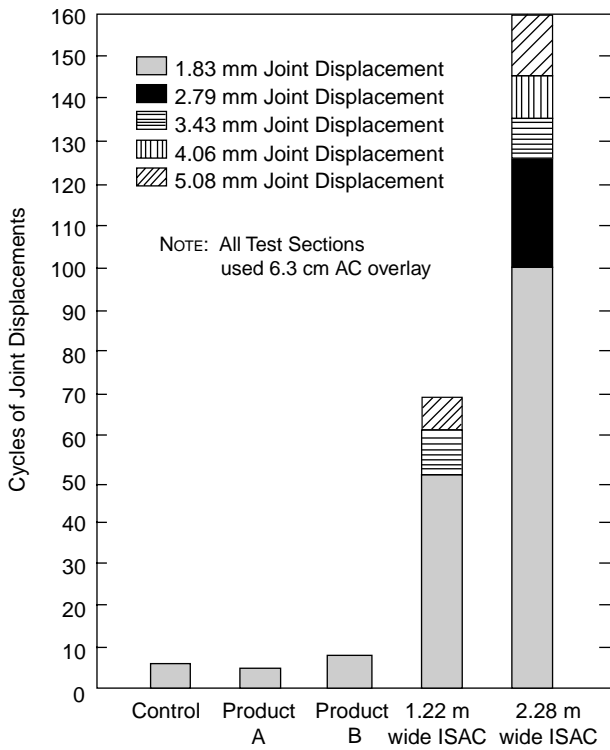
FIGURE 13 Comparative laboratory test results.
